Development and Recommendations for a Non-Proprietary, High-Tension, Cable End Terminal System

DEVELOPMENT AND RECOMMENDATIONS FOR A
NON-PROPRIETARY, HIGH-TENSION, CABLE END
TERMINAL SYSTEM

A THESIS

Presented to the Faculty of
The Graduate College at the University of Nebraska
In Partial Fulfillment of Requirements
For the Degree of Master of Science

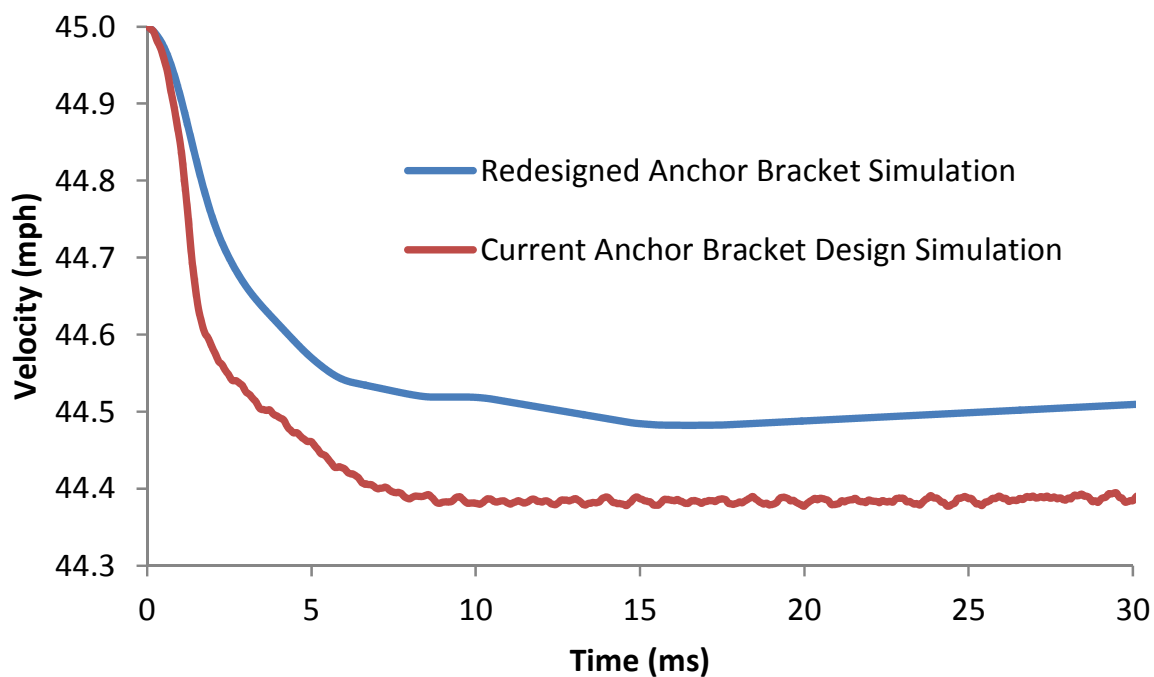
Figure 109. Anchor Bracket Assembly Simulations Velocity Comparison

The bogie velocity from the simulation with the current, high-tension, cable anchor bracket assembly design as well as that of the redesigned anchor bracket assembly exhibited similar trends. The Δv due to impacts were 0.48 mph and 0.56 mph for the redesign and current simulations, respectively. As such, the impact severity due to the bogie's impact with the cable release lever was reduced in the redesigned anchor bracket assembly simulation as compared to the simulation with the current anchor bracket assembly. The impact severity from the redesigned, high-tension, cable anchor bracket assembly was 166.44 lb-in. compared to 225.72 lb-in for the current anchor bracket assembly. The differences in impact severities resulted in a 26 percent reduction between the current design and the redesigned cable anchor bracket assembly. A comparison of the bogie velocity in the current high-tension cable anchor bracket assembly simulation and the redesigned high-tension cable anchor bracket assembly simulation is shown in Figure 109.

The primary reason for the reduction in impact severities was due to the change in the overall height in the cable anchor bracket assembly. Since the whole assembly was restricted to a 4-in. maximum height, the anchor point for the cables on the cable plate had to be lowered. The cable release lever support assembly was also lowered to properly align with the cable slots. By lowering the cables and the cable release lever assembly, the moment arm for the impacting vehicle was increased. The increased moment arm allows impacting vehicles to release the cables with less applied force, thus lowering decelerations and Δv . One consequence of increasing the moment arm is that the vertical, cable release tubes will be subjected to higher bending stresses. However, after review of the simulation results, there was no indication that tube deformation would be a potential issue.
