## In-situ, time resolved monitoring of uranium in BFS:OPC grout. Part 1: Corrosion in water vapour

Uranium encapsulated in grout was exposed to water vapour for extended periods of time. Through synchrotron x-ray powder diffraction and tomography measurements, uranium dioxide was determined the dominant corrosion product over a 50-week time period. The oxide growth rate initiated rapidly, with rates comparable to the  $U + H_2O$  reaction. Over time, the reaction rate decreased and eventually plateaued to a rate similar to the  $U + H_2O + O_2$  reaction. This behaviour was not attributed to oxygen ingress, but instead the decreasing permeability of the grout, limiting oxidising species access to the metal surface.

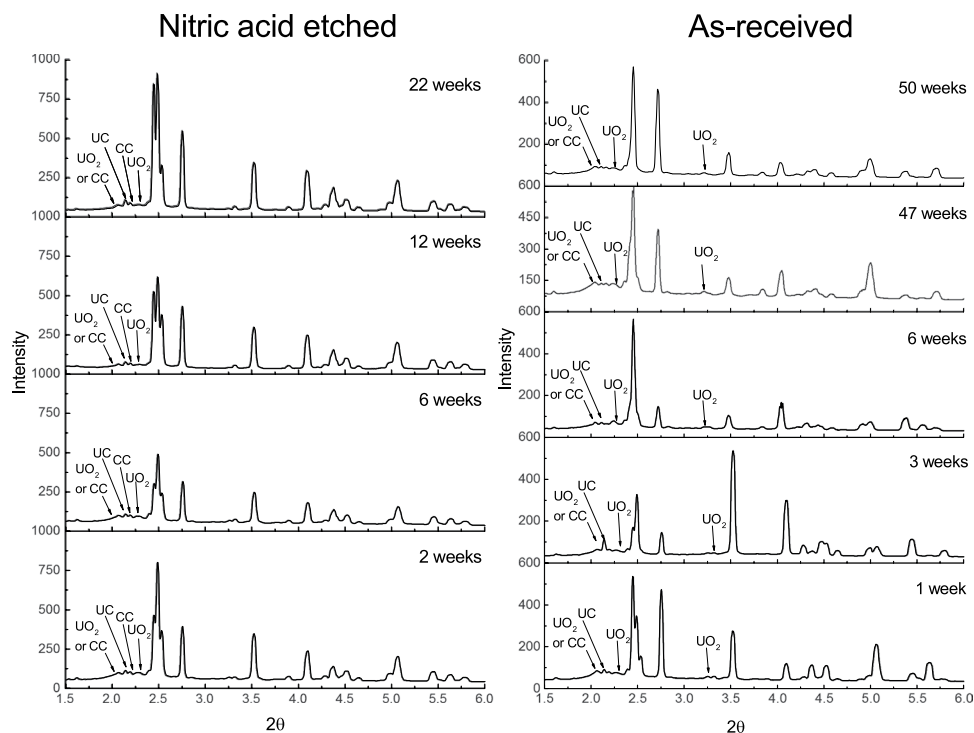
**Figure 1.** XRPD exhibiting the evolution of nitric acid etched and as-received, grout encapsulated uranium when exposed to de-ionised water vapour over time. CC = Calcium carbonate ( $\text{CaCO}_3$ ). All unlabelled peaks are attributed to uranium metal.

On each sample XRPD line scan data were averaged and are displayed in Fig. 1. The intensity of the measured corrosion product peaks between samples were not appropriate to compare since the photon flux and extent of

attenuation varied between beam times and due to the imperfect geometry of each sample.  $\text{UO}_2$  was identified as the dominant corrosion product in all samples, and no  $\text{UH}_3$  was detected over the 50-week period.

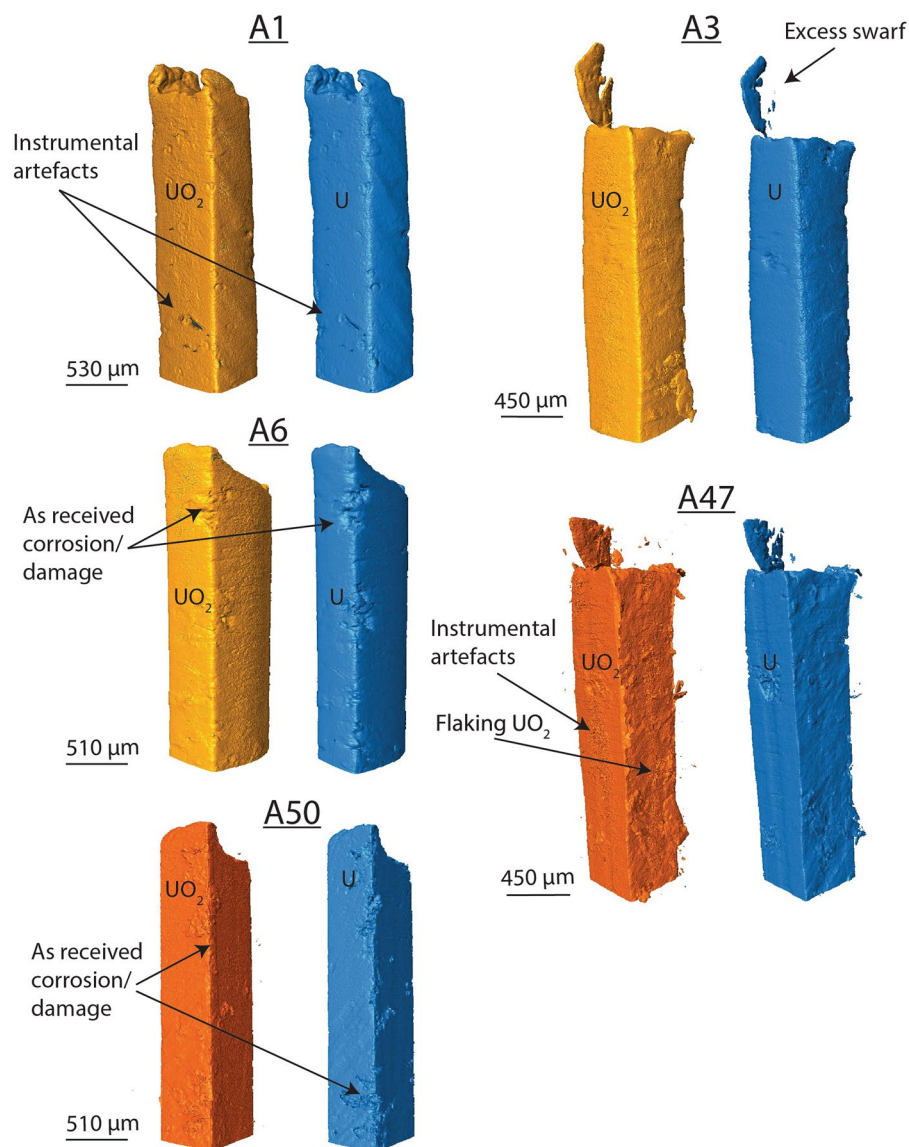
**Figure 2.** 3D renders of the as-received samples after exposure to water vapour. The contrast in density between uranium and  $\text{UO}_2$  permitted rendering of the two materials separately, thus the 3D renders of each sample are displayed in pairs. The images in blue show the residual uranium metal (right) and yellow or orange represents  $\text{UO}_2$  (left). The XRT quality between the two beam times changed dramatically and to show this, 3D renders in yellow are from using higher energies (115.6 keV) and orange from the lower energy (113.3 keV). Generally, edge artefacts, instrumental artefacts and absorption by the uranium prevented clean and sharp 3D renders for the higher energy beam time.

XRT images of each sample are displayed in Figs 2 and 3. As we expected from uranium characterisation before grout encapsulation (see Supplementary Fig. S1) the 'as-received' samples (Fig. 2) displayed a rough surface, with large areas of irregular sized pitting ( $\leq 250\ \mu\text{m}$  diameter) which were filled with a corrosion product  $\leq 40\ \mu\text{m}$  thick. The pitted areas were localised, with flat and uniform areas between. Only  $\text{UO}_2$  was detected by XRPD, however previous SIMS analysis also indicated carbon contamination (see Supplementary Fig. S2).

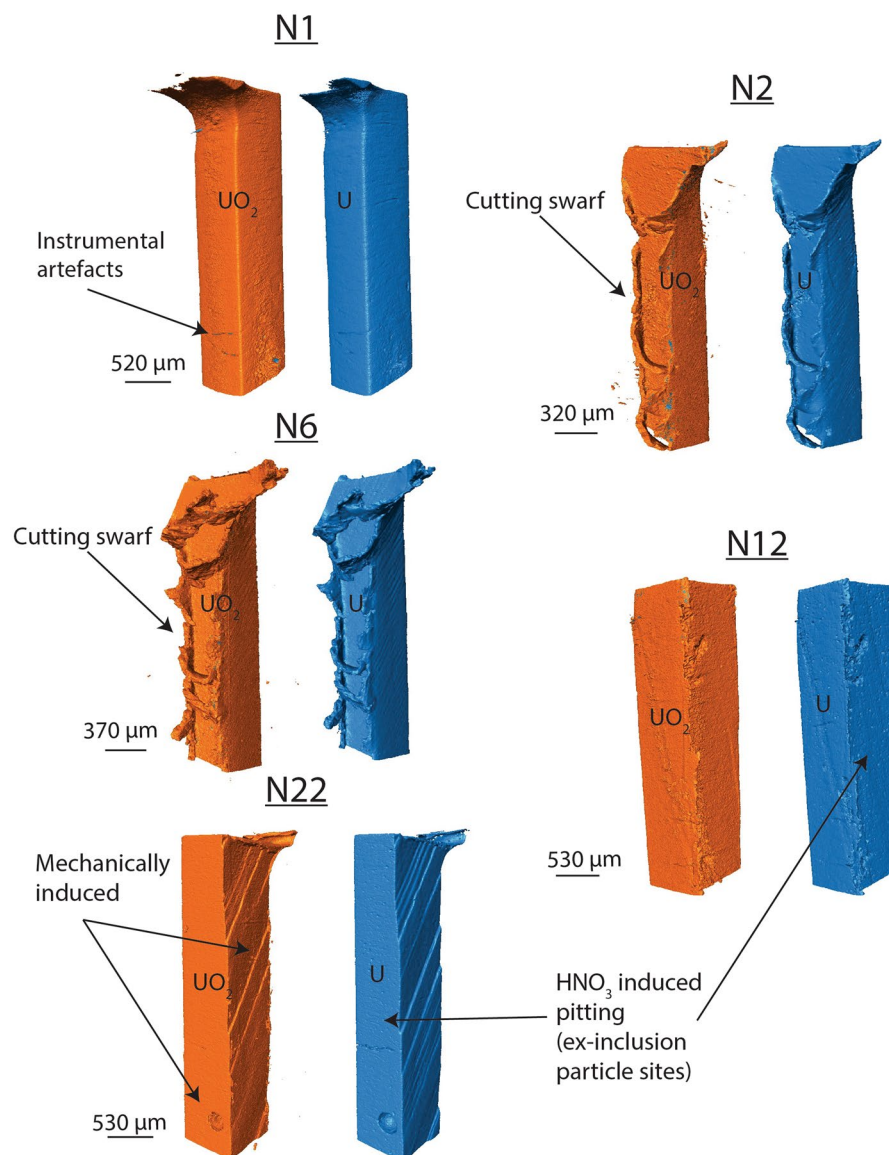
**Figure 3.** 3D renders of the nitric acid etched samples. The corrosion products are exhibited in orange (left) and the uranium in blue (right).

The nitric acid etched samples XRT also showed some as-received features (Fig. 3): excess swarf, from high speed cutting of the sample (for example N2 and N6); large spherical holes and ridges assumed to have formed during the metal casting process, as both were present in the corrosion product and uranium metal render; and small  $\sim 18\ \mu\text{m}$  diameter pits, with a spatial density of  $39.9\ \text{pits}\cdot\text{mm}^{-2}$  attributed to the pitting of removed inclusion particles after nitric acid etching (see Supplementary Fig. S3). However, consistent with XRPD analysis, uniform growth of a continuous corrosion layer across the metal surface was observed, indicative of uranium oxide formation.

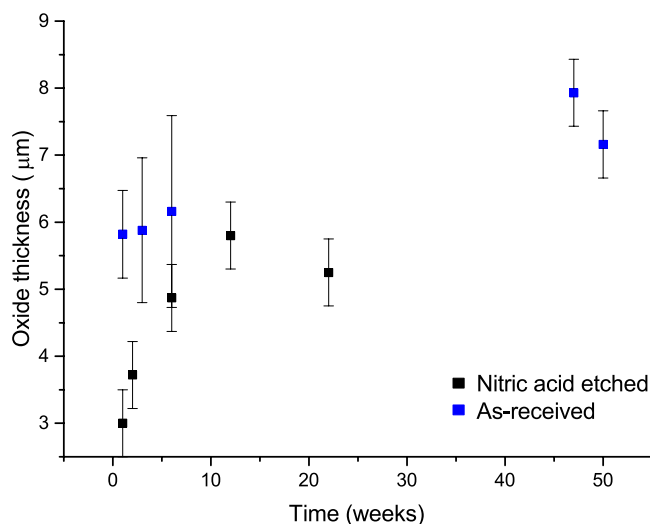
**Figure 4.** A plot demonstrating the change in  $\text{UO}_2$  thickness on each uranium sample when exposed to water vapour over time. Values and errors are extracted from Table 2.

Overall, we observed limited visual change between grout encapsulated uranium samples exposed to water vapour over progressively longer periods of time. We used cross sections at multiple positions of each sample render to measure the oxide thickness at 80 locations, and the average oxide thickness, with an associated error and range are shown in Table 2. In general, the oxide thickness of the uranium samples was observed to increase over time. More specifically, over the first 12 weeks the nitric acid etched uranium oxide growth appeared to initially grow rapidly, but then the growth rate decreased by 22 weeks (Fig. 4). Oxide thicknesses were greater and displayed a greater range on the 'as-received' samples owing to the initial corrosion layer present prior to encapsulation in grout.

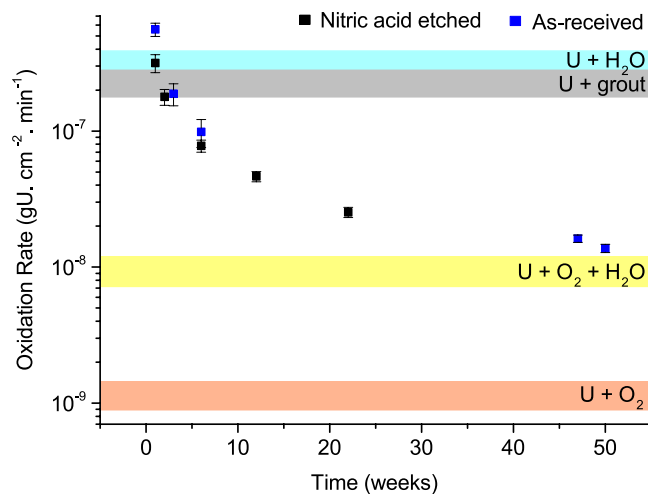
**Figure 5.** A plot demonstrating the variability in oxide growth rates of grout encapsulated uranium exposed to water vapour over time. Each band of colour represents the oxidation rate at 25 °C calculated from the empirically derived equations displayed at the beginning of this section by<sup>12, 13, 30, 36</sup>. These rates are compared to the rates calculated from the oxide thicknesses determined here. The error bars originate from the errors exhibited in Table 2, which have been processed through the equations.

To indicate the predominant mechanism for corrosion in the grouted system, we compared the rates of oxidation observed here to the empirically derived linear rates from the literature, in Fig. 5. The derived Arrhenius rate expressions used were:

Figure 5 shows that the oxidation of grout encapsulated uranium, which had been exposed to water vapour for increasingly longer time periods, initially proceeded at rates similar to those observed for the rapid  $\text{U} + \text{H}_2\text{O}$  oxidation regime reported by Delegard and Schmidt (6). However, over time the oxidation rates gradually decreased towards an apparent  $\text{U} + \text{O}_2 + \text{H}_2\text{O}$  regime, with a decay rate (D) of  $(3.96 \times 10^{-7})T^{-0.86}$ , where T = time (weeks) (Fig. 5). It is believed that this behaviour was directly related to the ageing properties of the grout.

Toward 50 weeks, the uranium oxidation rates change again and are observed to plateau (Fig. 5). This may suggest the beginning of a linear rate which is governed by the established permeability of a near fully matured grout, achieving a steady state which allows some slow diffusion of water vapour to the metal surface.
