Corrosion Protection of Hot Dip Galvanized Steel in Mortar

Rita M. Figueira,^{a,b,*} Elsa V. Pereira,^a Carlos J.R. Silva,^b Maria M. Salta^a

^a *LNEC – Laboratório Nacional de Engenharia Civil, Lisboa, Portugal*

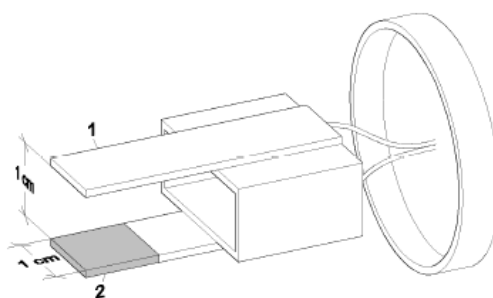
Figure 1. Schematic representation of electrochemical system developed for assess coating performance through monitoring of i_{gal} . Legend: 1. Stainless steel counter electrode (CE); 2. HDGS coated working electrode (WE), with OIH gel deposit represented by a grey zone.

To assess the reliability of the electrochemical system, macrocell current density (i_{gal}) 0 measurement was performed using a system based on two electrodes (parallel rectangular metal plates with 5.0x1.0x0.1 cm), as shown in Fig. 1. The working electrode (WE) was a HDGS plate, also with two cm² of area, and coated as described in section “Preparation of HGDS coated samples”. The grey area in Fig. 1 represents the OIH coating on HDGS. The counter electrode (CE) was a stainless steel (SS, type 316L) plate with an active surface section of 2 cm². The edges of both of the electrodes plates, as well the non-active area and connecting zones were protected with a two-component epoxy resin (Araldite®). The set of the two electrodes was fixed in plastic lids that fit in a 100 mL polyethylene flask (Normax). For comparison purposes, cells using a HDGS WE without any OIH coating were prepared to be used as reference (hereafter referred generically as control cells).

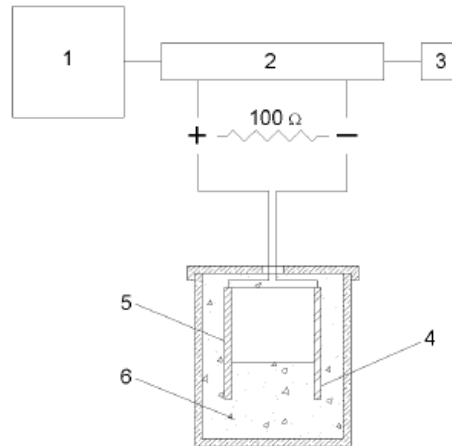
Figure 2. Schematic representation of assembled two electrodes cell. Legend: 1. PC; 2. Datataker; 3. Power supply; 4 and 5. Working and counter electrodes, respectively; 6. Mortar.

To assemble the electrochemical cells used to measure i_{gal} , 120±10 g of fresh mortar was transferred to each 100 mL PE flask where the electrodes were immersed and the flask closed (mortar was prepared according to section 2.3 and immediately used). Using an automatic data acquisition system (Datataker DT505, series 3), the i_{gal} measurement of the prepared cells were performed through reading the potential difference to the terminals (shunted with a 100 Ω

resistor *vide* Fig. 2) immediately after being embedded in fresh mortar. Measurements were performed with a periodicity of 1 minute at the first seven days, and at each 5 minutes during the remaining time until the record was completed, at the 74th day.

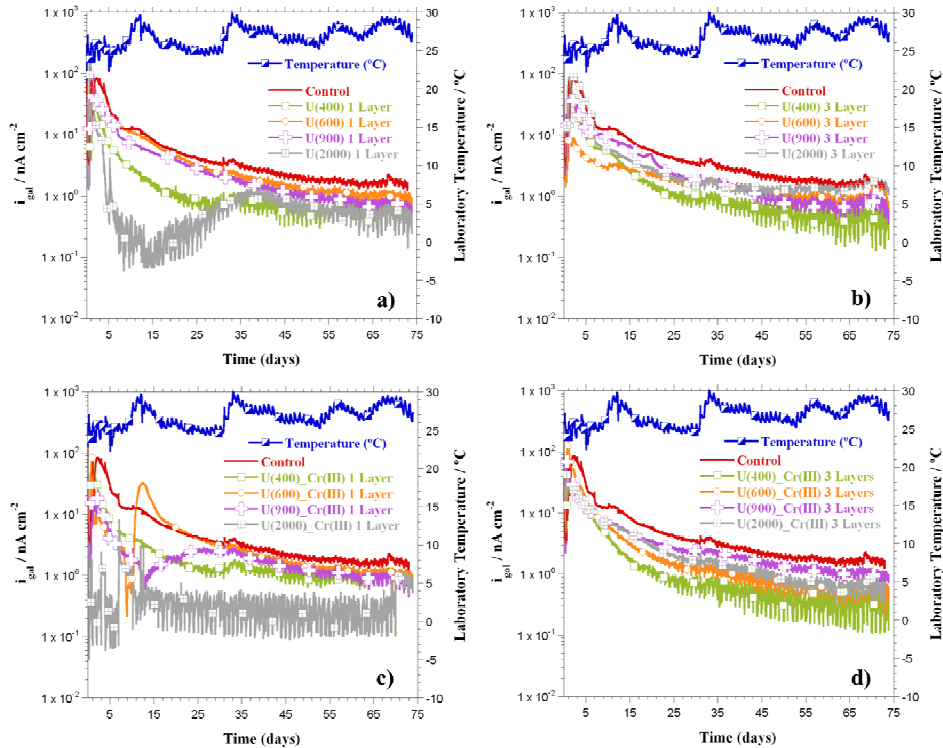
Figure 3. Recorded galvanic current profiles.

Fig. 3 shows the macrocell current density (i_{gal}) response collected from the different prepared electrochemical cells involving the HDGS coated samples and the control cell during 74 days 0.

The high values of i_{gal} recorded for the first days of contact with the fresh mortar are due to zinc corrosion, that in the presence of high alkaline environments it corrodes 0-0. Nevertheless, the coated samples tend to lower values when compared to control sample. The obtained evolution of cell current density with time shows a profile that is dependent on OIH coating matrix, the presence of Cr(III) ions and the number of dipping steps. Globally the measured current

density decreases along the contact time showing in the 74th day an average value that is about two orders of magnitude lower than the initially observed. Cells based on one layer coated HDGS samples reveal a very noisy behavior comparatively with samples with a coating produced by three dipping steps.

As shown, the i_{gal} cell values are sensitive to the external laboratory temperature variation and to the composition and number of OIH deposited (one and three) layers. The collected data make possible to distinguish between the different used OIH coatings as the output response changes with the coating composition and with the presence or absence of inhibitor (Cr(III)). It was also observed that the uncoated HDGS specimen shows the higher current density values among the all set of tested macrocells.

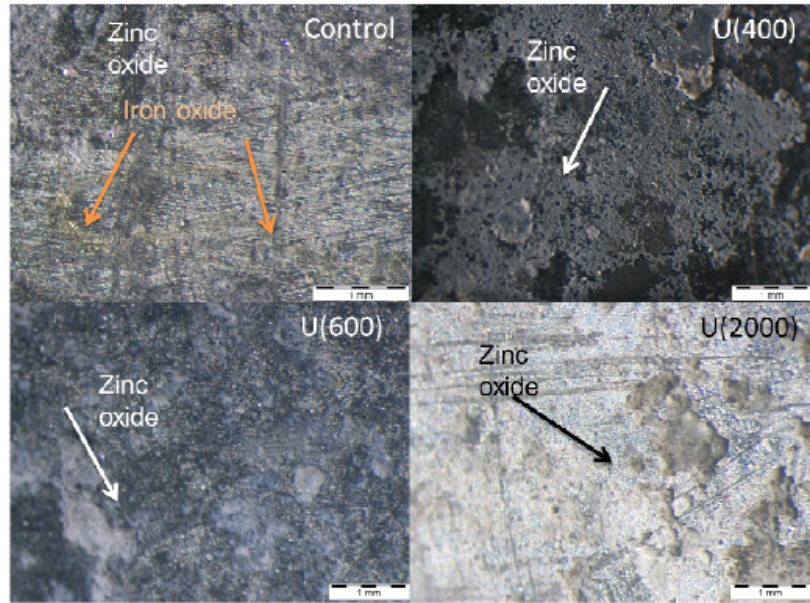
Figure 4. Observation of HDGS surfaces uncoated (control) and coated with OIH sol-gel with stereomicroscope after being embedded in mortar for 74 days, showing the presece of zinc oxide and traces of iron oxides.

Fig. 4 shows the images obtained with a stereomicroscope for the uncoated HDGS (control) and for HDGS coated by one dip step for U(400), U(600) and U(2000). The stereomicroscope images that show to be less attacked by the electrolyte correspond to cells where lower values of i_{gal} data were recorded.

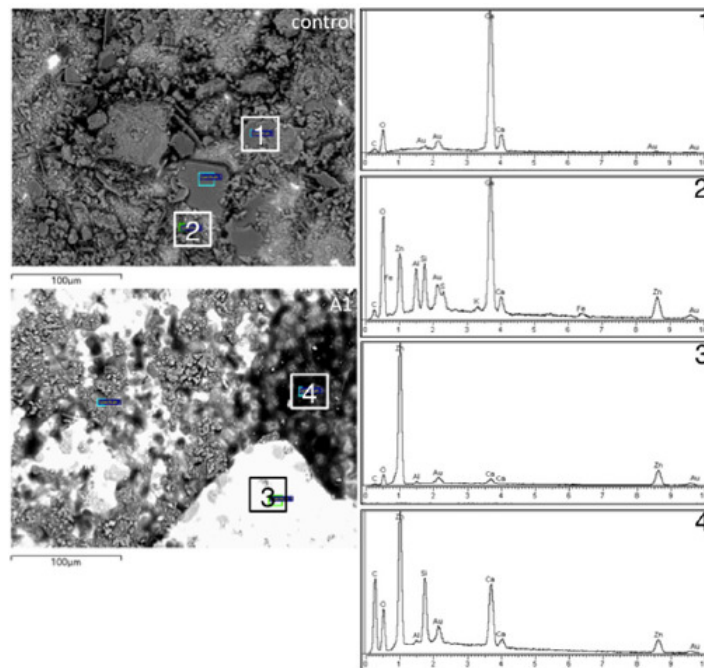
Figure 5. BSE images of the HDGS samples surface for control and HDGS coated with U(400) after being embedded in mortar for 74 days with the localization of the EDS spectra; 1, 2 EDS spectra for control; 3 and 4 EDS spectra for HDGS coated with U(400).

Fig. 5 shows the SEM images and EDS spectra obtained for the control and for HDGS coated with U(400) by one dip step.

From the analysis of the collected set of images obtained by SEM, it can be concluded that the surface of uncoated HDGS sample (control cell) reveals the most severe damages among all that were exposed to mortar. The obtained results from EDS analysis reveal the presence of iron peaks. These results are in agreement with i_{gal} data and with stereomicroscope images.

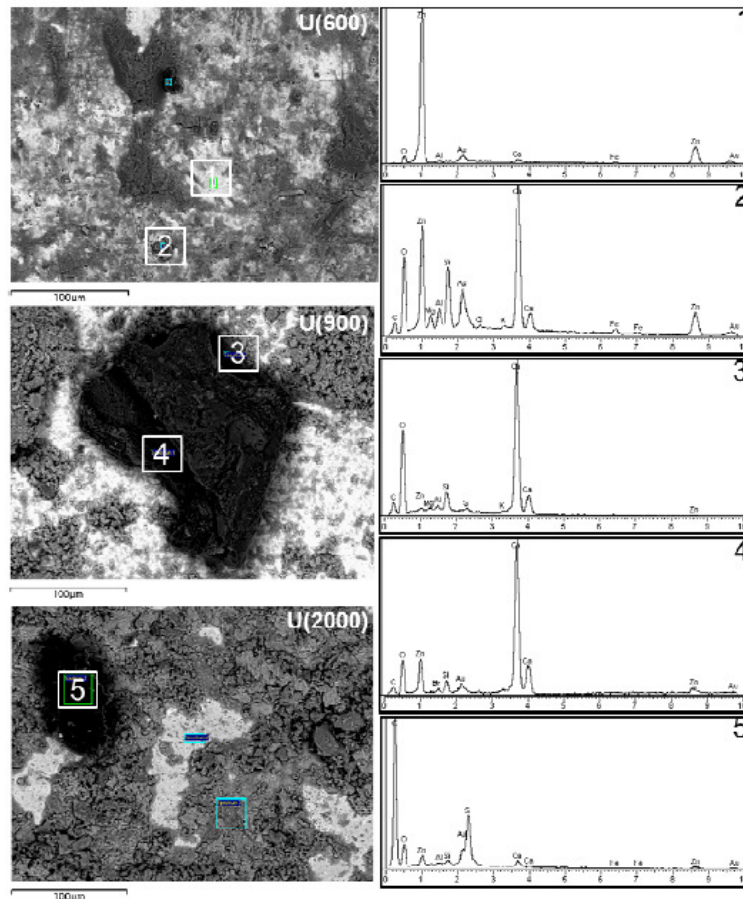
Figure 6. BSE images of the HDGS samples surface coated with U(600), U(900) and U(2000) after being embedded in mortar for 74 days with the localization of the EDS spectra; 1, 2 EDS spectra for HDGS coated with U(600); 3 and 4 EDS spectra for HDGS coated with U(900); 5 EDS spectrum for HDGS coated with U(2000).

Fig. 6 shows the SEM images and EDS spectra obtained for HDGS coated with U(600), U(900) and U(2000) by one dip step.

The topic of this paper is to evaluate the response and the behavior of the electrochemical system when testing different OIH coatings. It was observed that the HDGS coated samples do not show to be similarly affected by the corrosive action of mortar components and depend on the OIH coating applied, as observed in stereomicroscope images displayed in Fig. 4. The EDS correspondent spectra show the presence of carbon and silicon on the surface indicating that the applied coating preserved their initial form. The information obtained by these two techniques confirms that the barrier stability and efficiency of the OIH gel coating contribute to minimize the recorded current density and consequently minimize the extent of HDGS corrosion process. The results obtained show that the electrochemical system is reliable and suitable to evaluate the behavior of the OIH coatings.
