40th IABSE Symposium, 19-21 September 2018, Nantes, France.
Tomorrow's Megastructures

Lifecycle Assessment of Different Constructive Solutions in Aggressive Maritime Environments - Application to the Viaduct of the Oil Terminal of the Port of Leixões

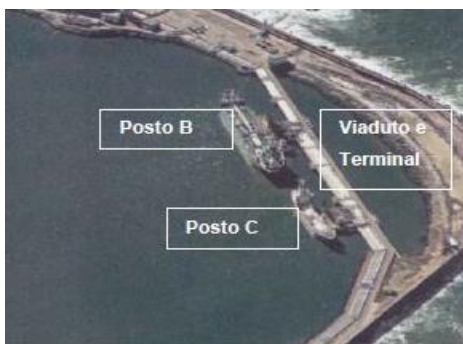
Figure 1. Aerial view of Viaduct and Terminal

The Viaduct and the Maritime Terminal of Oil Tankers of the Port of Leixões have their initial project dated 1967, which is supposed to be the execution date. This is a structure consisting of longitudinal beams and crossbeams all in prestressed reinforced concrete based on pillar piles, which support a beam tray with 33 independent spans of 10 m in length each. The structure between supports has an extension of approximately 380 m [3]. Figures 1 and 2 represent an aerial view of the Structure and a cross section.

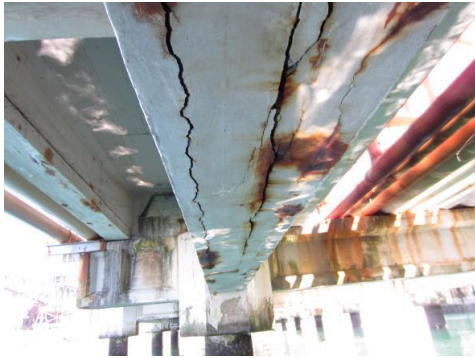
Figure 1. Longitudinal cracks in the bottom flange of the beam

During the course of these inspections, a survey was made, based on visual observations and photographic records, of the state of the structure, identifying the main pathologies presented in Figures 3 to 6 [3].

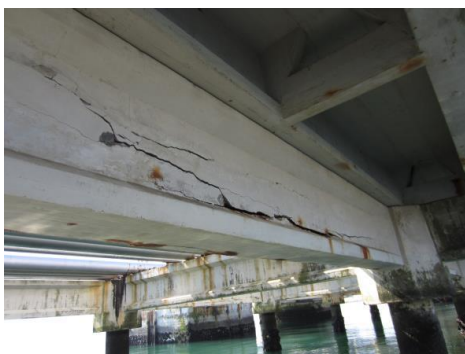
Figure 2. Longitudinal cracks in the core of the beam associated with the pre-stress cables

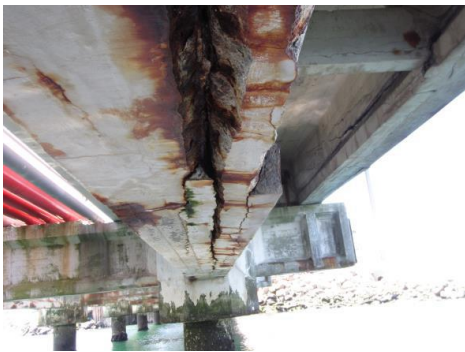
Figure 3. Loss of section associated with the corrosion of the reinforcement

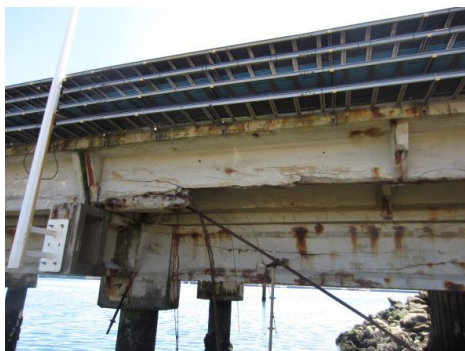
Figure 4. Beam ruin
