## Research Article

# Encoding Scratch and Scrape Features for Wear Modeling of Total Joint Replacements

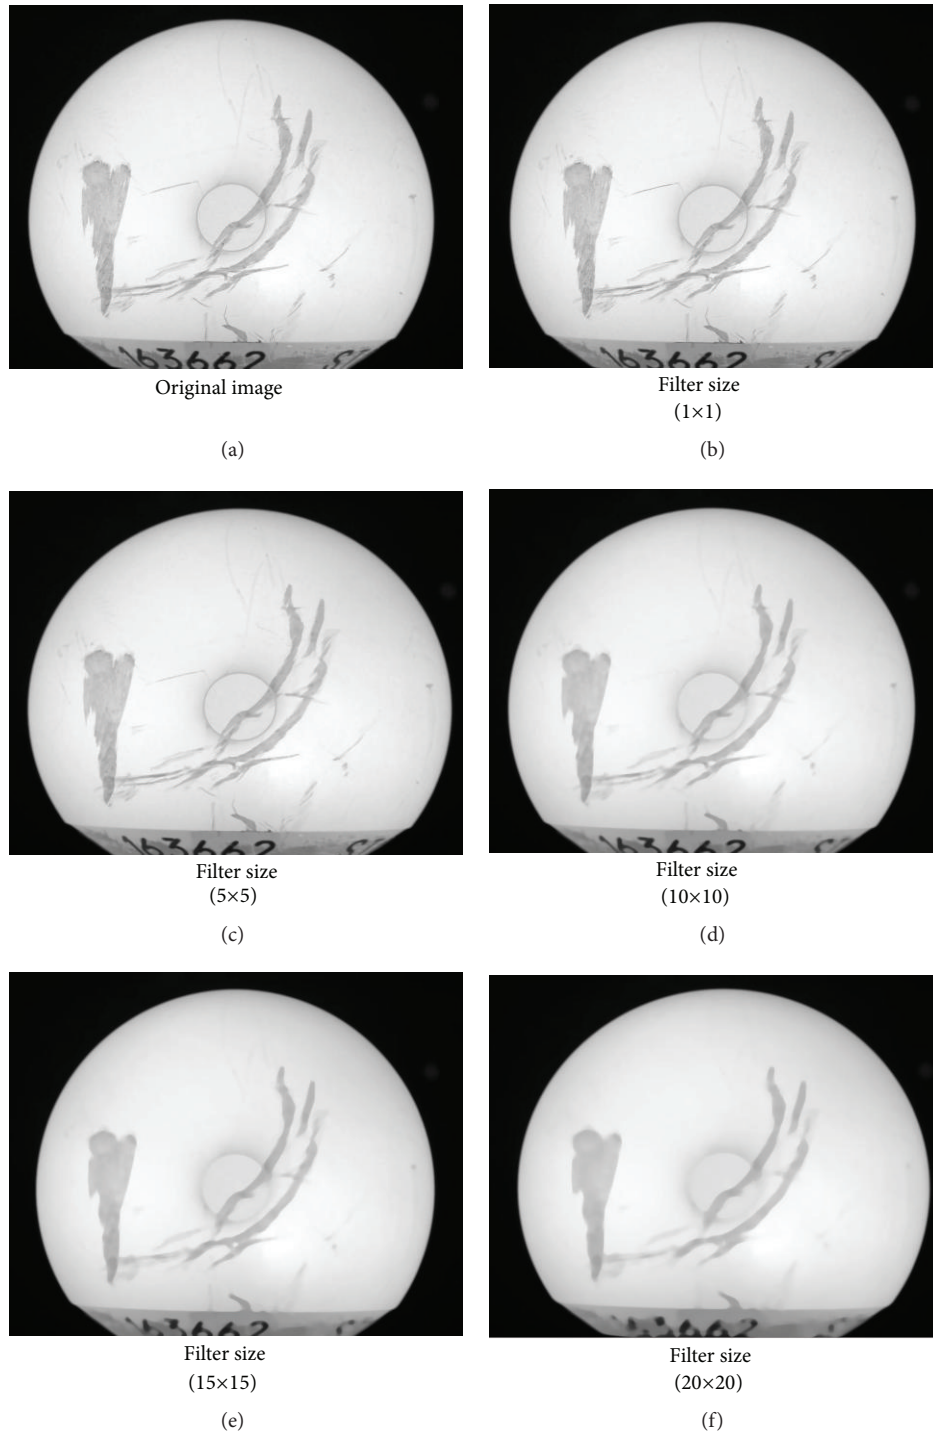
FIGURE 1: Successively stronger median filters of various sizes applied to an original image of a retrieval femoral head. The filter size indicates the neighborhood around the corresponding pixel in the input image for which the median value is calculated. This parameter allowed the analyst to control the distinction between scratch and scrape.

A custom-written MATLAB routine was used to determine regions of damage apparent in the global-level images. Canny edge detection was first performed to detect regions of damage, based on grayscale discontinuity relative to (bright) undamaged regions. This edge detector distinguished edges on the basis of maximum gradients of intensity. Edges were flagged if their gradients fell above an analyst-set threshold. This threshold value was set such that it was sensitive enough to detect the fine-scale scratches, but high enough so as to avoid influence from grayscale variations associated with the necessarily nonuniform distance from the camera lens. Next, a median filter was applied to the original images, replacing each pixel's intensity with the median of pixel intensities in a surrounding square region of analyst-specified size. Median filtering in this context had the effect of "blurring away" linear damage features (i.e., scratches) whose breadths were below a specific threshold. Analyst specification of the median filter size thus provided a basis for objectively distinguishing between scratches versus scrapes, for which different computational treatments were utilized for purposes of polyethylene wear modeling (see below). Empirically, various filter sizes were applied to representative original images that contained both scratches and scrapes (Figure 1). A  $20 \times 20$  filter size was judged appropriate for distinguishing between scratches and scrapes, and was therefore used for *en masse* data processing in this retrieval series.

The darkened regions remaining after the median filtering operation were then autosegmented using an analyst-set intensity threshold. These constituted the scrape features. The scrape regions thus identified were then removed from the pre-median-filtered Canny edge detection result, leaving the remaining (i.e., non-scrape) damage features to be classified as scratches (Figure 2). A Hough transform was then used to discretize these scratch damage features into straight-line scratch segments. This analysis technique used a linear transform and the parametric equation of a straight line to determine the number of points falling along any given candidate straight line. Those candidate lines whose lengths fell above an analyst-set threshold were flagged, thus discretizing curvilinear scratches into concatenations of straight-line scratch segments.

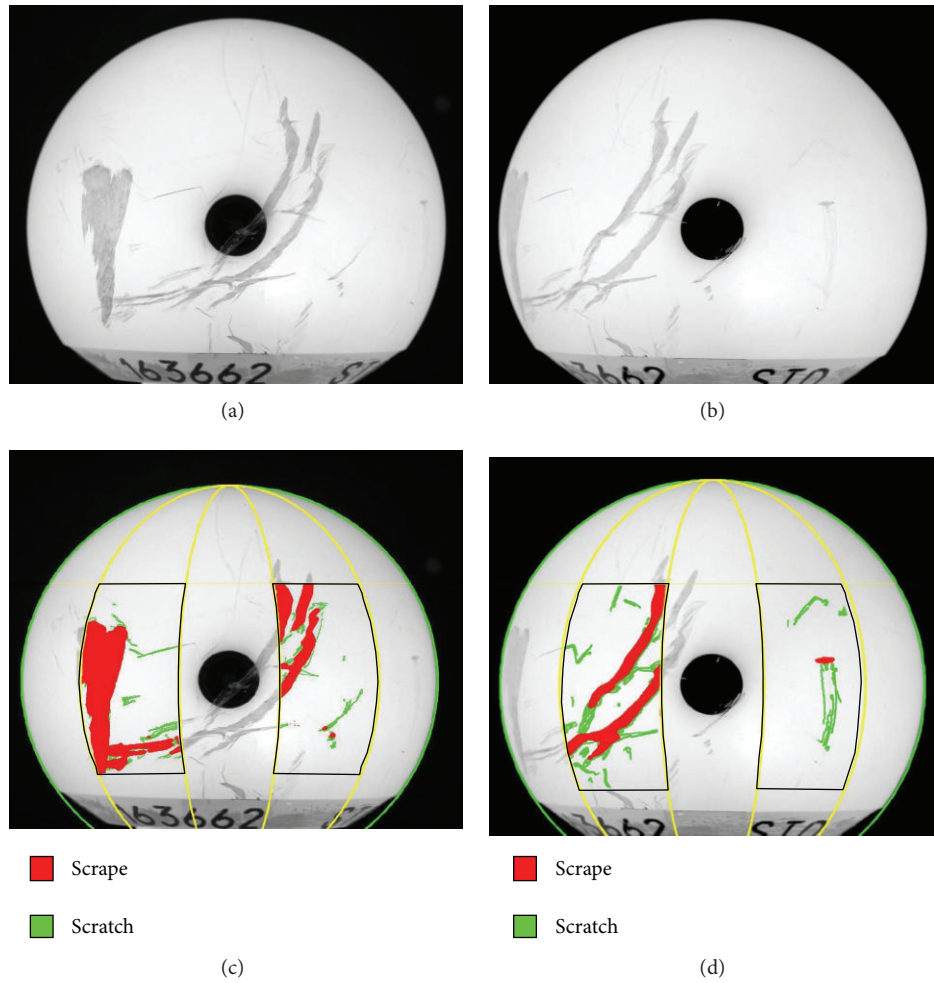
FIGURE 2: ((a), (b)) Diffused-light images of a femoral head displaying both scratch and scrape damages, captured from two orientation directions  $30^\circ$  apart circumferentially. (The black dot in the center of the images is from camera lens reflection. This reflection required that multiple view directions be utilized.) ((c), (d)) Image-processed results displaying identified damage regions. The sectors outlined in black indicate areas analyzed for this particular image. The top of the femoral head was captured and analyzed in companion polar images.

Retrieval femoral heads were first digitally photographed using a novel diffused-light illumination technique [17]. This involved positioning the implant component on an angular indexing stage, inside a translucent white tube which eliminated spurious reflections from ambient lighting and room surroundings. Globally registered 1.6 megabyte digital photos ( $4432 \text{ pixels/mm}^2$ ) were then taken from the polar direction and at 30 degree increments circumferentially, so as to image

the entire bearing surface. These images provided vivid visual rendition of all macroscopically apparent damage features on the entire implant bearing surface. (As noted below, images taken at this resolution have been shown to highlight scratches that are well below wear-consequential severities.) The associated (grayscale) intensity modulations provided a basis for the damage to be objectively registered for purposes of image analysis. The damage was of two principal types: scratches and scrapes. The distinction was that scratches were manifest as thin discrete individual darkened lines, whereas scrapes were manifest as broad swaths of diffuse darkening, within which individual scratch tracks could not be distinguished at the global image level.

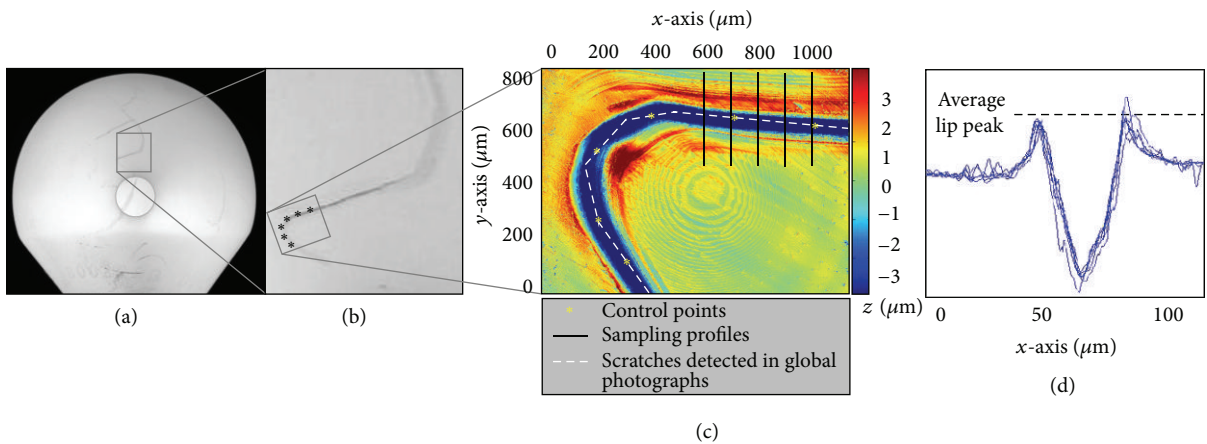
FIGURE 3: Global (a) and close-up (b) photographs of a scratched femoral head. Control points used for alignment with the OP scans are indicated by asterisks. (c) Local OP scan of selected region. (d) OP scan profiles used to calculate scratch lip height for a single scratch segment.

Superimposition of analyst-selected control points allowed alignment of the OP scans with their respective global-level images (Figures 3(a)–3(c)). For each OP scan, six sets of control points were chosen from damage features that were visually distinguishable on both the global-level image and the OP scan. These control points were used to compute a 2D transformation structure, based on second order polynomials. The global image was then translated and rotated based on this 2D transformation, to associate the detected damage features with their respective locations on the OP scan.

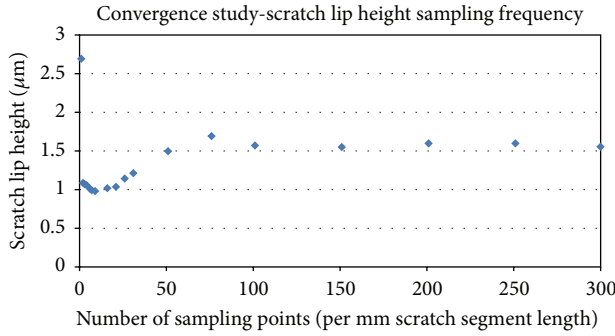
FIGURE 4: The results of a sampling convergence series, undertaken to determine appropriate sampling frequency.

Encoding the identified damage features involved accounting for both directionality and severity. In the case of scratches, directionality was simply the locally prevailing orientation of the scratch, and severity was based on the average scratch lip height (the dominant factor in wear elevation [18]) calculated from the OP data. To make the severity calculation, each designated scratch segment was first superimposed on its corresponding OP image(s) (Figure 3(b)). Values of surface vertical height were then queried from the OP dataset(s) along a series of equally spaced sampling lines directed perpendicular to the scratch segment. The peak surface height was identified along each of those sampling lines, and the mean of those peak heights was designated as the scratch lip height for that individual scratch segment (Figures 3(c) and 3(d)). (Convergence analysis had been performed to determine appropriate density of the sampling lines (Figure 4).)

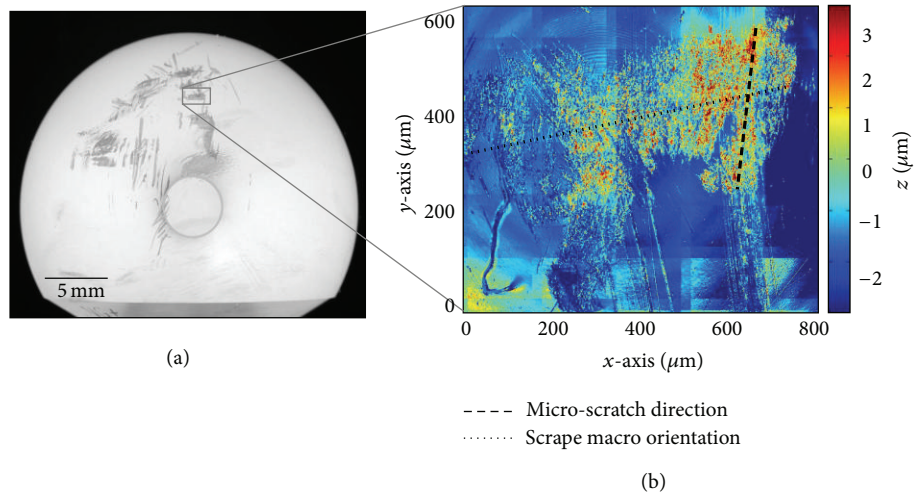
FIGURE 5: (a) Global photograph of scrape region. (b) Local OP scan, revealing scrape morphology. The dashed black line indicates the direction of microscratching, as determined by Hough transform. The dotted black line indicates the orientation of the macroscopic scrape.

In the case of scrapes, the directionality of interest for purposes of polyethylene wear modeling was not the macro-level direction of the scrape, but rather the direction of "micro-level" scratching within the scrape. While these two orientations were similar or nearly so for many scrapes, there were notable exceptions, such as when circumferentially oriented macroscrapes resulted from transverse sliding during egress of edge-loaded femoral heads during subluxation. To identify the direction of microscratching, a Hough transform was performed on each scrape OP dataset, which detected the microscratch lines within the scrape. The longest such line was designated as the scraping direction for that scrape area (Figure 5). Severity of scraping was quantified in terms of the average roughness within the segmented scrape region. This computation was made from OP data, again based on control point registration between (polygon-delineated) macrolevel scrape features and corresponding features in the OP datasets. The average roughness ( $R_a$ ) value within each scrape polygon

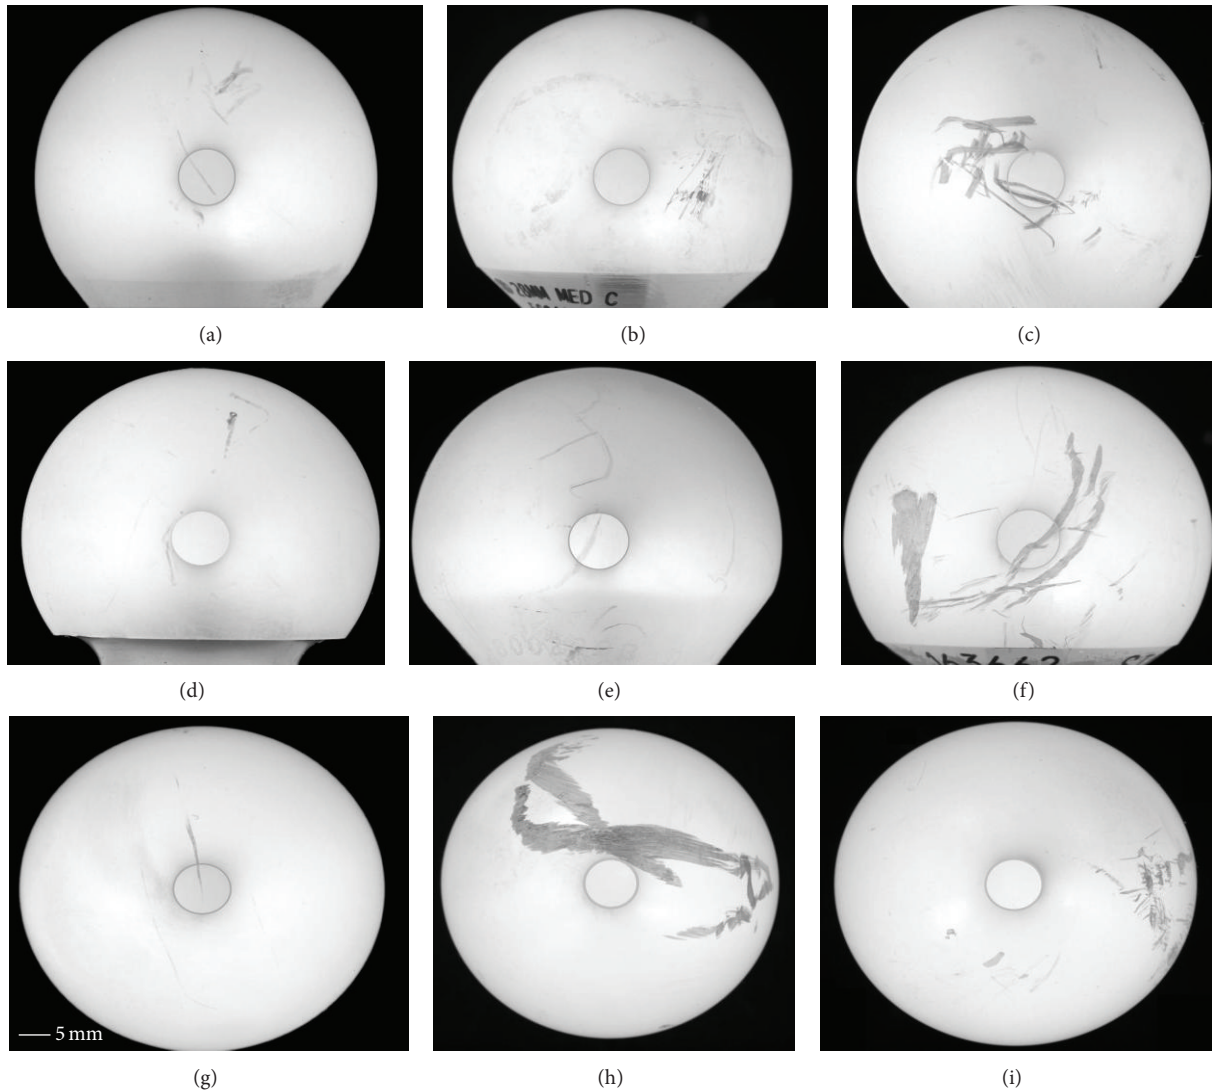
FIGURE 6: Global photographs of representative retrieval femoral heads.

Scratch and scrape damage was encoded for nine representative specimens from our institution's collection of femoral

head retrievals (Figure 6). The image processing routine detected scratches on seven of those specimens and scrapes on five of them. The distribution of severities of detected scratches (lip heights) and scrapes ( $R_a$  values) are reported in Tables 1 and 2, respectively. The seven specimens exhibiting scratch damage all showed large variability in the severity of individual scratches (Figure 7). The particular specimen showing the greatest amount of variability (specimen no. 5) had scratch lip heights ranging from 0.10 to 9.75  $\mu\text{m}$ . In the interest of completeness, the present set of results includes scratches with lip heights as low as 0.07  $\mu\text{m}$ . This may be unnecessarily exhaustive, however, since there is experimental evidence that the lip height threshold for detectable wear rate acceleration from individual scratches is substantially higher, on the order of 1  $\mu\text{m}$  [18]. If desired for purposes of computational economy, wear-inconsequential scratches can be disregarded from further consideration in downstream wear modeling, simply by Boolean masking on the basis of lip height.

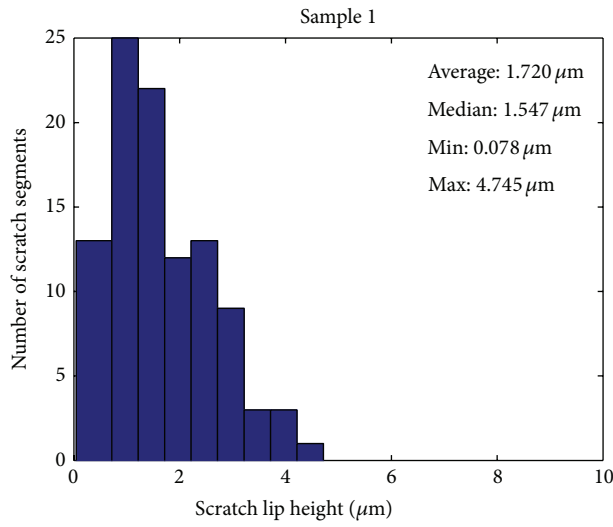
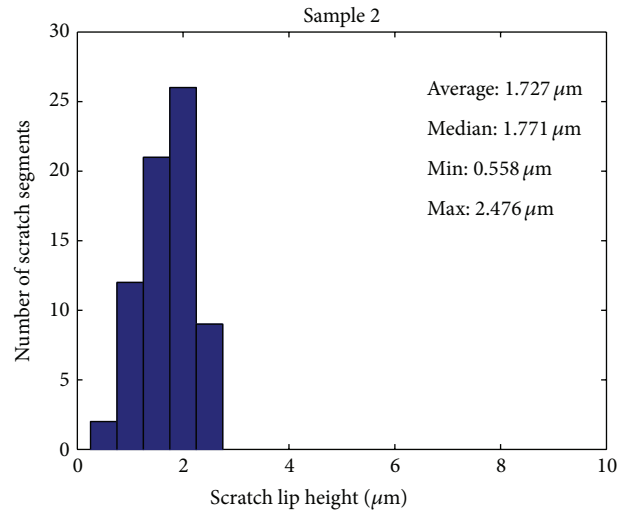
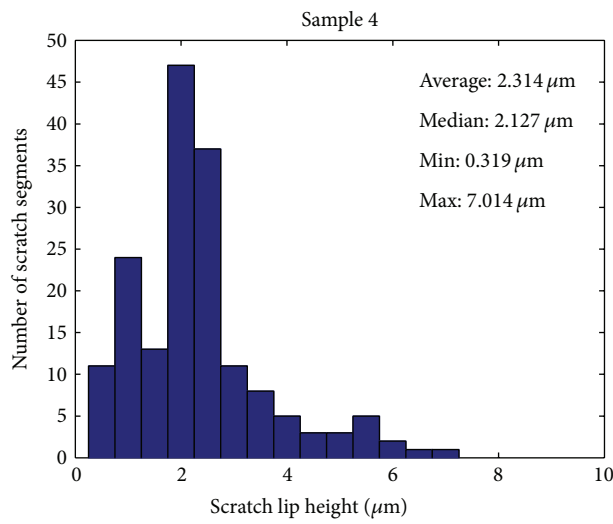
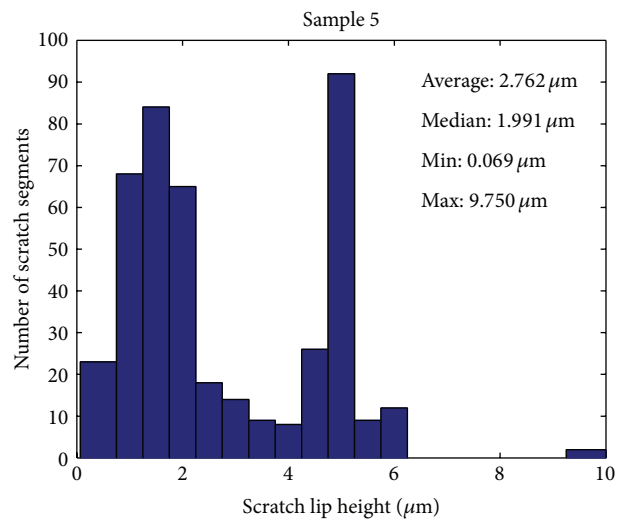
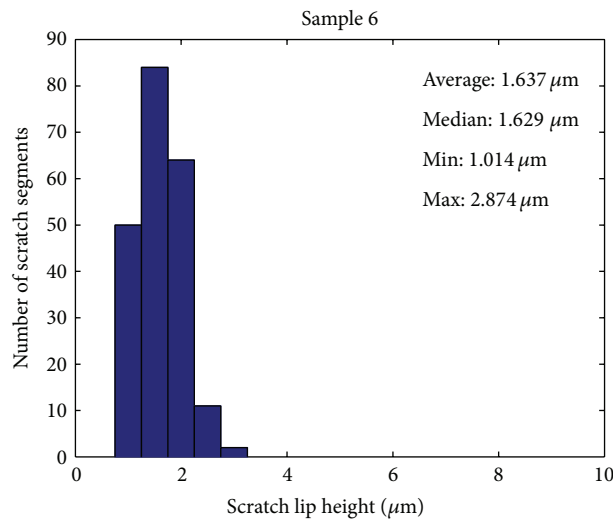
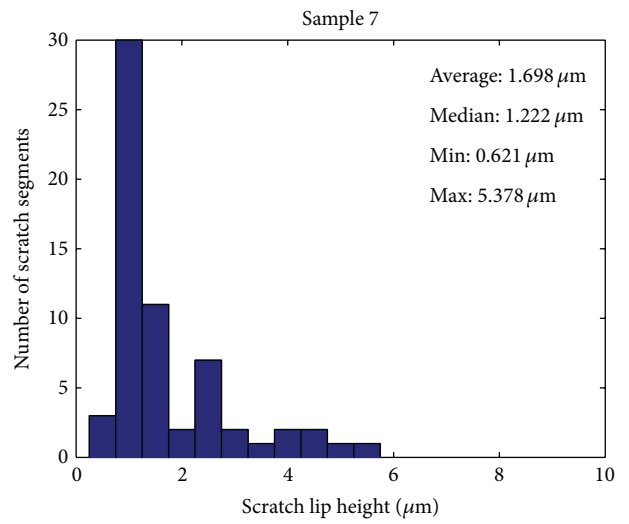
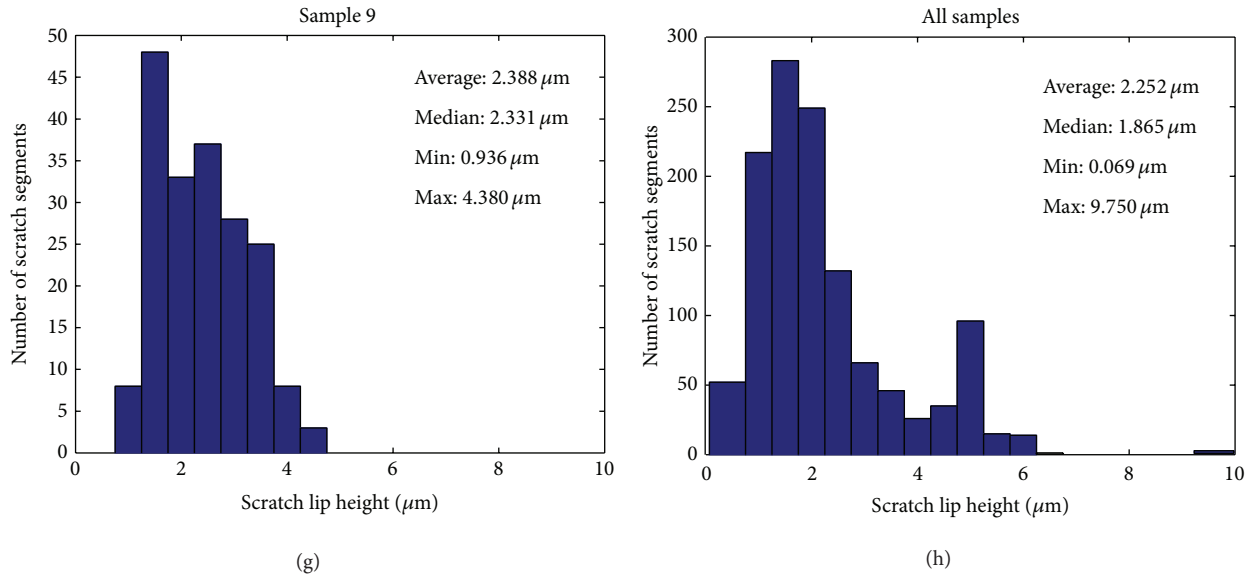
FIGURE 7: Distributions of the scratch lip height values for each femoral head that displayed scratch damage.

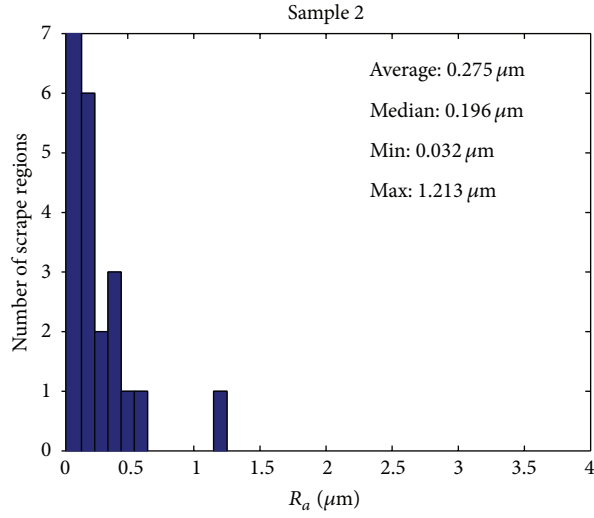
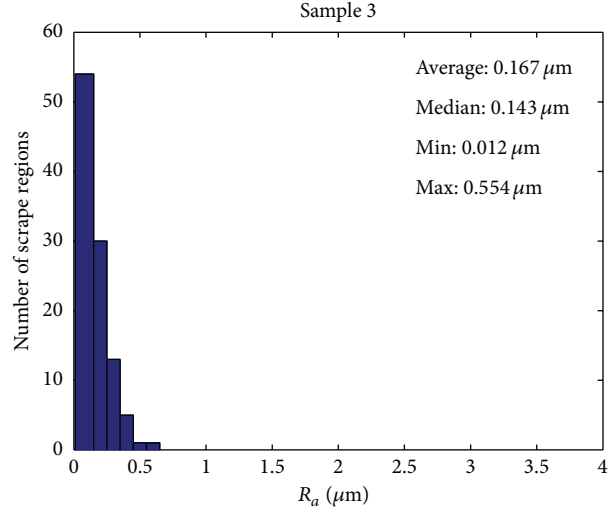
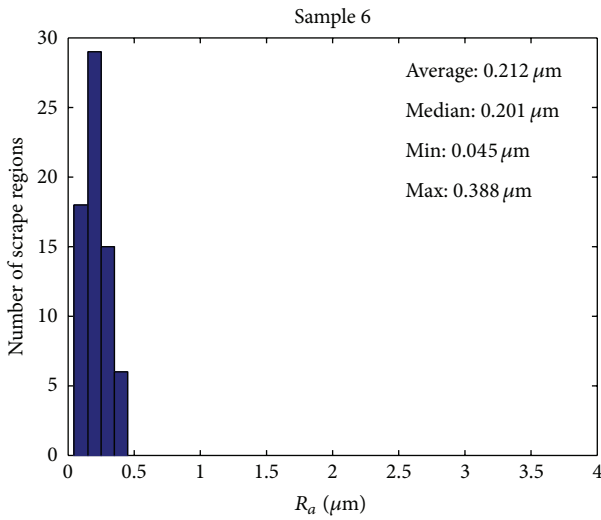
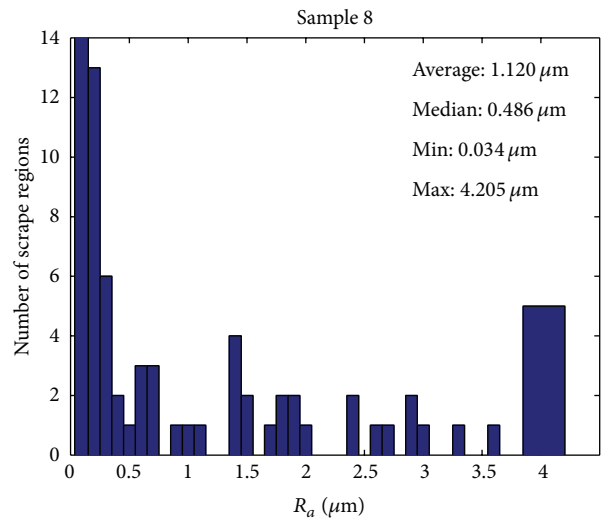
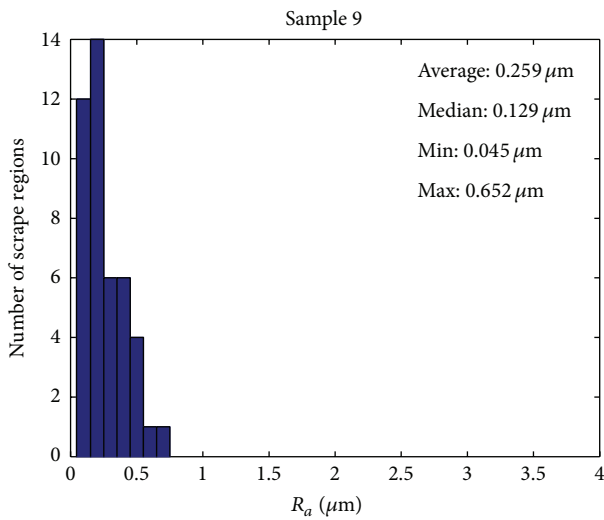
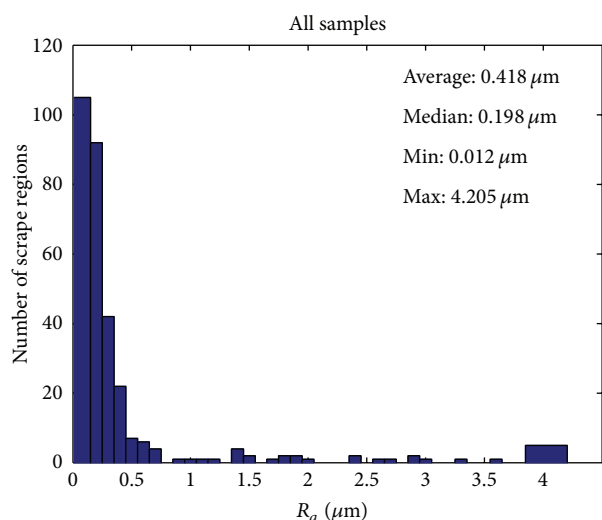
FIGURE 8: Distributions of the  $R_a$  values for each scrape region in the femoral heads that displayed scrape damage.

The computed  $R_a$  values of scraped regions also showed considerable variability (Figure 8). Series-wide, the highest scrape-average roughness value was 4.20  $\mu\text{m}$  (specimen no. 8), a three-order-of-magnitude elevation relative to typical  $R_a$  values for undamaged implant surfaces [16].

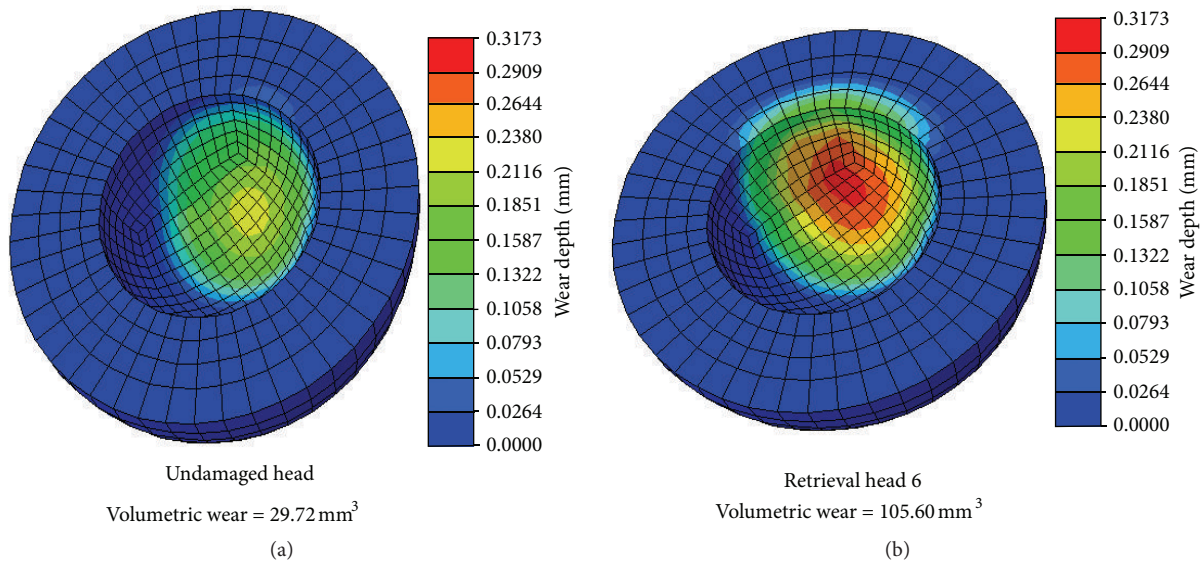
FIGURE 9: Computed wear depths ( $1 \times 10^6$  cycles) for an undamaged and retrieval femoral head (28 mm).

Illustratively, an FE wear model of one particular specimen (specimen no. 6) from this series was generated by mapping each identified damage feature's severity, orientation, and global-level geometry onto the femoral head. Collectively, these damage features, comprised of a total of 211 scratch segments and 68 scrape regions, led to a 3.8-fold increase in polyethylene liner wear, compared to a baseline simulation of an otherwise-identical undamaged femoral head (Figure 9). Of this wear increase, 68% was due to the scratch damage and 32% was due to the scrape damage.
