## **Numerical analysis of the partial collapse of a twin-tubes tunnel**

# Numerical analysis of the partial collapse of a twin-tubes tunnel

On the 1st of January 2014, the left tunnel of the twin-tube situated in the eastern part of the East-West Algerian highway, still under construction, was affected by a partial collapse, which induced significant damages over a distance of 120 m. In this paper, a 3D numerical simulation was used to investigate the loading state and deformation pattern governing the structure during the partial collapse. The results shows that the failure was mainly triggered by a large displacements of the primary lining which was applied to the left tunnel without final reinforcements, and was insufficient to counteract the applied stresses. Practical recommendations that could be drawn from this case are suggested.

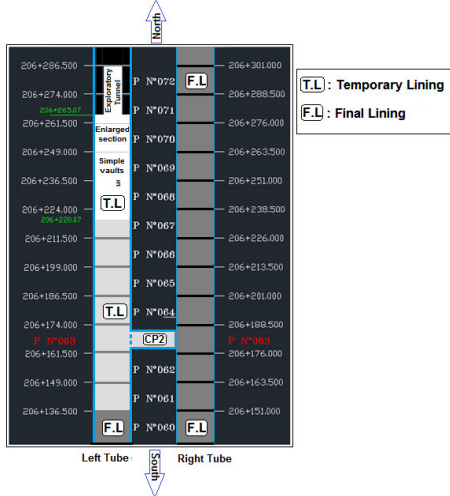
Fig. 4 Top view of the twin tubes tunnel.

On the 1<sup>st</sup> of January 2014, the twin-tube highway tunnel "T1" was affected by a partial collapse over a linear distance of about of 120m. Figure 4 summarize the situation (lining) of the tunnels before the collapse, the right tube was already completed and opened to the traffic for four months since September 2013, while the left tube was still being excavated after a long halt of 18 months. After the partial collapse, the significant damages found on the right tube are characterized by the breakdown of the final concrete lining. As shown in Figure 5, the zone of collapse is located between the vaults N° 60 and N° 72. It includes the cross-passing N° 2 (CP2), situated in the middle of the vault N° 63. The collapse area started from the vault N°63 towards the north to the vault 72.
