# Chapter 7

## Bird Collisions in a Railway Crossing a Wetland of International Importance (Sado Estuary, Portugal)

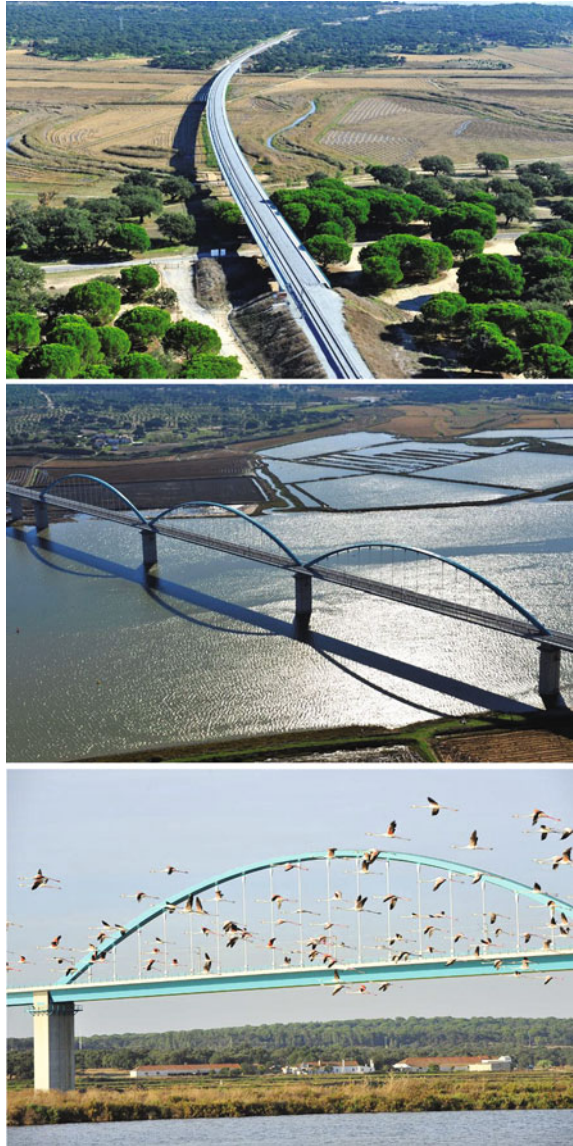
**Fig. 7.2** Photographs illustrating aspects of the study area. *Upper panel* railway crossing rice fields (São Martinho stream); *middle panel* bowstring railway bridge crossing the Sado River; *lower panel* flock of flamingos flying close to the Sado railway bridge

The study was carried out in Portugal, focusing on the “Variante de Alcácer” railway, whose construction started in February 2007, with train circulation beginning in December 2010 (Figs. 7.1 and 7.2). This is a single-track electrified railway extending over 29 km, that is part of the network connecting Lisbon to the south of the country. It crosses the Natural Reserve of the Sado Estuary (Portugal) in a section of about 2.6 km (38° 24'N, 8° 36'W), most of which is occupied by wetland habitats including the Sado River, rice fields and salt pans (1.6 km), while the rest is dominated by cork oak *Quercus suber* and stone pine *Pinus pinea* woodlands. The crossing is made through a bowstring bridge built between 2007 and 2010, with a length of 2735 m and three 160 m high arcs (Fig. 7.2). Another viaduct of this railway (about 0.8 km) crosses a small wetland outside the Natural Reserve, which corresponds to the São Martinho stream and the adjacent rice fields (Fig. 7.2). During the period of observations conducted over one year (see below), the bridge was crossed by  $26 \pm 4$  [SD] trains/day. The train speed ranged from 44 km/h (charcoal trains) to 170–200 km/h (passenger trains).

To evaluate bird movements across the Sado bridge, observations were made within 500-m buffers at three sampling points set 1 km apart along the bridge, and covering all deck (Figs. 7.1 and 7.2). The points were set to cover the main habitats available in the area: North—forested areas; Central—river and wetland habitats; South—forest and wetland habitats (Fig. 7.2). Twenty-two survey sessions took place between November 2012 and September 2013 by three observers simultaneously. The number of birds crossing the railway were counted during the day in two 6-hours sessions per month (i.e.,  $\approx 400$  h of observation homogeneously distributed during the study period), to cover the tidal cycle. Observers rotated between observation points every 3 h to avoid hour-related biases. Species, number of individuals, hour, flight direction and height (based on structural elements of the bridge: (deck, electric cables and bridge arcs) were recorded for each crossing. Particular care was taken to estimate the number of birds crossing at the train collision risk zone, corresponding to the area between the deck and the catenary lines.

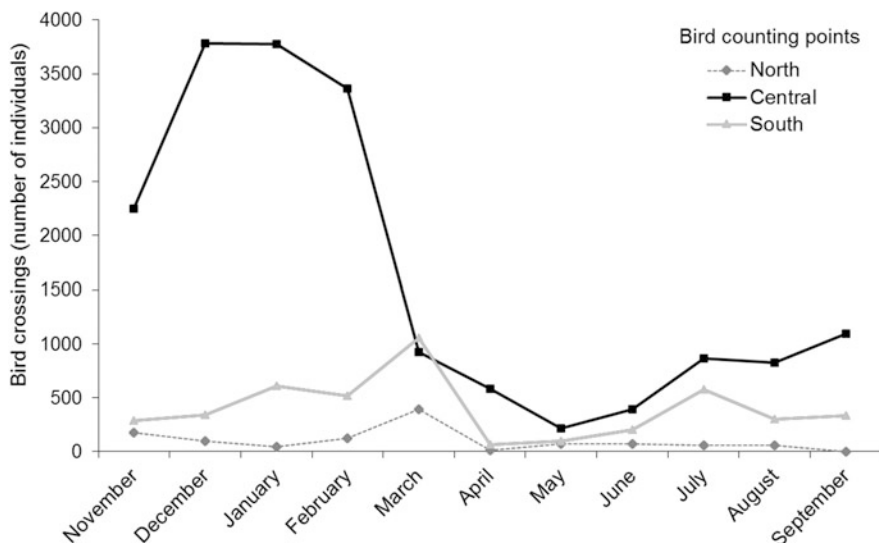
**Fig. 7.3** Monthly number of aquatic birds observed crossing the railway bridge over the Sado River, between November 2012 and September 2013. Numbers are presented separately for the three sampling points covering the main habitats available in the area: north (forested areas); central (river and wetland habitats); and south (forest and wetland habitats)

We observed a total of about 27,000 birds crossing the bridge during the observation periods, most of which (82.7%) were waterfowl and other aquatic birds, and the others were mainly passerines. Overall, most crossings (76.6%) were detected in the central section of the bridge, followed by the south (18.7%) and north sections (4.7%). More than half the crossings were detected in winter (December–February), corresponding to 4217 crossings/month (Fig. 7.3). Spring (March–June) was the season with fewer crossings observed, with 571 crossings per month (Fig. 7.3). Less than 1% of the crossings were made between the deck and the

catenary lines, where there is a risk of collision with trains (Fig. 7.3). Although most birds crossed the bridge above the train collision risk zone (91.3%), 39.1% of the crossings were recorded below the top of the bridge arcs (Fig. 7.3).
