Effectiveness Study On Temporary Pavement Marking Removals Methods

Report #: SPR-P1 (11) M305

EFFECTIVENESS STUDY ON TEMPORARY PAVEMENT MARKING REMOVALS METHODS

Effectiveness Study on Temporary Pavement Marking Removals Methods

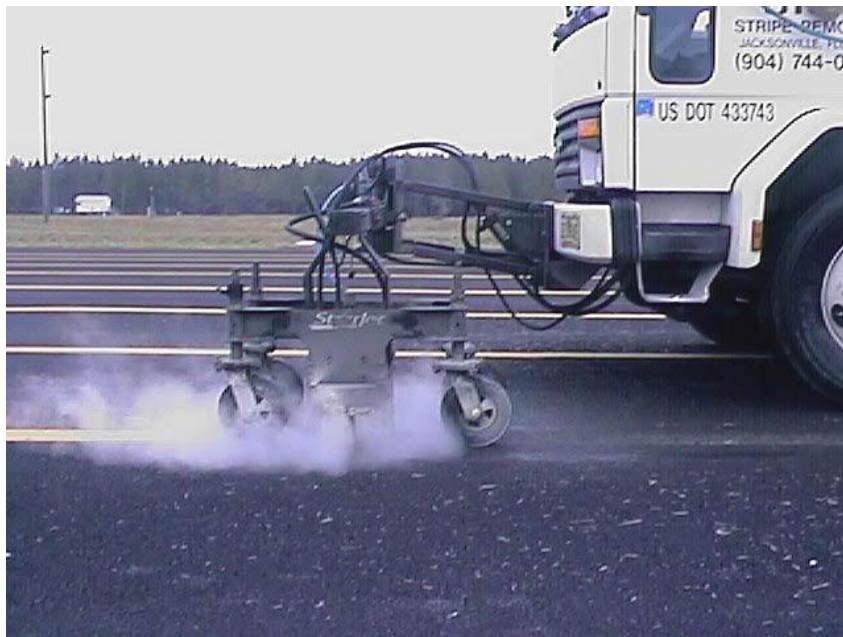
Water blasting is a process of using a high pressurized water jet—usually greater than 10,000 psi depending on the thickness of the paint and/or type of pavement surface—to remove markings from pavements. This method is effective in removing the markings, but can also leave scars on the pavement and leave the site messy. Water blasting costs can be high depending on the amount of water needed to remove the markings. Removal speed might also be a disadvantage as it requires added time to completely remove the markings. Figure 2.2, taken from a Florida Department of Transportation final report on the subject, shows a high pressure truck mounted water blaster unit being used on an asphalt surface (Ellis and al. 1999).

Figure 2.2. High pressure water jet water blasting pavement marking

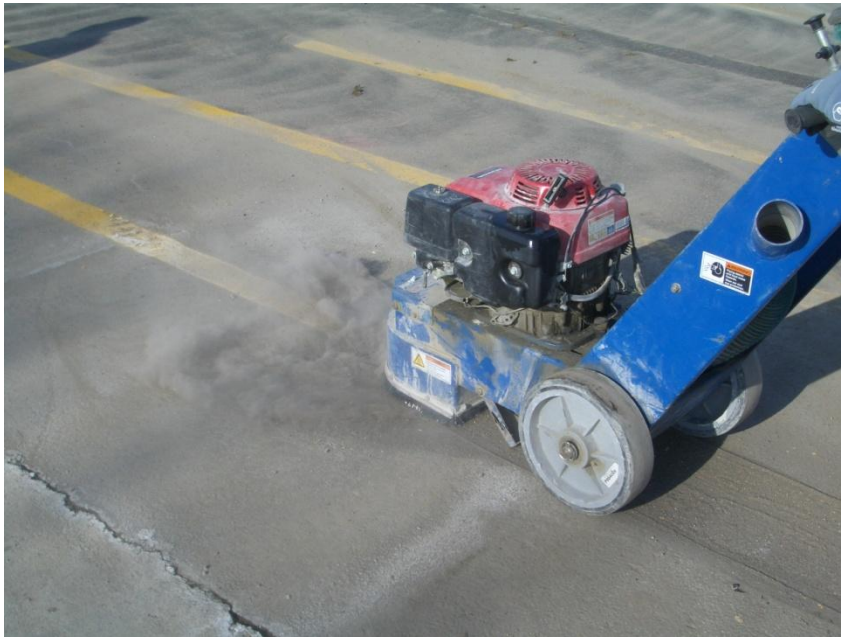
The method used most commonly, grinding, effectively removes markings. Depending on the cutting teeth applied on the grinder, it can be rapid by quickly cutting through the pavement. Interchangeable heads make grinding ideal for different pavement thicknesses and applications. The biggest disadvantage of grinding is scarring—affecting both the pavement texture and color—since a deep scar will confuse motorists and lead to accidents. Figure 2.3 is an example of a grinder being used to remove paint on concrete.

Figure 2.3. Grinder removing paint on asphalt pavement

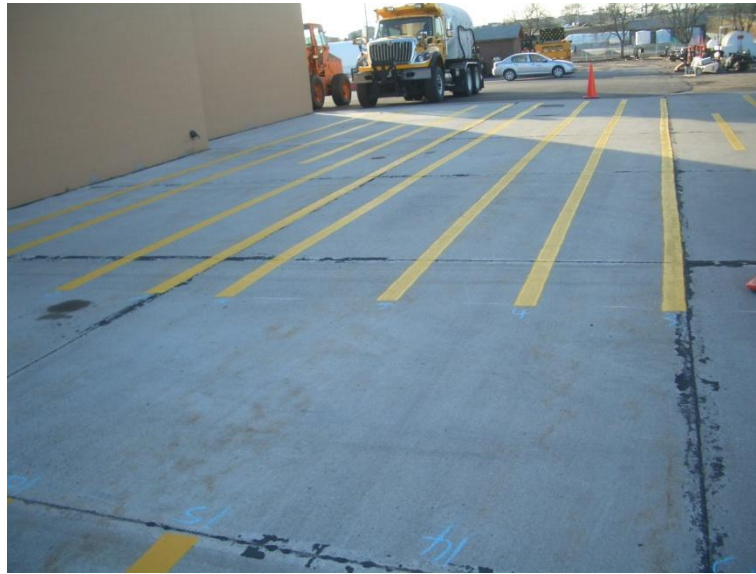
Figure 4.1. Concrete site used for testing

The research team used the NDOR District 1 office parking lot (Figure 4.1) and yard (Figure 4.2) to test onto concrete and asphalt sites. Marking lines were applied onto each site for testing. A total of 40 lines were made with yellow paint, each measuring about 50 feet in length. To test differences in paint types, 12 and 20 mils of water-based and oil based paint were used to make lines 6 inches wide on both the concrete and asphalt pavements. Additionally, 5 preformed foil-backed tape lines also measuring about 50 feet were installed on both sites.

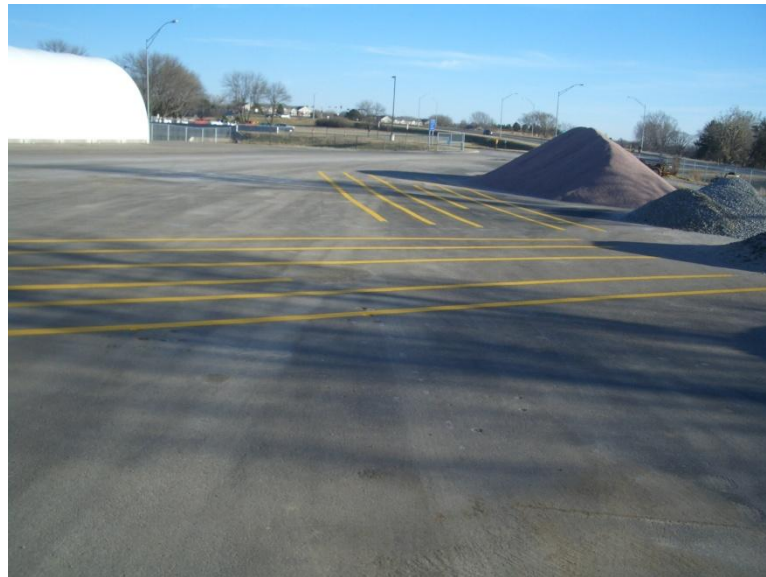
Figure 4.2. Asphalt yard used for tests

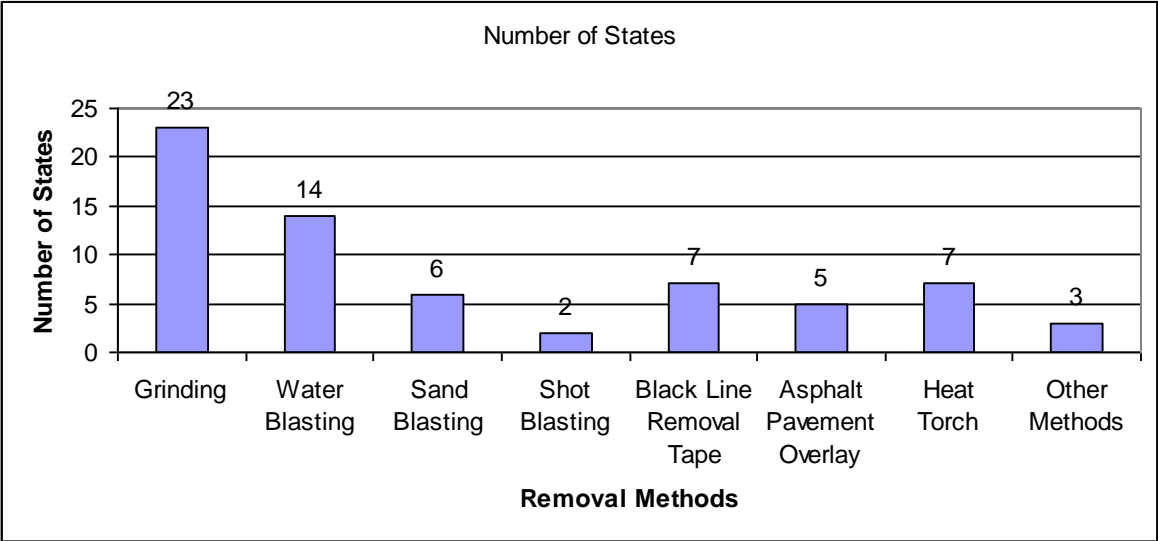
Figure 5.2. Most commonly used methods frequency graph

The responses to the most commonly used methods are summarized in Figure 5.2, and broken down by percentage in Table 5.2.

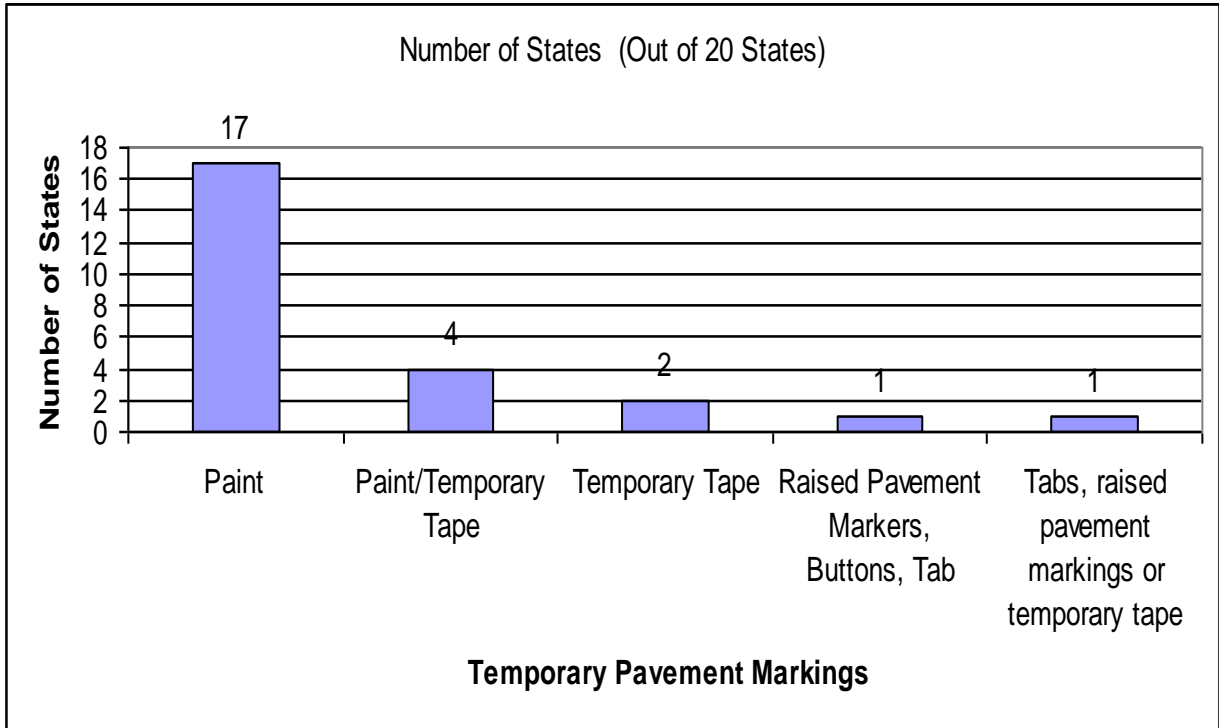
Figure 5.4. Most types of pavement markings frequency graph

Finally, the responses concerning the types of pavement marking materials that are used often are summarized in Figure 5.4 as well as Tables 5.4 and 5.5.

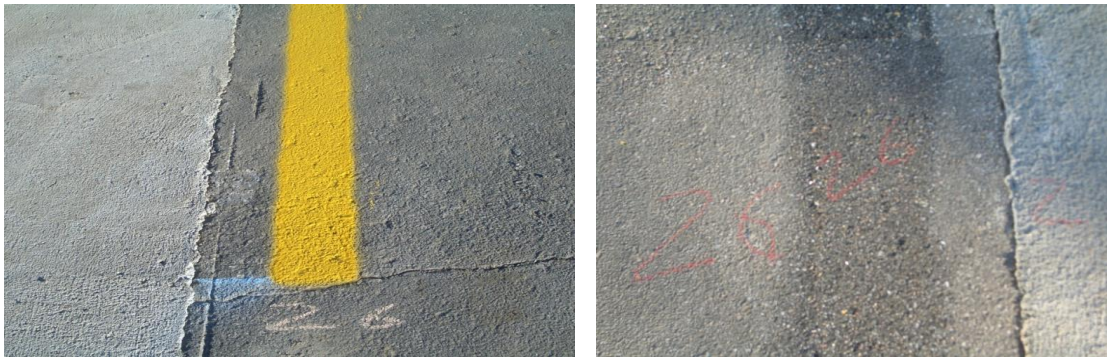
Figure 6.3. Asphalt pavement condition before (left) and after (right) 10 mils water-based paint has been removed by water blasting

Water blasting removed the marking on all surfaces, but left a scar that could lead to confusion. Water blasting worked the best on concrete while removing water based paint of 12 mils (Figure 6.1). Figures 6.2 and 6.3 show the results of water blasting on oil-based paint concrete and water-based paint on asphalt, respectively.

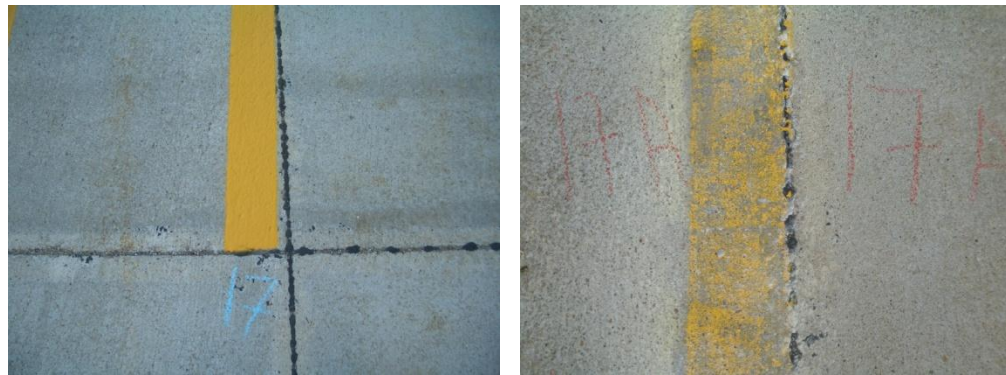
Figure 6.8. Concrete pavement condition before (left) and after (right) 12 mils oil-based paint has been removed by dry ice blasting

Dry ice blasting did not entirely remove the paint markings on the concrete surface, as shown in Figures 6.7 and 6.8. On asphalt pavement, however, the removal was well completed, but left a scar on the pavement (Figure 6.9). Dry ice blasting was the slowest method of removal. Results

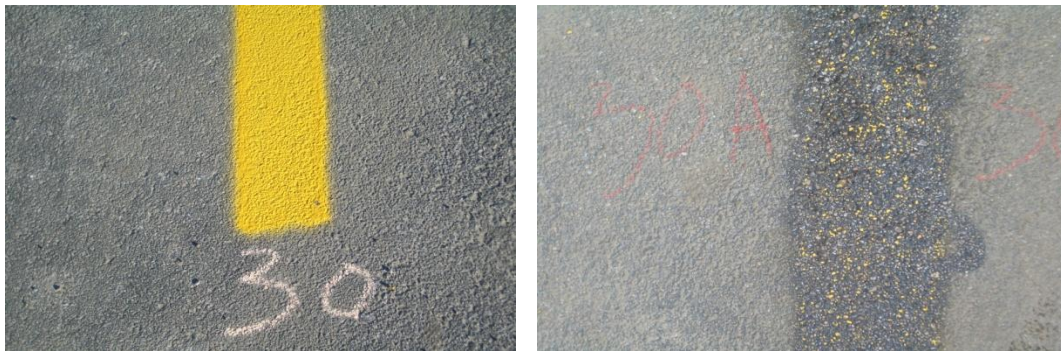
Figure 6.9. Asphalt pavement condition before (left) and after (right) paint has been removed by dry ice blasting

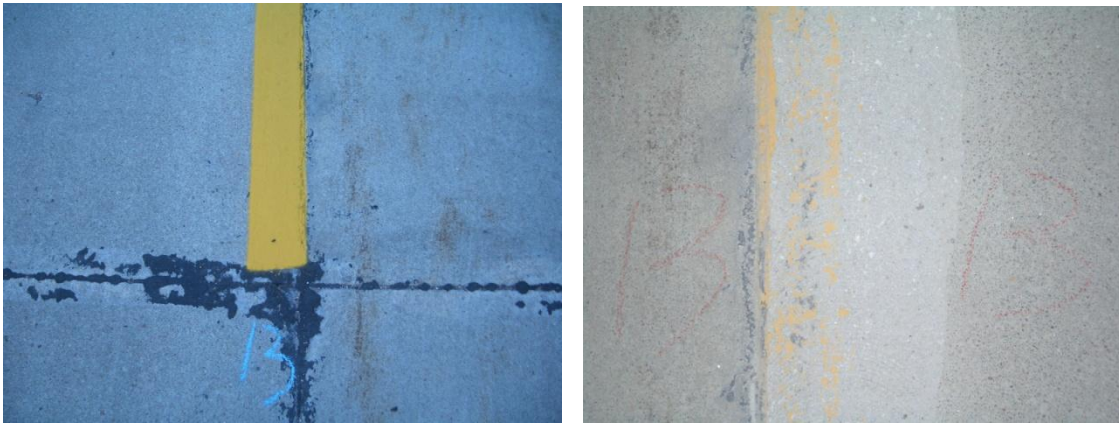
Figure 6.10. Concrete pavement condition before (left) and after (right) paint has been removed by grinding

increases. The grinder damaged the pavement by causing minimal color and texture discrepancies. Regardless of the pavement type or marking material, the grinder did leave scars, as shown by Figure 6.10 on concrete and Figure 6.11 on asphalt.

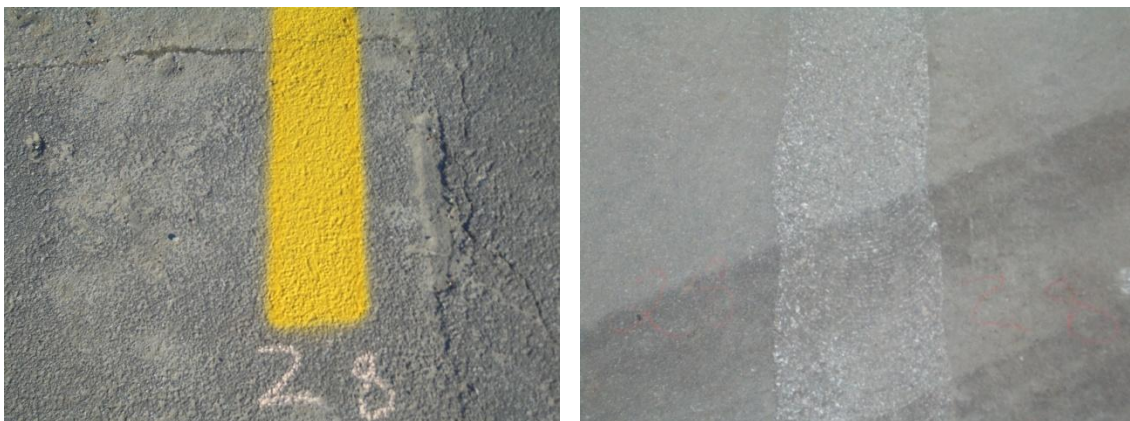
Figure 6.11. Asphalt pavement condition before (left) and after (right) paint has been removed by grinding

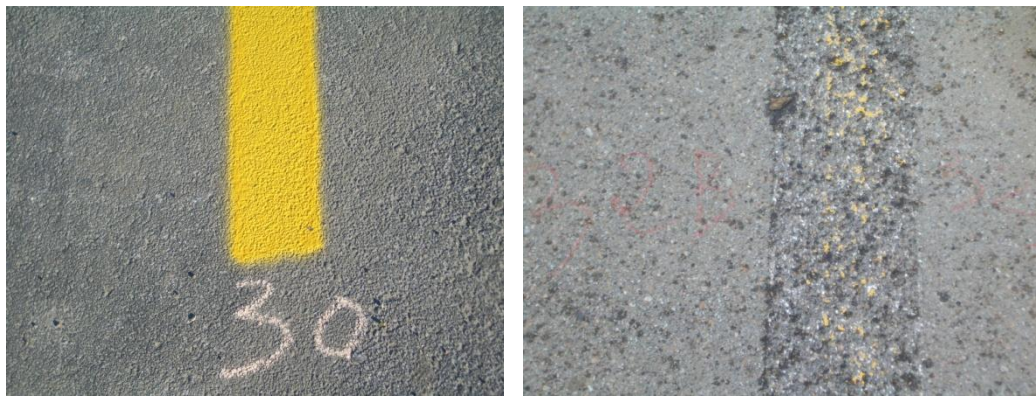
Figure 6.13. Asphalt pavement condition before (left) and after (right) paint has been removed with scarifier

The scarifier is just like a grinder except the cutting blade heads never leave the surface while cutting in forward and reverse directions. While the scarifier is a fast process, it damages the pavement and does not completely remove the paint markings. The scarifier also left scars on the pavements. Figures 6.12 and 6.13 show the results of using a scarifier on concrete and asphalt pavements, respectively.

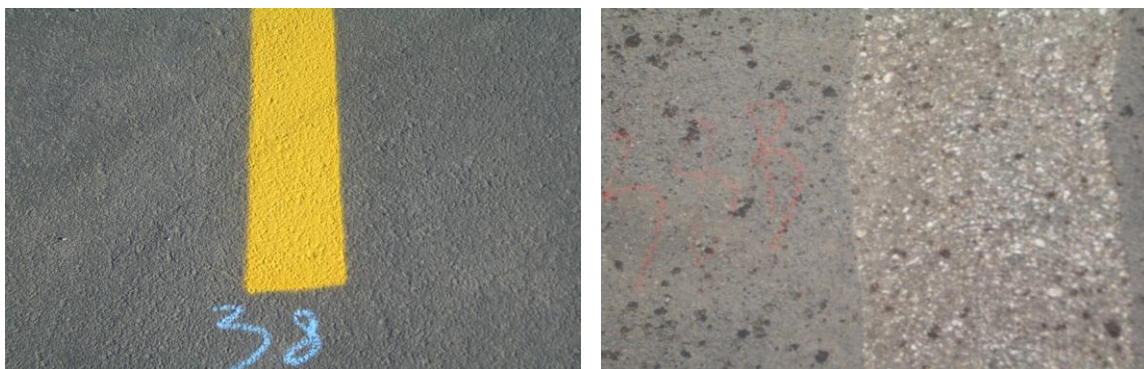
Figure 6.15. Concrete pavement condition before (left) and after (right) 12 mils paint has been removed by PCD grinder

For evaluative purposes, the PCD was only used to remove one marking, and it displayed similar results as the grinder. Figure 6.15 shows the concrete pavement condition before and after the PCD was used.

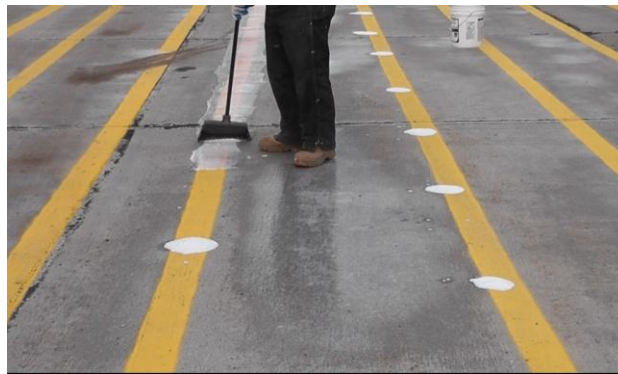
Figure 6.16. Applying the chemicals on the markings

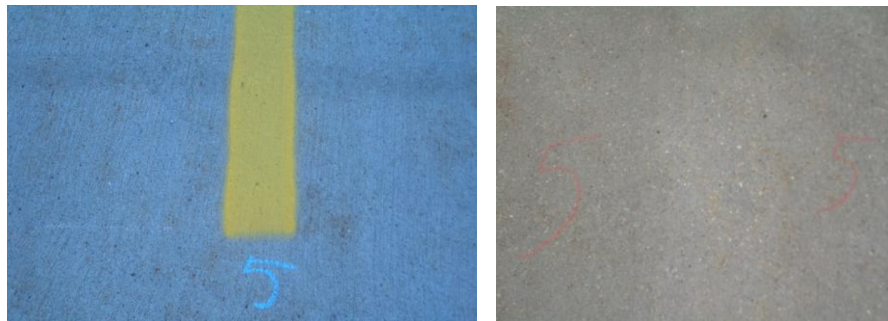
Figure 6.18. Concrete pavement condition before (left) and after (right) paint has been removed by chemicals

The chemical stripping method was the most effective during tests and left no or very little paint on both surfaces (Figure 6.18 and 6.19).

There was no visible scar on the pavement after the use of chemical strippers. Table 6.1 below is a summary of some data that were recorded during testing. The complete data is shown in

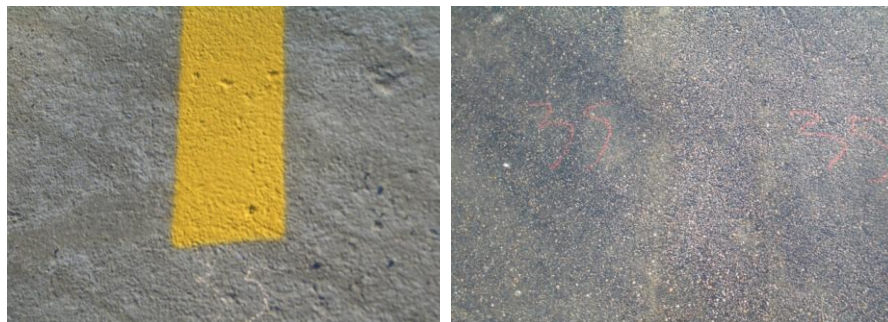
Figure 6.19. Asphalt pavement condition before (left) and after (right) paint has been removed by chemicals

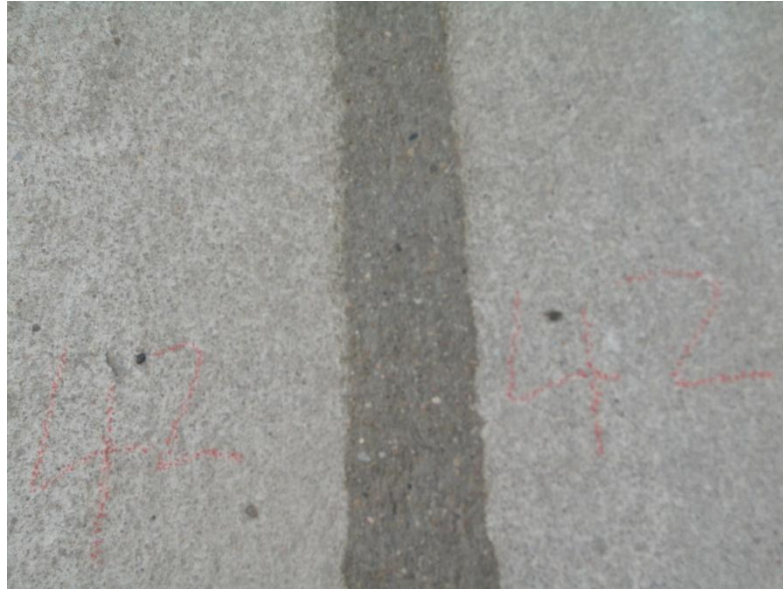
Figure 6.20. Condition of concrete pavement after heat torch applied on tape

laid down on the pavements; therefore, most of the tape did not stick well to the surface, and some were not even entirely set. Almost every method used on tape was successful except for dry ice and heat torching which left some marks on the pavement. Figure 6.20 shows the result of the heat torch on concrete pavement.

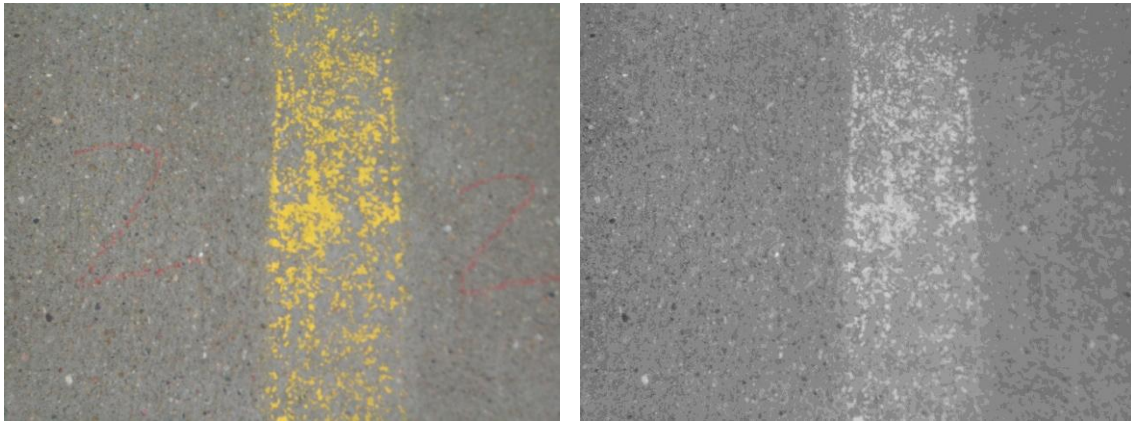
Figure 7.1. Actual picture (on left) and grayscale image (on right) of pavement after marking has been removed
