Dynamic Testing of a Non-Proprietary, High-Tension, Cable End Terminal System

DYNAMIC TESTING OF A NON-PROPRIETARY, HIGH-TENSION, CABLE END TERMINAL SYSTEM

MwRSF Research Report No. TRP-03-294-14

March 21, 2014

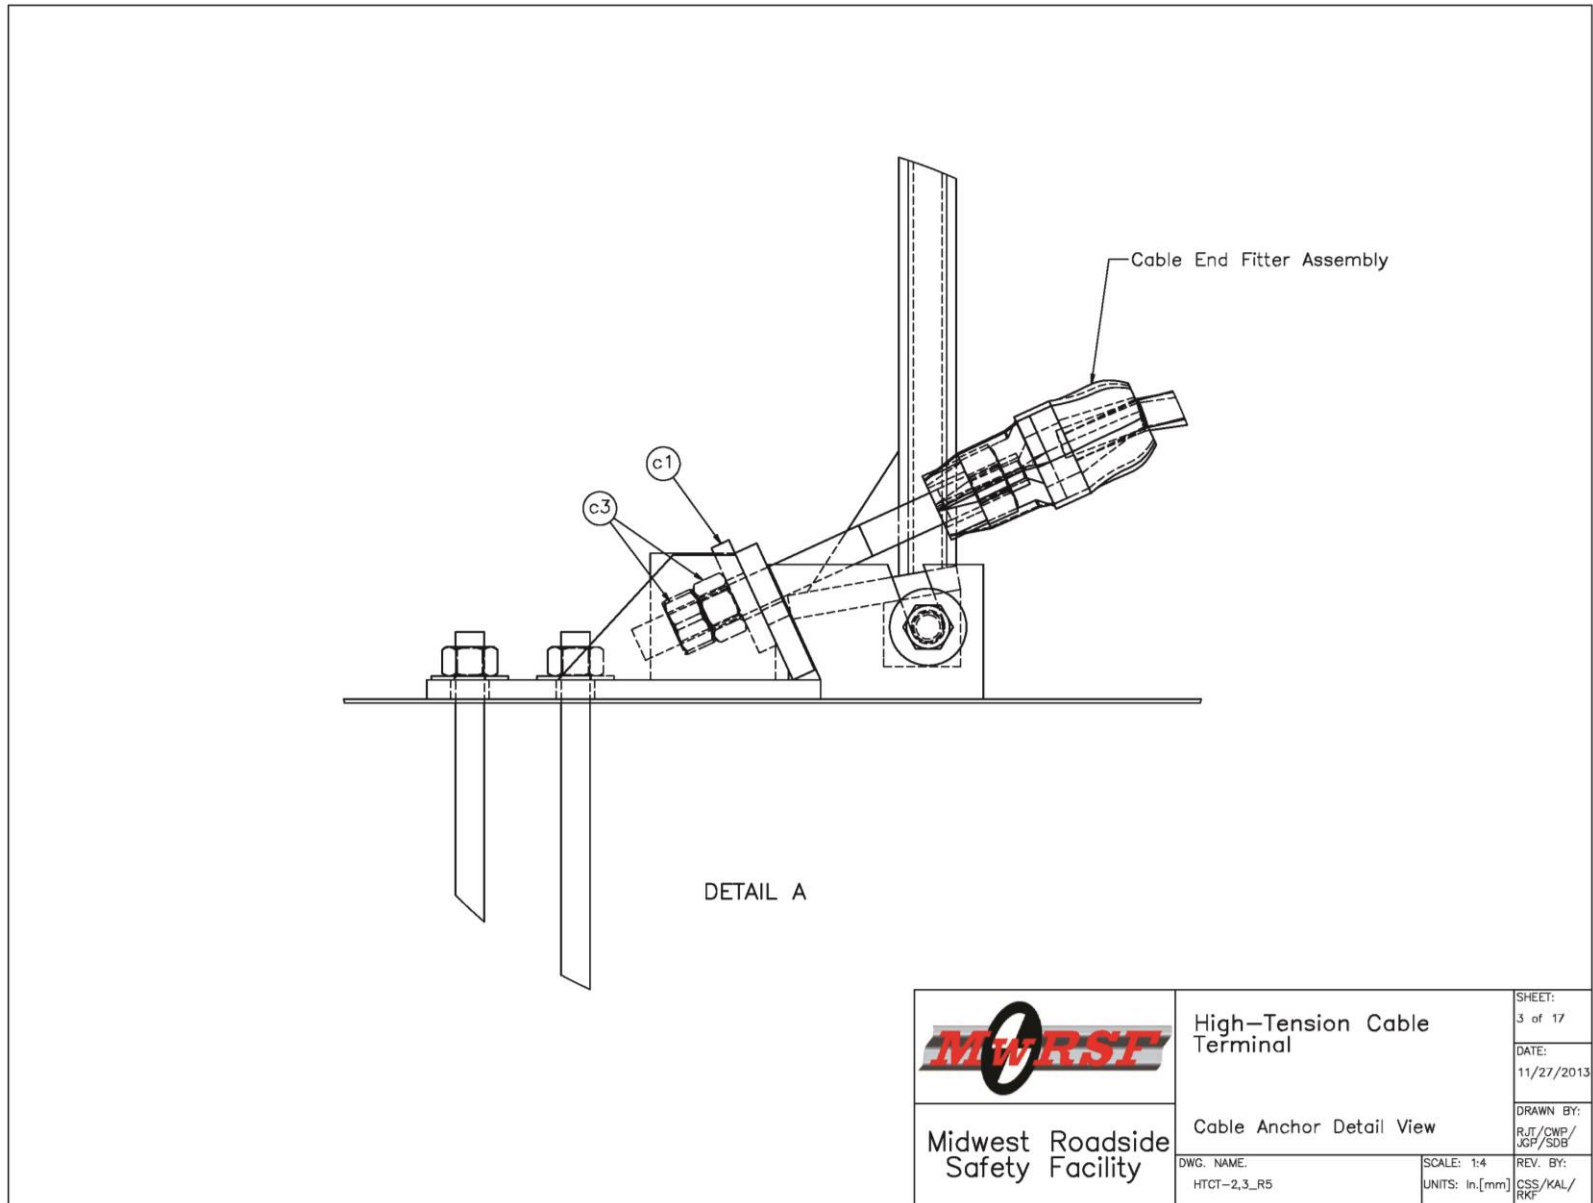
Figure 4. Cable Anchor Assembly Detail View, Test Nos. HTCT-2 and HTCT-3

Four $\frac{3}{4}$ -in. (19.1-mm) diameter, 3x7 wire rope cables were used in the barrier system. The cables were tightened to approximately 4,200 lb (18.7 kN) through the use of cable turnbuckles. The ends of the cable contained $\frac{7}{8}$ -in. (22-mm) diameter threaded rod fittings that

terminated in the cable anchor bracket. Each threaded rod was secured in the cable plate notches with a 3-in. x $2\frac{3}{8}$ -in. x $\frac{1}{2}$ -in. (76-mm x 60-mm x 12.7-mm) thick plate washer and two heavy hex nuts.

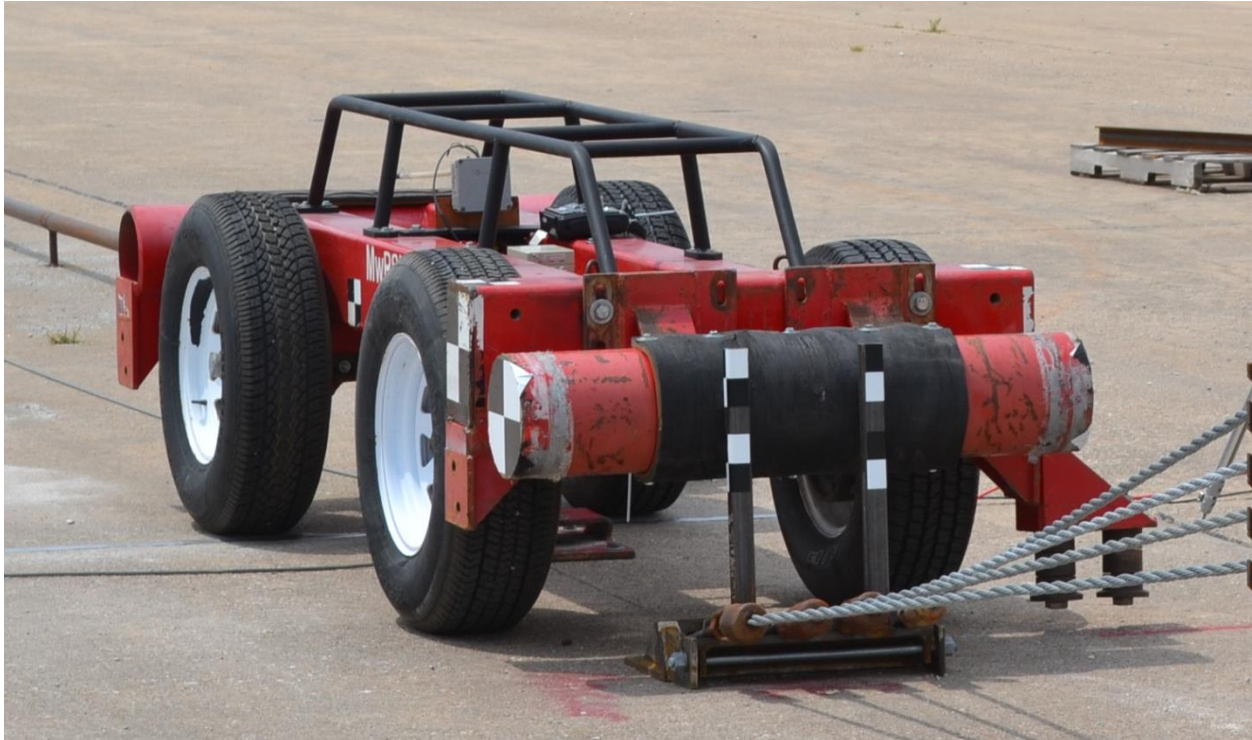
Figure 21. Rigid Frame Bogie on Guidance Track

A rigid frame bogie was used to impact the cable end terminal. A variable height, detachable impact head was used in the testing. The bogie head was constructed of 8-in. (203-mm) diameter, ½-in. (13-mm) thick standard steel pipe, with ¾-in. (19-mm) neoprene belting wrapped around the pipe to prevent local damage to the post from the impact. The impact head was bolted to the bogie vehicle, creating a rigid frame with an impact height of 19 in. (483 mm). The bogie with the impact head is shown in Figure 21. The weight of the bogie with the addition of the mountable impact head and accelerometers was 1,861 lb (844 kg) in test no. HTCT-2 and 1,853 lb (841 kg) in test no. HTCT-3.

A pickup truck with a reverse cable tow system was used to propel the bogie to the target impact speed. When the bogie approached the end of the guidance system, it was released from the tow cable, allowing it to be free rolling when it impacted the post. A remote braking system was installed on the bogie, allowing it to be brought safely to rest after the test.

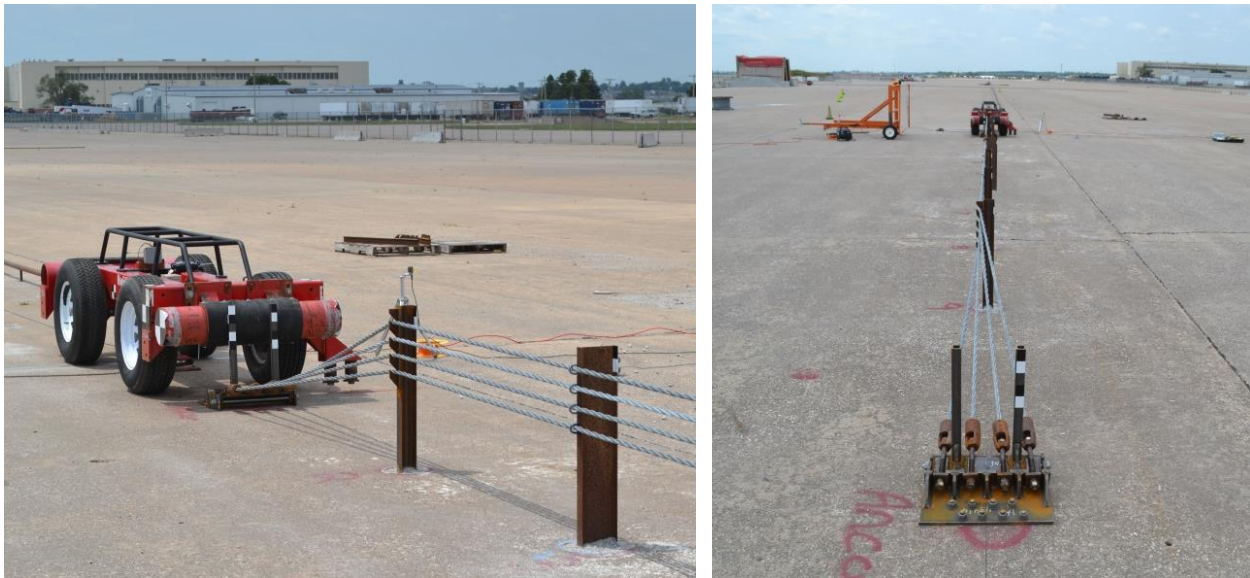
Figure 22. Impact Location, Test No. HTCT-2

The 1,861-lb (844-kg) bogie impacted the high-tension cable terminal system at a speed of 52.8 mph (85.0 km/h) and at an angle of 0 degrees. The impact location is shown in Figure 22. The cables were tensioned to approximately 4,300 lb (19 kN). The cables were numbered from 1 to 4 as shown in Figure 23. Cable no. 1 corresponded to the bottom cable, and cable no. 4 corresponded to the top cable. A sequential description of the impact events is contained in Table 2. The times are approximate as the bogie wheel obstructed the view of the cable releases. Sequential photographs are shown in Figures 24 through 26.

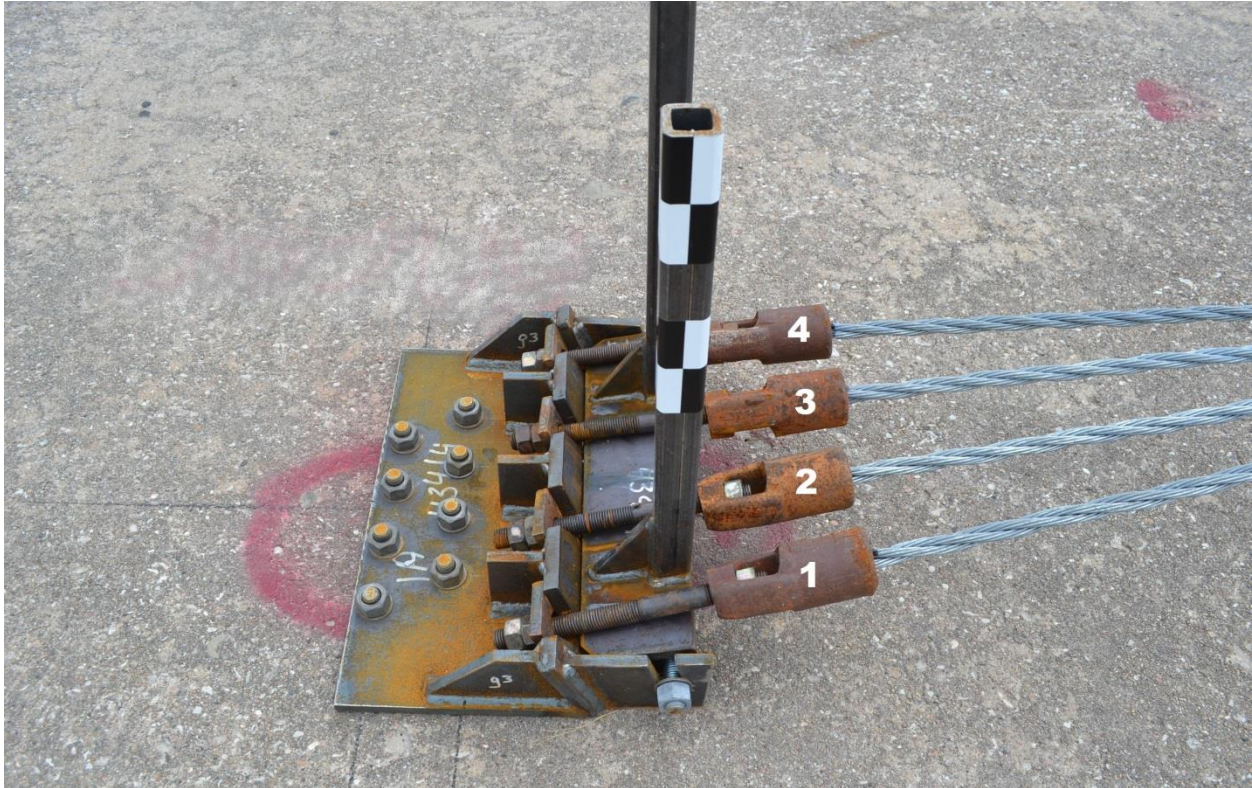
Figure 23. Cable Numbers at Upstream Cable Anchor Bracket, Test No. HTCT-2

Cable nos. 1, 3, and 4 released from the upstream cable anchor bracket early on the event, However cable no. 2 did not release until the cable lost tension and the stress wave propagation caused the cable to lift out, which occurred very late in the event. Cable no. 2 not releasing and post no. 2 bending downstream may have contributed to the bogie becoming airborne during most of the event.

In test no. HTCT-2, cable nos. 1, 3, and 4 released quickly from the end terminal as desired. However, the second cable did not release until 0.766 seconds after the first three cables, and cable no. 2 only lifted out due to the stress wave that propagated through the cable after tension was released. Some slight permanent bending was found in the kick plate, which may have contributed to cable no. 2 not releasing as quickly as the other cables. The washer snagging on the cable plate notch may have also contributed to the delayed release.

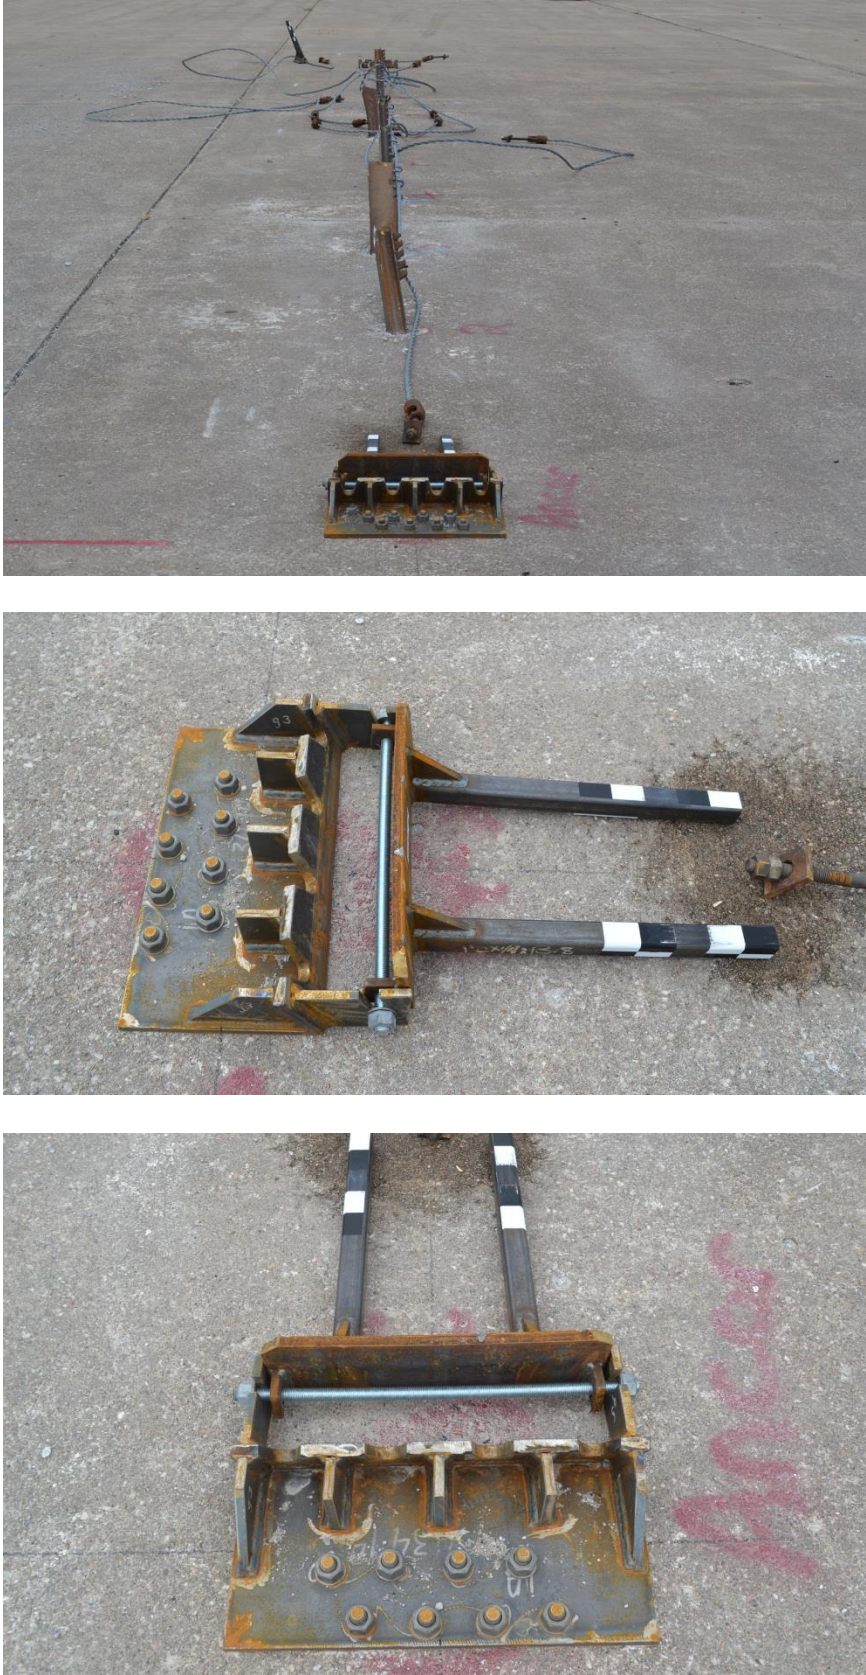
Figure 27. System Damage – Upstream Cable Anchor Bracket, Test No. HTCT-2

Damage to the end terminal system was moderate, as shown in Figures 27 through 30. The cable release lever was retained in the upstream cable anchor bracket. The kick plate had some minor permanent deformation. Post nos. 2 through 9 were all bent downstream. Posts with holes in the flanges at groundline all buckled at the holes, and the flanges tore from the upstream edge to the location of the weakening holes.

Minimal permanent deformation was found in the kick plate in test no. HTCT-2, which may have contributed to the second cable not releasing from the terminal as desired. More significant permanent deformation was found in the kick plate and vertical tubes in test no. HTCT-3. However, no permanent deformation was found in the fixed portion of the cable anchor bracket.

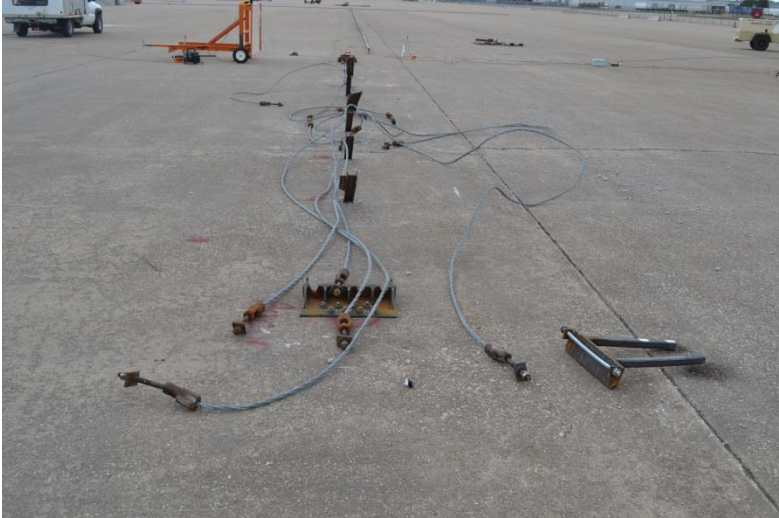
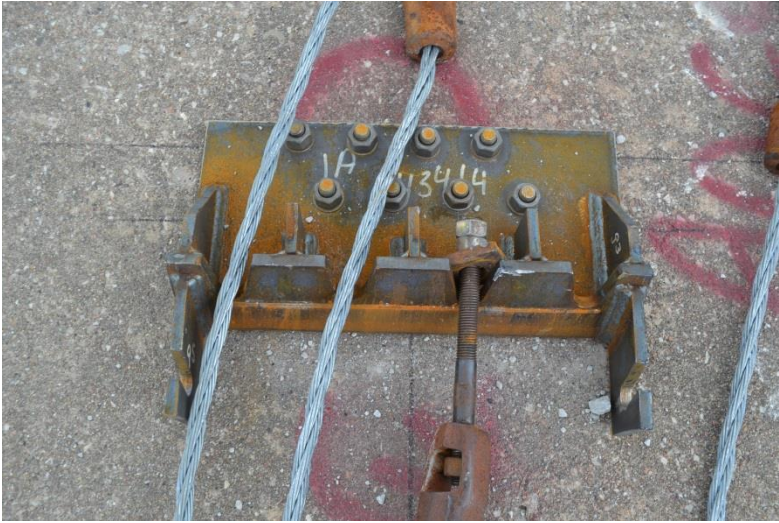
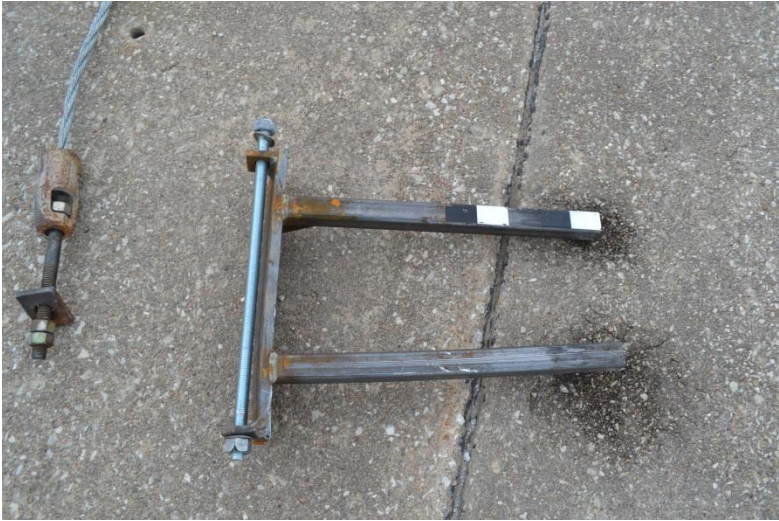
Figure 30. System Damage – Downstream Cable Anchor Bracket, Test No. HTCT-2

The cable release lever released from the downstream cable anchor bracket. Cable nos. 1, 3, and 4 released from the downstream cable anchor bracket. Gouging was found in the steel plate around the second cable notch on the downstream cable anchor bracket. The kick plate had some minor permanent deformation. The bogie also sustained minor damaged to the tires and tow pin.

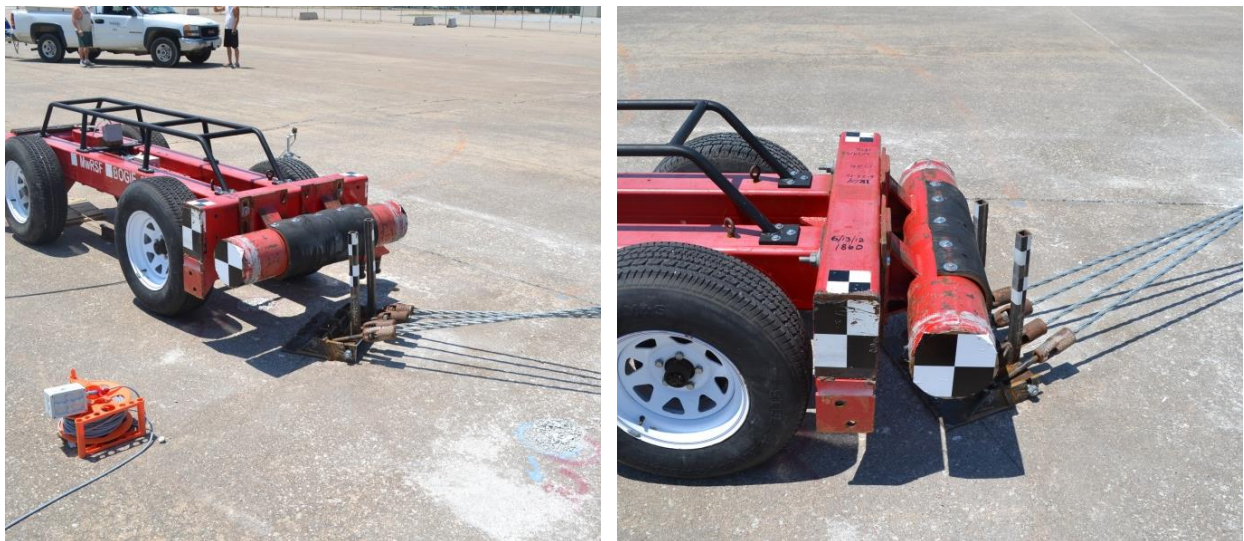
Figure 32. Impact Location, Test No. HTCT-3

The 1,853-lb (841-kg) bogie impacted the high-tension cable terminal at a speed of 51.1 mph (82.2 km/h) and at an angle of 25 degrees. The impact location is shown in Figure 32. The cables were tensioned to approximately 4,300 lb (19 kN). The cables were numbered from 1 to 4 as shown in Figure 33. Opposite of the previous test, cable no. 1 corresponded to the top cable, and cable no. 4 corresponded to the bottom cable. A sequential description of the impact events is contained in Table 4. The times are approximate as the bogie wheel obstructed the view of the cable releases. Sequential photographs are shown in Figures 34 and 35. Documentary photographs are shown in Figures 36 and 37.

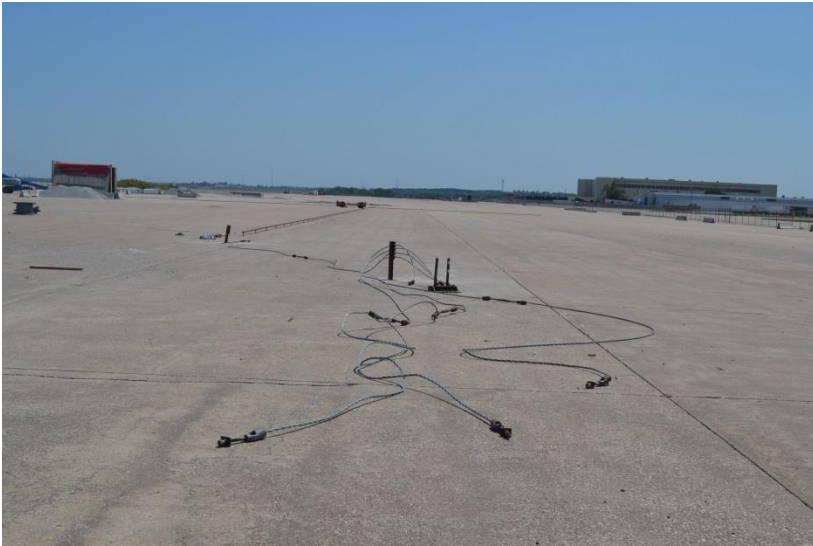
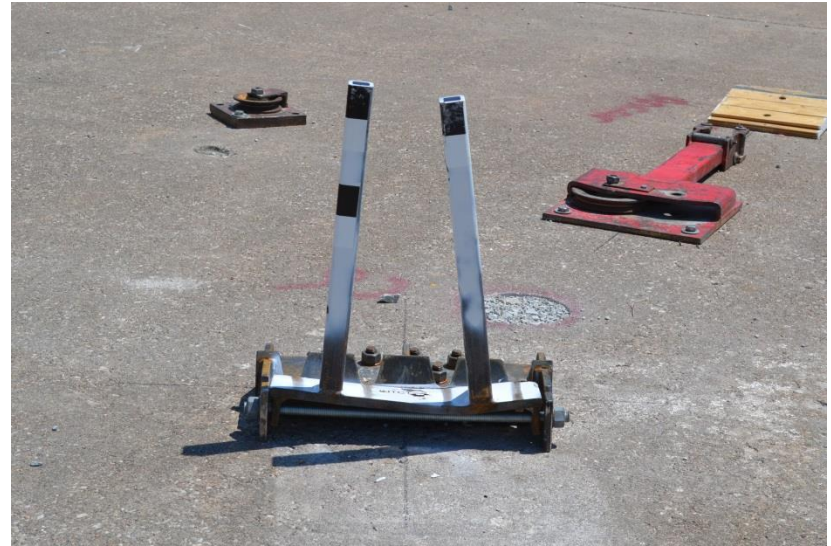
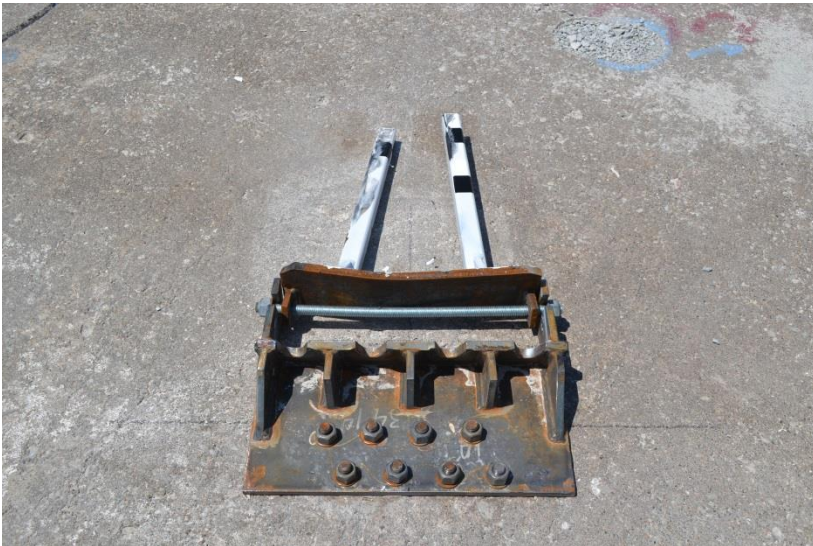
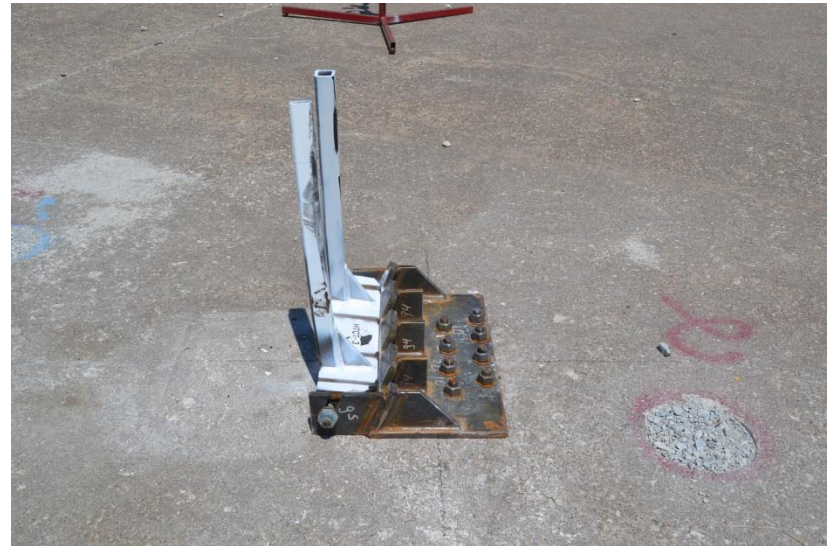
Figure 38. System Damage – Overall and Upstream Cable Anchor Bracket, Test No. HTCT-3

Damage to the cable end terminal system was moderate, as shown in Figures 38 and 39. The cable release lever was retained in the upstream cable anchor bracket. The kick plate had

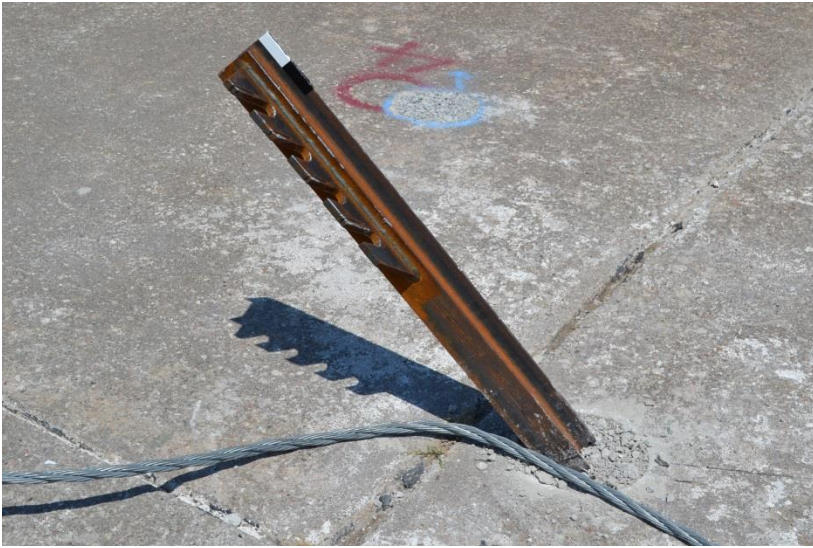
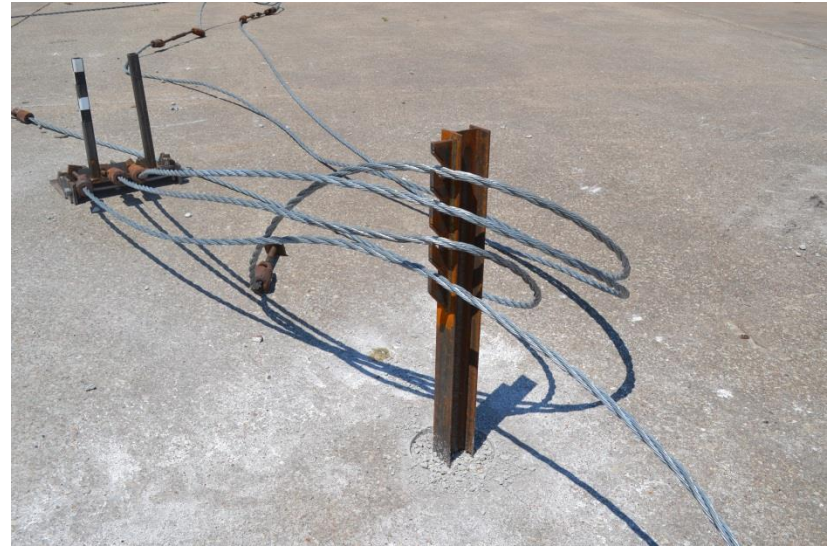
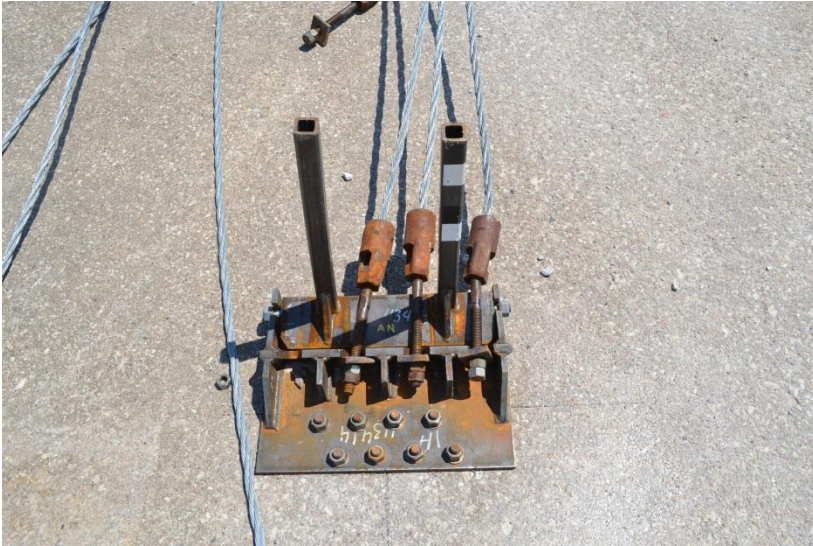
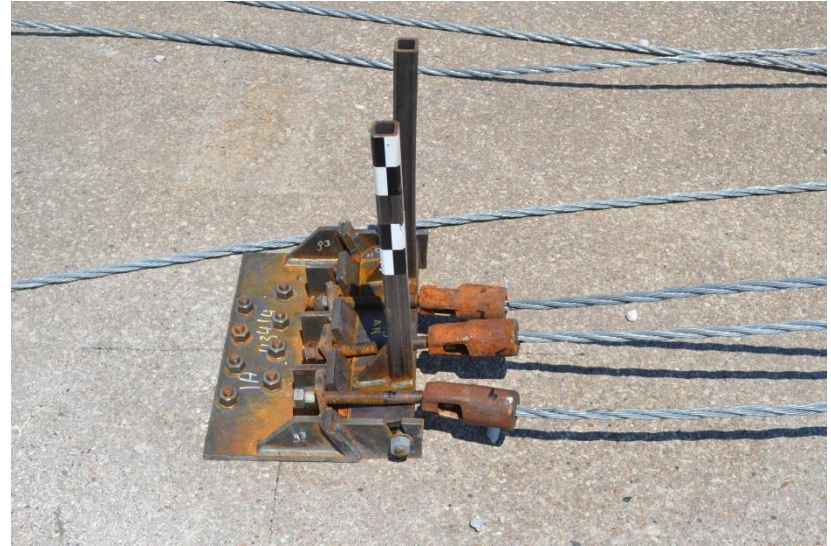
Figure 39. System Damage – Posts and Downstream Cable Anchor Bracket, Test No. HTCT-3

No damage occurred to the downstream cable anchor bracket or cable release lever. Cable no. 1 released from the downstream cable anchor bracket as the cables wrapped around the bogie tow pin, and the stress wave propagation lifted the cable.

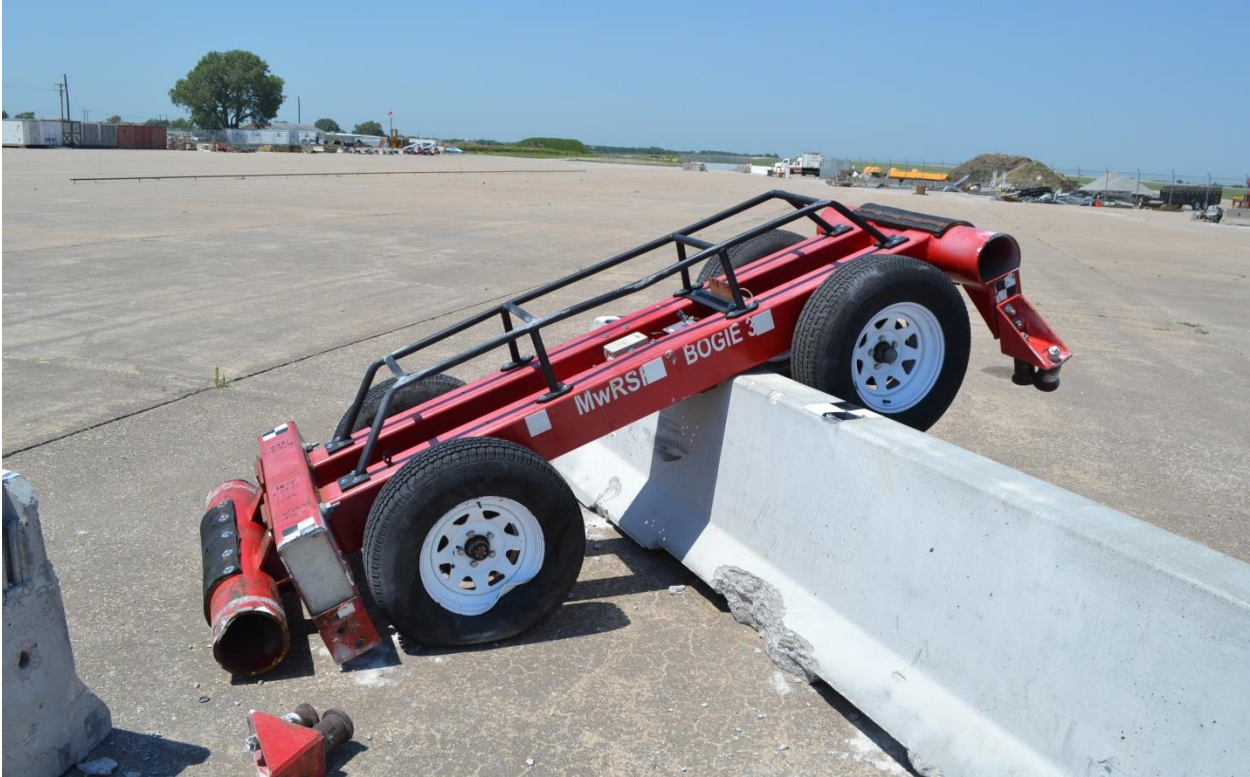
Figure 40. Bogie Damage, Test No. HTCT-3

The left-front tire of the bogie became airborne as it drove over the lower cables, which had not yet released by that time. After the cables released, they wrapped around the tow pin, the tow pin impacted post no. 2, and the roll motion of the bogie was accentuated. Minor damage occurred to the bogie when the vehicle rolled and subsequently impacted a temporary concrete barrier, as shown in Figure 40.

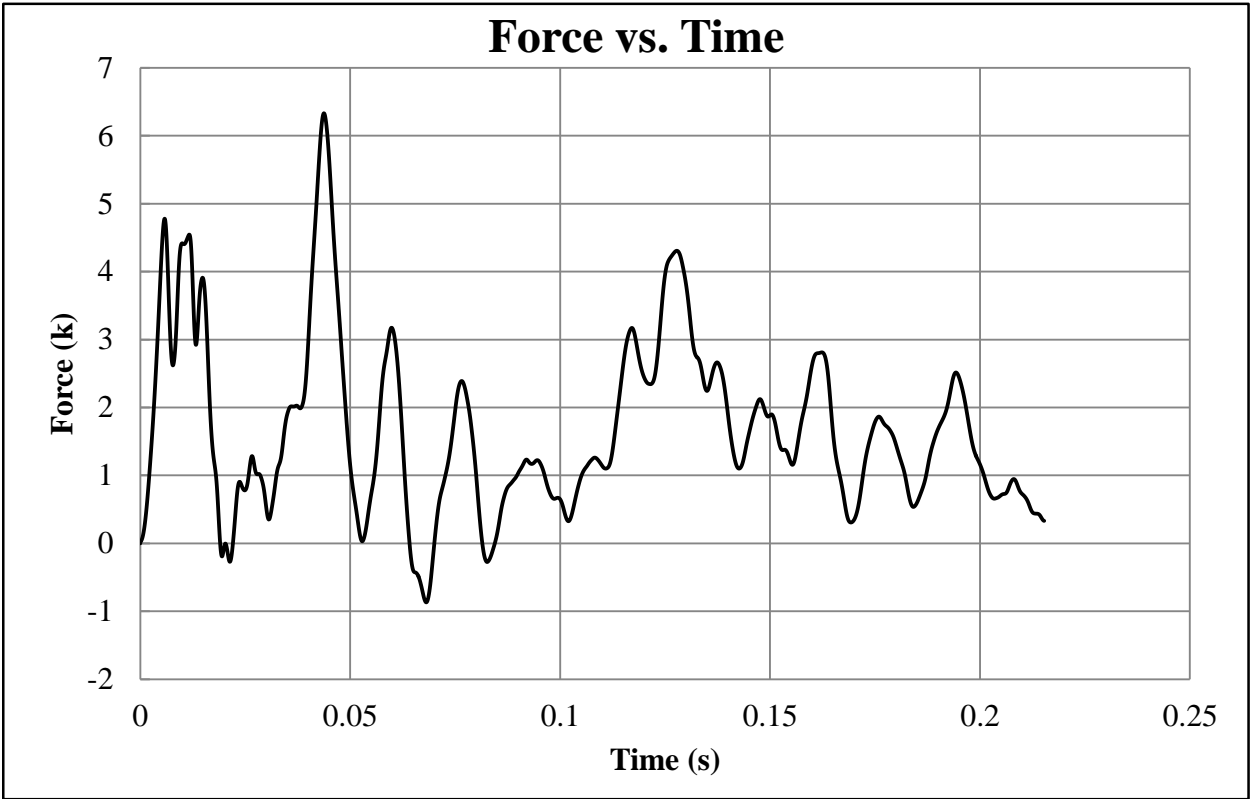
Figure 41. Force vs. Time, Test No. HTCT-3

The force vs. time is shown in Figure 41. A peak force of 4.8 k (21.3 kN) occurred when the bogie impacted the cable release lever. A peak force of 6.3 k (28.2 kN) occurred at 0.044 seconds, or between 0.026 seconds and 0.056 seconds when the cables were releasing.
