Anterolateral ligament injuries in knees with an anterior cruciate ligament tear: Contribution of ultrasonography and MRI. (2017) *European Radiology*, 28 (1). 58-65. ISSN 0938-7994

Anterolateral ligament injuries in knees with an anterior cruciate ligament tear: Contribution of ultrasonography and MRI

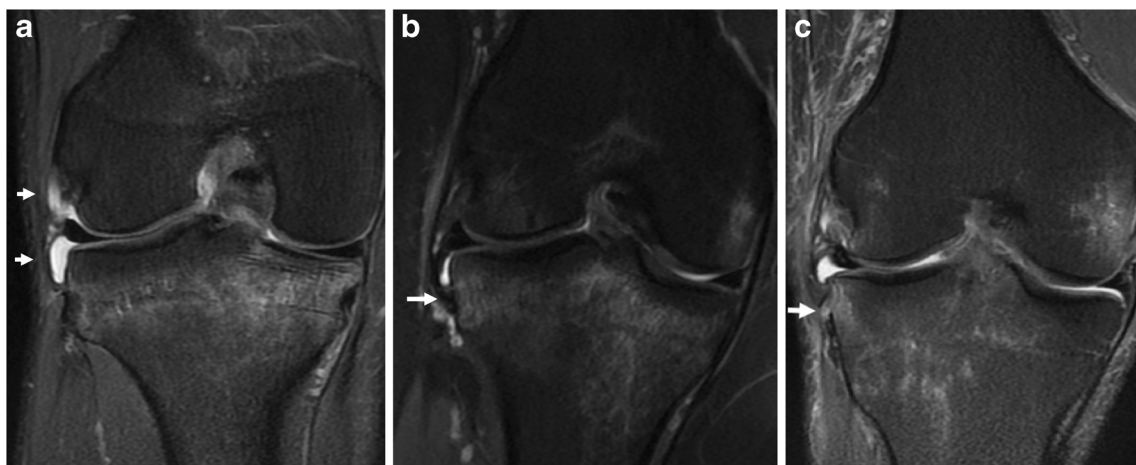
Fig. 1 Appearance of anterolateral ligament (ALL) on MRI. Anterolateral ligament of the knee in the coronal plane in fat saturated proton density weighted sequences. (A) Normal ALL. (B) Injured ALL:

hyperintensity at tibial insertion and increased thickness. (C) Segond fracture: bone avulsion at tibial enthesis combined with hyperintensity at thickened tibial insertion

The ALL was considered normal if a low-intensity linear structure was visible between the femoral epicondyle and tibial plateau [16, 17, 19, 23, 24]. The ALL was considered injured if it was torn or had high signal intensity with irregular contours [19]. Avulsion of the ALL at its tibial insertion was considered a Segond fracture [5, 23, 24]. The presence of bone oedema at the tibial enthesis was labelled grade 1 if it was less than 5 mm in diameter at its widest point, and grade 2 if it was more than 5 mm in diameter [25]. Figure 1 shows examples of normal and injured ALLs on MRI.

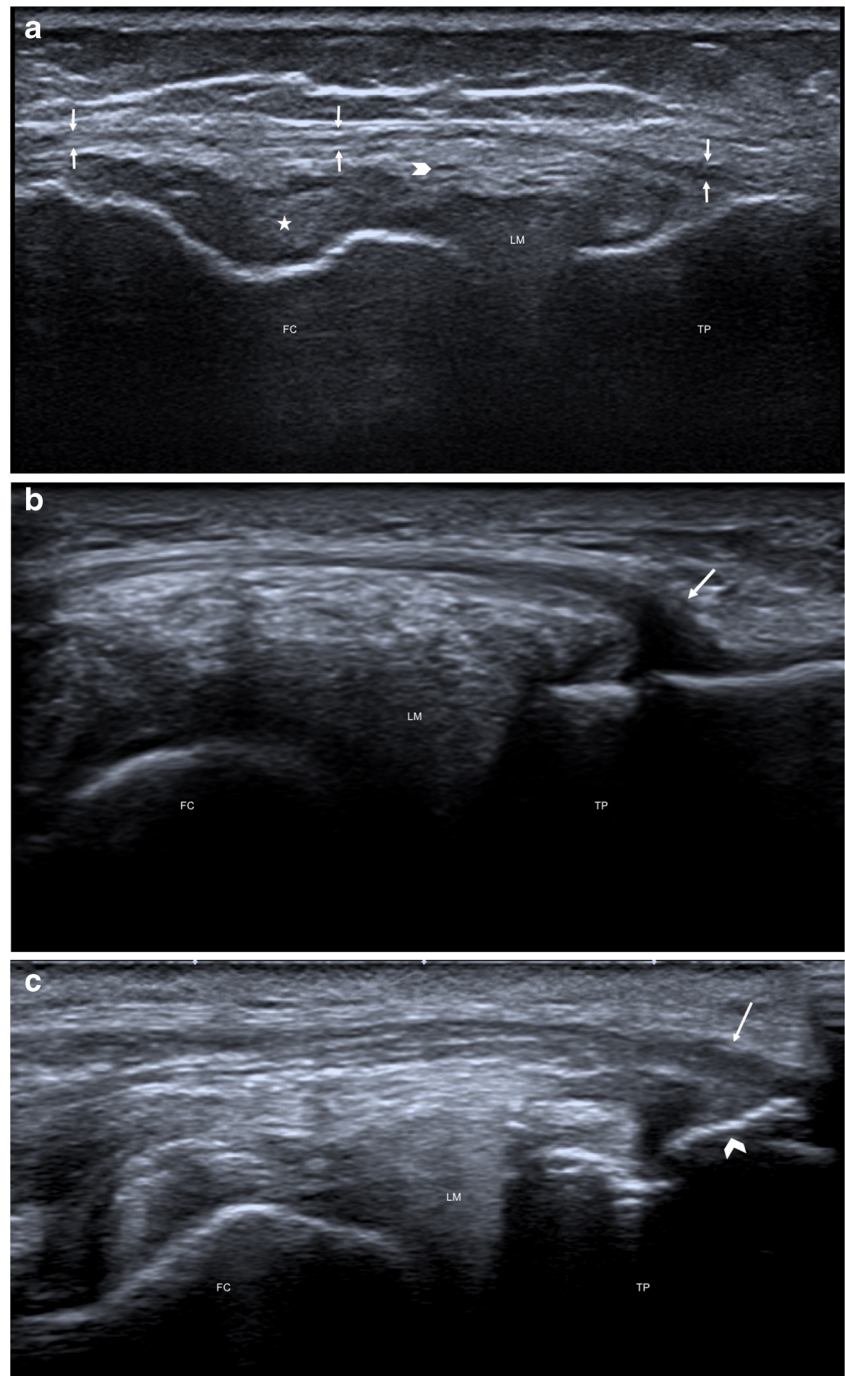
Fig. 2 Appearance of anterolateral ligament (ALL) on ultrasonography. Major axis of the anterolateral ligament of the knee; coronal plane image showing the ligament in the major axis. **(A)** Ultrasonography of normal ALL (arrows): hypoechoogenic, fibrillar, thin structure crossing superficially the inferior genicular artery (arrow head) and popliteal tendon (star). **(B)** Ultrasonography of injured ALL: the tibial insertion is hypoechoogenic and thickened (arrow) with fluid accumulation in the soft tissues around the ligament. **(C)** Ultrasonography of injured ALL: the tibial insertion is hypoechoogenic and thickened (arrow) and there is a bone avulsion at the tibial enthesis (arrow head), i.e. Segond fracture. *FC* femoral condyle, *LM* lateral meniscus, *TP* tibial plateau

ALL was considered normal if a fibrillar anisotropic structure was visible [18]. The ALL was considered injured if it was torn, stretched or hypoechogenic with irregular contours and fluid accumulated around the ligament. The thickness of the ALL was measured in the injured and contralateral knees at the level of the tibial plateau. Avulsion of the ALL at its tibial insertion was considered a Segond fracture and labelled an 'ultrasonographic Segond' [5, 24, 26]. Figure 2 shows examples of normal and injured ALLs on US. Figure 3 shows an example of different findings on ultrasound and MRI.
