## Rain erosion of leading edges of wind turbine blades. What is up and down?

*Publication date:*  
2018

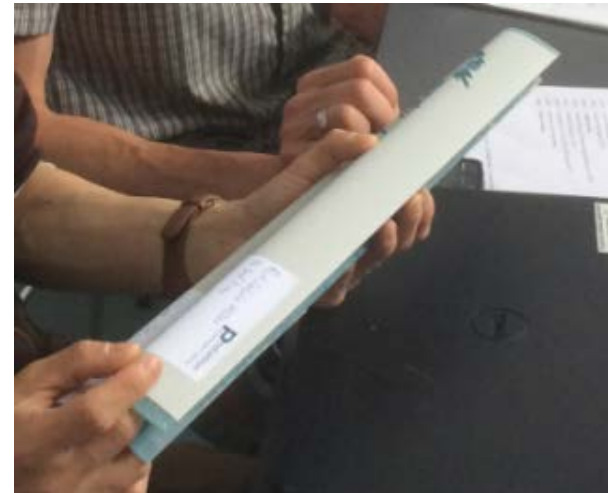
## Rain Erosion Tester by R&D Test Systems

Example of specimen
