## Reflow Soldering Process for Sn3.5Ag Solder on ENIG Using Rapid Thermal Processing System

### ABSTRACT

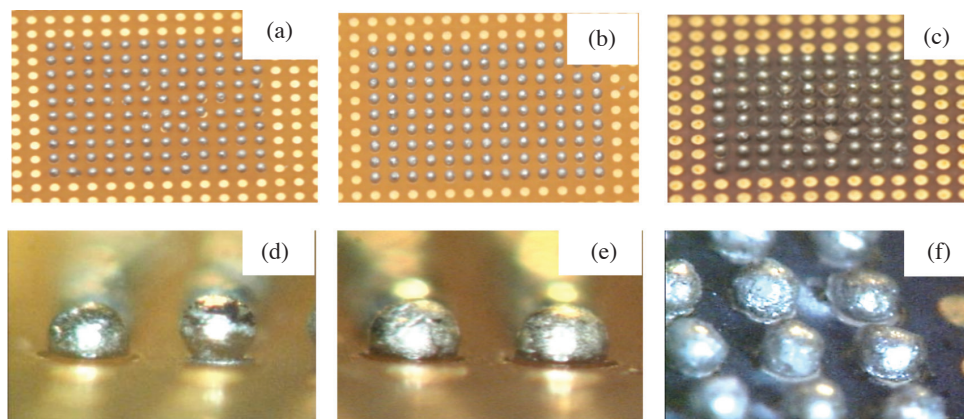
Figure 1 shows a visual micrograph for Sn3.5Ag solder on ENIG substrate as-reflowed at  $T_{peak}$  of 246, 251 and 260°C, respectively. Figure 1(a) shows an uneven reflowed solder of Sn3.5Ag solder on ENIG substrate at  $T_{peak}$  of 246°C. This condition occurs due to an inadequate reflow profile using RTP system. Time, temperature and reflow atmosphere have a great impact on the wetting performance. Too short of a time or too low of a temperature causes insufficient heat input which resulted in an incomplete fluxing reaction as well as incomplete metallurgical wetting, thus resulting in poor wetting (Lee 2001). An uneven heating due to the non-uniform method of heating source also contributes to the reflowed solder defect. Diepstraten (2010) reported that the substrate or part with the highest heat capacity sets the profile and the part with the lowest heat capacity can get warm fast. It is reported that in a non-uniform method of heating source, heating object will never reach the same temperature as the heating source. These reflowed solder defect can be observed in Figure 1(d). Poor RTP system design can lead to a significant temperature difference during the reflow soldering process. Non-uniform heating or cooling in the RTP system contributed to the material failure due to increasing of thermal stresses or serious damage, thus limiting the applicability of the RTP system (Ching et al. 2003).

FIGURE 1. Sn3.5Ag solder on ENIG substrate after reflow soldering process with  $T_{peak}$  of (a) & (d) 246°C, (b) & (e) 251°C and (c) & (f) 260°C

Figure 1(b) shows a better reflowed solder of Sn3.5Ag on ENIG substrate at  $T_{peak}$  of 251°C. An efficient reflow profile with the sufficient heating input contributed to the good fluxing reaction and metallurgical wetting, thus

resulting in good metallurgical bonding between Sn3.5Ag solder and ENIG substrate. An efficient RTP system design can lead to a uniform temperature distribution on the solder bonding and decreased of the thermal stress to the reflowed solder, thus enhancing the applicability of the RTP system. The adequate coalescence/wetting of the solder joint also contributes to the smooth joint appearance over the solder pad and formed a regular joint shape of the solder, as shown in Figure 1(e). The sufficient reflow process in the RTP system formed reliable solder joints while maintaining component integrity. The solder melted, coalesced and wet to appropriate terminations without damaging the materials (either components or board material).

Figure 1(c) shows charred defect due to the inadequate reflow profile at  $T_{peak}$  of 260°C. Peak temperature should be high enough to obtain a good wetting but not so high as to cause discoloration and charred to the ENIG substrate. Excessive high peak temperature and extended duration over the solder melting point introduced thermal stress to the ENIG substrate. On the other hand, an excessive heat input prior to solder melting not only oxidize the metallization pads excessively, but also will burn off more fluxes, thus resulting to the poor wetting (Gilbert 2001). As the fluxes are subjected to excessive high peak temperature, the activation systems become exhausted quicker and the viscosities of the flux are reduced, potentially leading to a reduction in the protective layer of flux that surrounds the solder before reflow process (Gilbert 2001). The wetting process occurs where the solder may be in contact but does not form a good metallurgical bonding with the substrate. This condition causes grainy, rough surface and irregular joint shape of the solder as shown in Figure 1(f).

Temperature non-uniformity of the wafer in the RTP system also contributes to the charred defect during the reflow soldering process. Ching et al. (2003) reported that the temperature gradient induces thermal stress which is compressive in the central region of the wafer where the sample was placed in the RTP system. The amount of stress depends on the initial temperature distribution and power distribution. It is also indicated that the induced temperature non-uniformity can cause plastic deformation

of the substrate during the RTP cycle and the problem is exacerbated by single-side heating, increased processing temperature and ramp rate (Ching et al. 2003). The adequate reflow profile and uniform method of heating source should be optimized to ensure better wetting process between solder and substrate in order to achieve a good metallurgical bonding between solder and substrate during the reflow soldering process using RTP system.

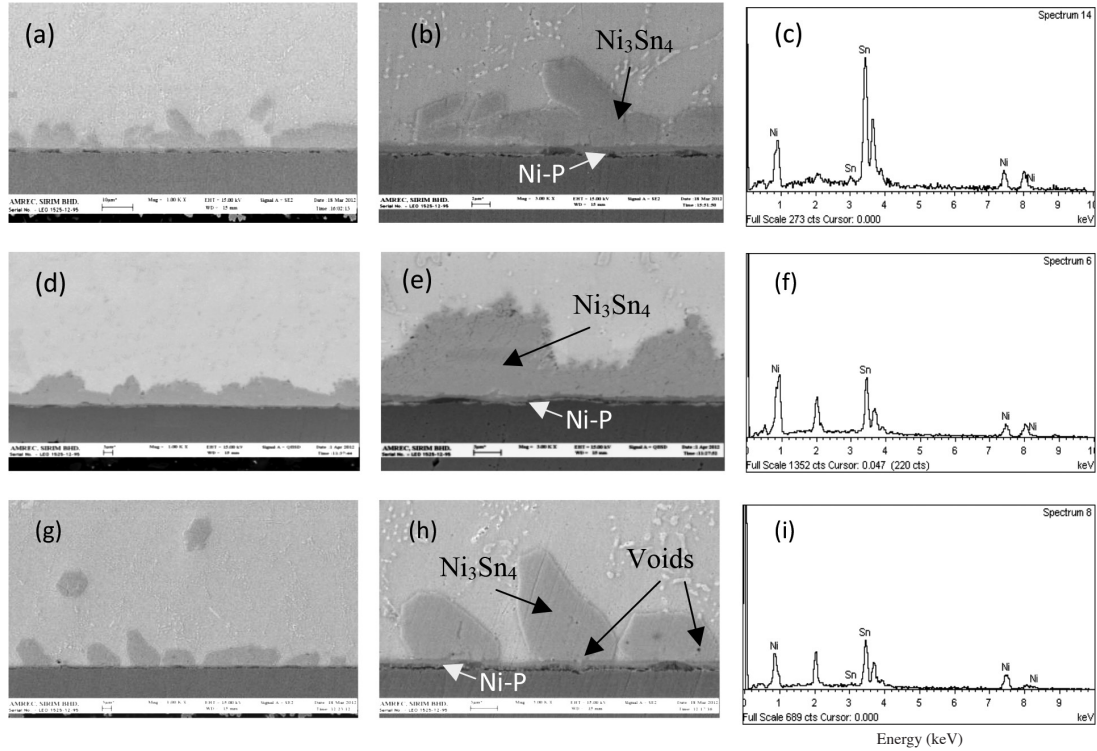
Figure 2 shows the microstructures and EDX spectrum of the as-reflowed interface between Sn3.5Ag solder and ENIG substrate at three different  $T_{peak}$  of 246, 251 and 260°C. The composition of phases formed during reflow soldering process was shown in Table 2. Figure 2(a) shows the formation of scallop and plates shape with big chunks type IMCs occurred along the interface of reflowed solder at  $T_{peak}$  of 246°C. The discontinuous formation of IMCs was observed along the Sn3.5Ag solder and ENIG interface, thus leading to the weakness of the metallurgical bonding between the Sn3.5Ag solder and ENIG metallization pad. EDX analysis shows that the IMCs formed at the Sn3.5Ag solder and ENIG interface was identified to be Ni<sub>3</sub>Sn<sub>4</sub> with approximate composition of 56.4 at.% Sn and 43.6 at.% Ni as shown in Figure 2(b). The EDX spectrum analysis for Ni<sub>3</sub>Sn<sub>4</sub> IMC can be observed in Figure 2(c). In as-reflowed solder process, the topmost Au layer dissolved into the molten solder and a reaction layer of Ni<sub>3</sub>Sn<sub>4</sub> IMC was formed at the interface of reflowed solder. In addition, Ni-P layer were also observed at the interface between the Ni<sub>3</sub>Sn<sub>4</sub> IMC and the Ni layer.

FIGURE 2. Cross-sectional micrographs and EDX analysis spectrum of IMCs formation at Sn3.5Ag solder and ENIG interface with  $T_{peak}$  of (a), (b) & (c) 246°C, (d), (e) & (f) 251°C and (g), (h) & (i) 260°C

The morphology of the IMCs was plane and large chunks shaped at the Sn3.5Ag solder and ENIG interface as-reflowed in the RTP system at  $T_{peak}$  of 251°C as shown in Figure 2(d). The continuous formation of the IMCs layer was observed to attach very well at the interface of reflowed solder and denoted as Ni<sub>3</sub>Sn<sub>4</sub> from the EDX analysis with approximate composition of 54.8 at.% Sn and 45.2 at.% Ni. At  $T_{peak}$  of 251°C, Au signal could not be detected and the effects of Au on the interfacial reaction is minimal if the Au concentration is < 0.05 wt.% in the solder (Ruihong et al. 2009). The Ni-P layer was also found to be formed at the interface of the Ni<sub>3</sub>Sn<sub>4</sub> IMC and the Ni layer as shown in Figure 2(e). The EDX spectrum analysis for Ni<sub>3</sub>Sn<sub>4</sub> IMC can be observed in Figure 2(f).

Figure 2(g) shows the formation of IMCs at Sn3.5Ag/Ni interface as-reflowed at  $T_{peak}$  of 260°C. It was observed that the IMCs tend to be independent with one another, thus represent a discontinuous type of IMC formed at the interface of Sn3.5Ag solder and ENIG substrate. The formation of IMCs layer was observed at  $T_{peak}$  of 260°C not much different with the formation of IMCs layer at  $T_{peak}$  of 246°C. The significant differences for both of IMCs layer were IMC spalling at  $T_{peak}$  of 260°C was detected to leap to the surface of the solder materials from the interface of Sn3.5Ag solder and ENIG. However, the formation of IMC

spalling was detected less occurred at the Sn3.5Ag solder and ENIG interface at  $T_{peak}$  of 260°C. Sharif et al. (2005) reported that beyond 60 min reflow at 260 and 270°C, the thickness of the Ni-P layer does not increase in the Sn3.5Ag solder system. In this work, IMC spalling was observed less occurred due to the high soldering temperature at 260°C for 70 s caused the sample more easily be burnt. It also exhibited less dissolution of Ni-P and thus, reducing of the IMCs formation at the interface of Sn3.5Ag solder and ENIG substrate. However, the IMCs formation at  $T_{peak}$  of 260°C exhibits the formation of voids in the Ni-P and IMCs layers due to the rapid dissolution of Ni-P layer. The IMCs composition were also identified to be Ni<sub>3</sub>Sn<sub>4</sub> with approximate composition of 55.4 at.% Sn and 44.6 at.% Ni from the EDX analysis. The Ni-P layer was also observed to be formed at the interface of Ni<sub>3</sub>Sn<sub>4</sub> IMC and Ni layer as shown in Figure 2(h). The EDX spectrum analysis for Ni<sub>3</sub>Sn<sub>4</sub> IMC can be observed in Figure 2(i). After reflow soldering process at  $T_{peak}$  of 260°C, Au signal also cannot be detected due to the concentration of Au was minimal.

Composition (at.%)			Phase	
Sn	Ni	P		
56.4	43.6	-	$Ni_3Sn_4$	Figure 2(b)
54.8	45.2	-	$Ni_3Sn_4$	Figure 2(e)
55.4	44.6	-	$Ni_3Sn_4$	Figure 2(h)
-	75.0	25.0	$Ni_3P$	Figure 2(b)
-	73.5	26.5	$Ni_3P$	Figure 2(e)
-	70.2	29.8	$Ni_3P$	Figure 2(h)
