THE USE OF GIS FOR THE APPLICATION OF THE PHENOMENOLOGICAL APPROACH TO THE SEISMIC RISK ANALYSIS: THE CASE OF THE ITALIAN FORTIFIED ARCHITECTURE

E. Lenticchia ^a and E. Coïsson ^{b*}

KEY WORDS: GIS, phenomenological approach, fortified architecture, damage mechanisms, castles, fortresses

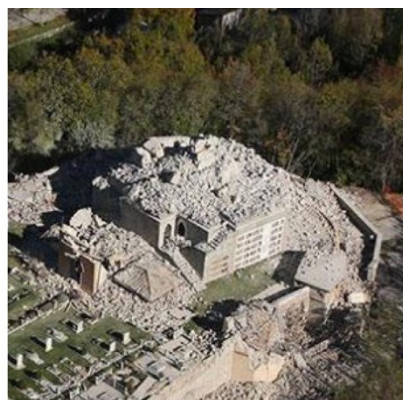
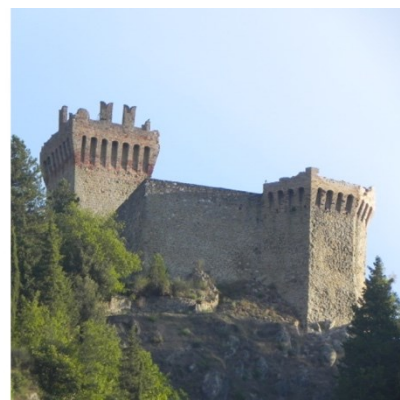
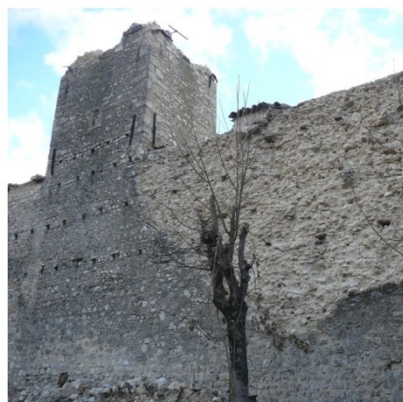
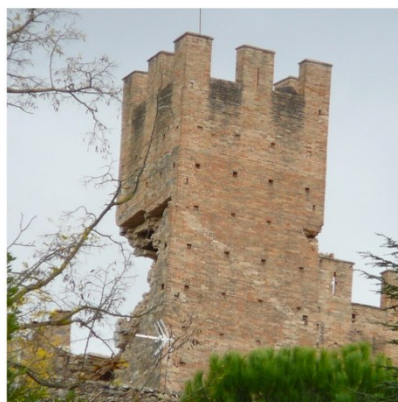
a) Fantellino Castle in Ussita

b) Fortified town of Visso

c) Arquata del Tronto Castle

d) Norcia walls, Central Italy 2016

e) Pallotta Castle in Caldarola

f) Tolentino defensive walls

Figure 9. Damaged fortified buildings after the seismic sequence started in August 2016.

Lastly, statistical analyses on these data have been conducted in order to inspect possible connections between building features, peak ground acceleration and damage mechanisms (Figure 9). Some of the analyses have already been reported in (Coisson et al 2016), indicating the relative frequency of the damage to the different elements and allowing to identify some threshold values for the damage expected. Moreover, the connection between the damage and the building features is evident, thus allowing to identify the most vulnerable elements on which the interventions should be focused.
