Nanoscale corrosion behavior of polycrystalline copper fine wires in dilute NaCl solution investigated by in-situ atomic force microscopy

著者	Ogata Shoichiro, Kobayashi Naritaka, Kitagawa Takuya, Shima Shohei, Fukunaga Akira, Takatoh Chikako, Fukuma Takeshi
journal or publication title	Corrosion Science
volume	105
page range	177-182
year	2016-04-01
URL	http://hdl.handle.net/2297/44823

Keywords: A. Copper, B. AFM, C. Anodic dissolution

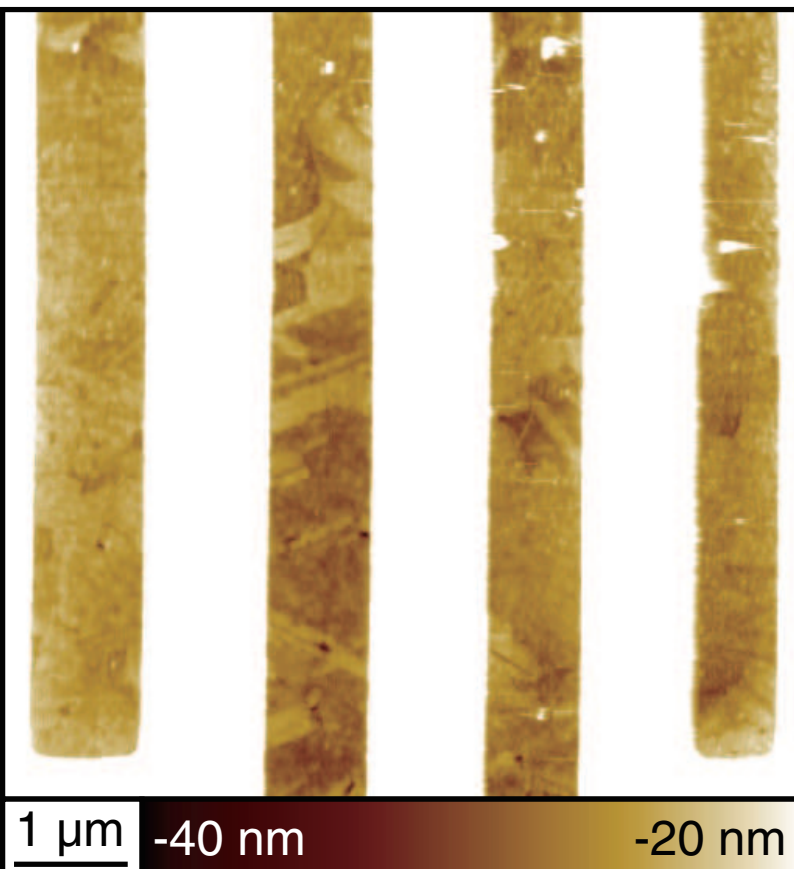
Figure 2: AFM images of copper wires in water at (a) 39 min and (b) 203 min. The 0 nm in the height scale corresponds to the approximate average height of the insulating areas. (c) IPF map of the same area as imaged by AFM. (d) Height changes at the locations indicated by the arrows No. 1 in (c).

Corrosion process of copper wires in water was imaged by AFM from 39 min till 203 min since the surface was immersed in the imaging solution. Figures 2(a, b) show AFM images of copper wires in water at 39 min and 203 min, respectively. See also a video consisting of all the AFM images obtained during the corrosion process (Water.gif in supplementary online materials). The images show four copper wires as illustrated in Fig. 1(b). At 39 min, the copper surface already shows nanoscale height variations. Such initial height variations may be caused by the CMP, Ar plasma or citric acid cleaning. As the main interest of this work is on the copper corrosion processes in dilute NaCl solution, hereafter we do not discuss formation mechanism of these initial height variations but focus on the time-dependent height changes observed during the AFM imaging. The image obtained at 203 min shows a larger local height variation than the one obtained at 39 min. This result shows that the corrosion resistance is not uniform but has local variation.

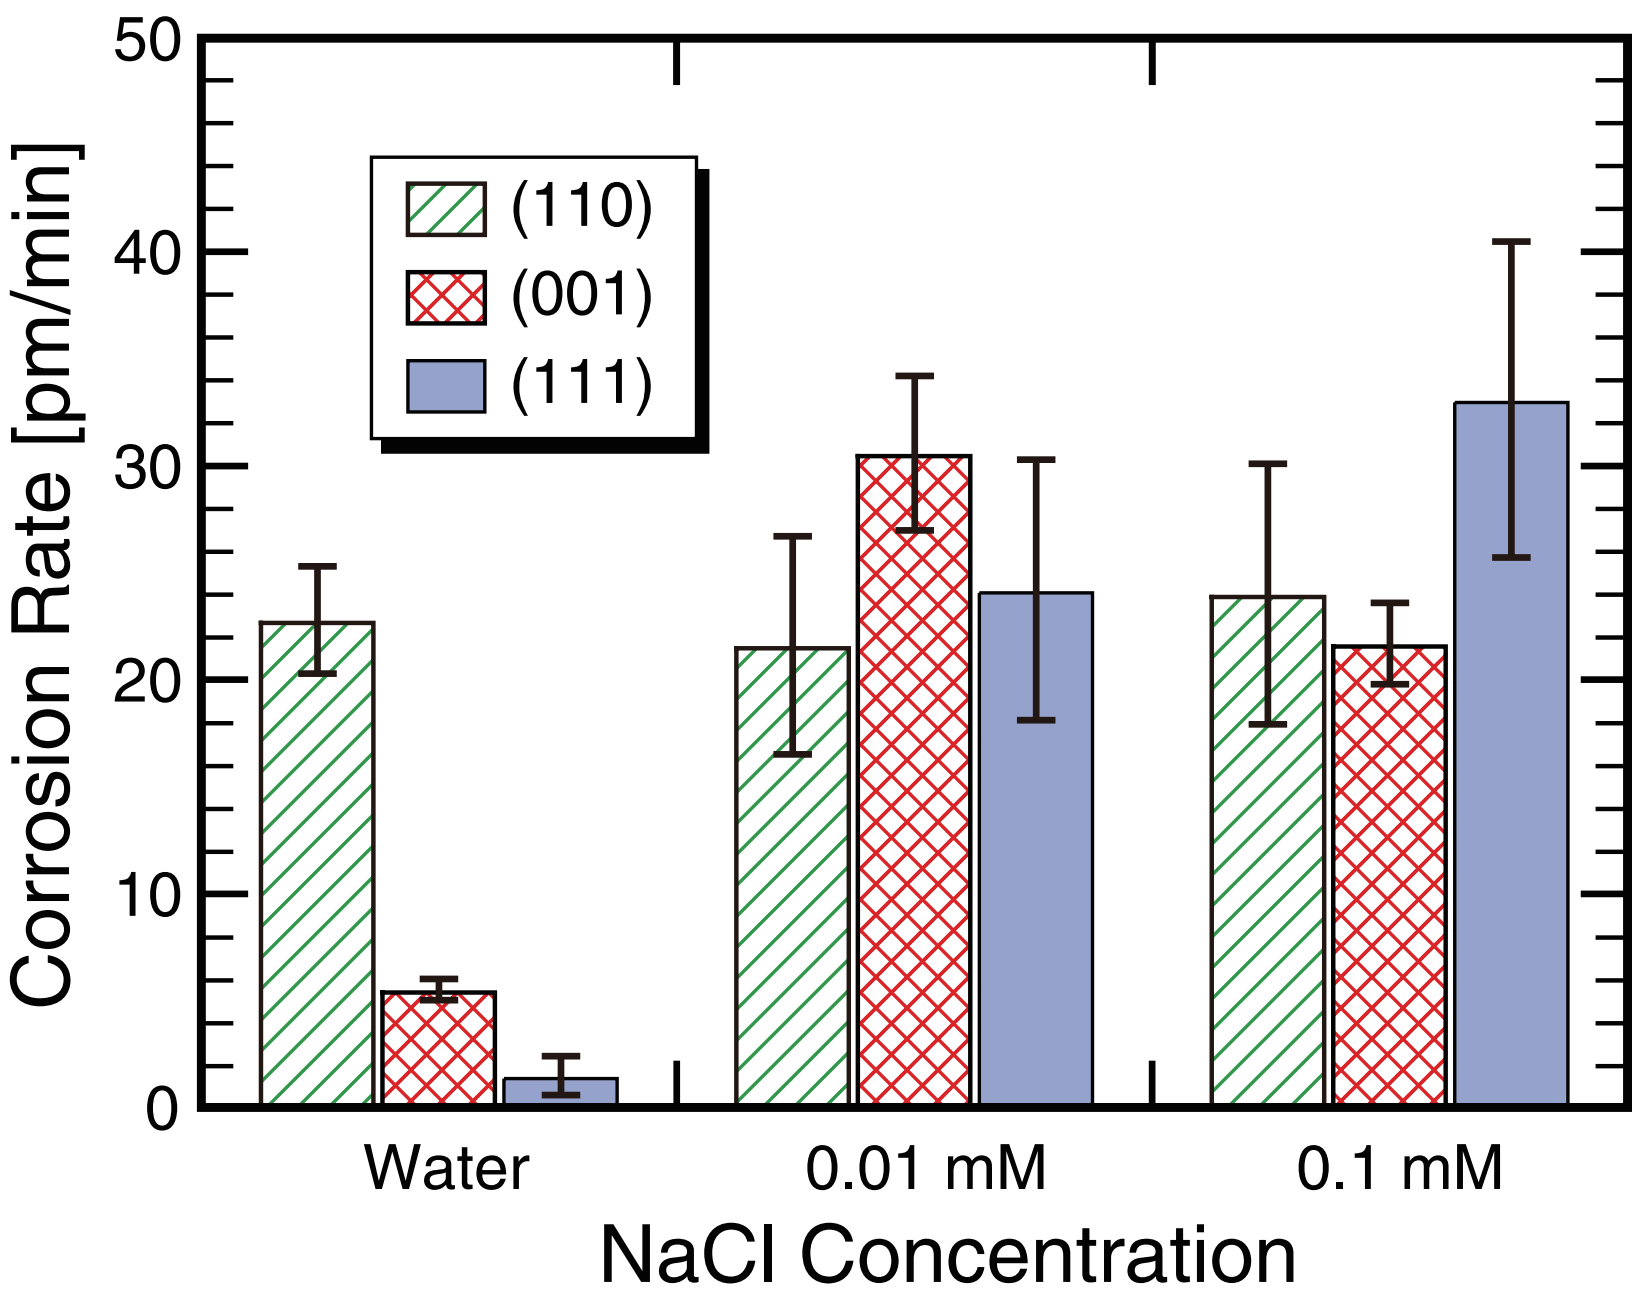
Figure5

Figure 5: Corrosion rates of the (110), (001) and (111) surfaces in water and 0.1/0.01 mM NaCl solution. The values correspond to an average of the values measured at the three locations indicated in Figures 2(c), 3(c) and 4(c). The only exception is the value for the (110) surface in 0.1 mM solution, where only the two (110) surface grains exist in the wire. The error bars correspond to a standard deviation of the measured values.

170 In pure water, the dissolution rate increases in the order of (111), (001)
and (110). However, the addition of Cl^- into water significantly increases the
dissolution rate of the (001) and (111) surfaces while it gives little influence on
the dissolution rate of the (110) surface. Further increase of Cl^- concentration
from 0.01 mM to 0.1 mM decreases the dissolution rate of the (001) surface.
175 Although the mean value of the dissolution rate of the (001) surface increases,

the significance of the difference is not confirmed due to the large error bars. For 0.01 mM and 0.1 mM NaCl solution, the dissolution rate shows no significant difference between different crystallographic orientations.
