Title: Human-planted alder trees as a protection against debris flows (a dendrochronological study from the Moxi Basin, Southwestern China)

HUMAN-PLANTED ALDER TREES AS A PROTECTION AGAINST DEBRIS FLOWS (A DENDROCHRONOLOGICAL STUDY FROM THE MOXI BASIN, SOUTHWESTERN CHINA)

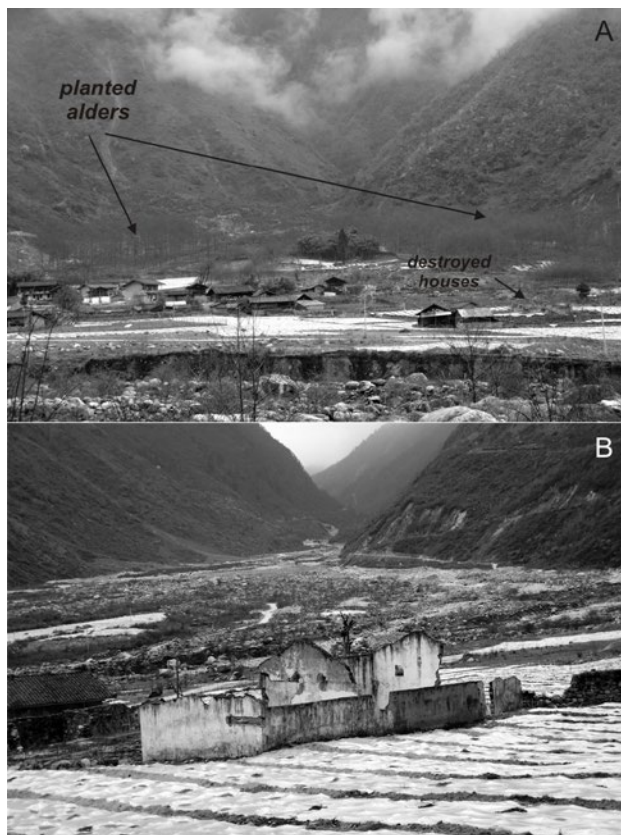
Fig. 1. The debris flow fan under study, (A) – the village is located on the debris flow fan and the planted alders are marked with arrows, (B) – one of the houses destroyed by debris flows.

The people living in the mountainous areas of Sichuan Province often occupy small debris-flow fans located at the foot of gullies formed in loose moraine sediments (Fig. 1A). The debris flows which develop in these areas destroy houses and threaten human lives (Fig. 1B). Local people plant *Alnus nepalensis* saplings on fan surfaces in order to protect their villages from destruction by debris flows (Fig. 2A). Alder trees growing within the fans are being wounded and tilted by the debris transported during flows. At the same time, the trees slow the movement of debris flows and capture a portion of the debris, thus protecting people and their houses (Fig. 2B). This creates an opportunity for carrying out dendrochronological studies on human-planted alder specimens.

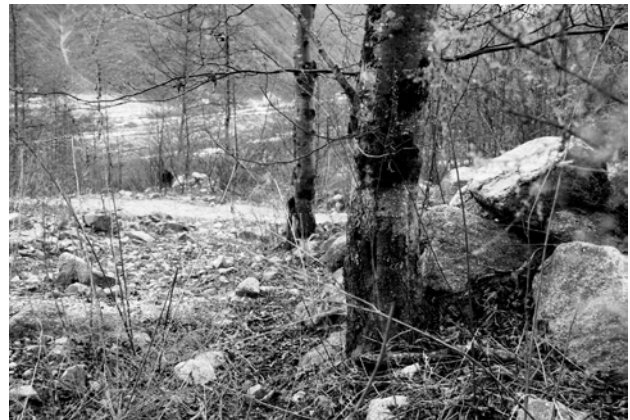
Fig. 9. Boulders captured by the stem of alder tree during a debris flow event.

It was found that 24% of analysed alder trees had captured coarse debris during past flow events (Fig. 9). The diameter of boulders rapidly decreases in the alder forest along the debris flow tracks. In the upper part of the fan, the average diameter of the rock particles reaches 145 cm (measuring point 1), whereas in the central and lower parts it only reaches 40-30 cm (points 4-5); (Table 1).
