# Inspection of Aircraft Wing Panels Using Unmanned Aerial Vehicles <sup>†</sup>

**Abstract:** In large civil aircraft manufacturing, a time-consuming post-production process is the non-destructive inspection of wing panels. This work aims to address this challenge and improve the defects' detection by performing automated aerial inspection using a small off-the-shelf multirotor. The UAV is equipped with a wide field-of-view camera and an ultraviolet torch for implementing non-invasive imaging inspection. In particular, the UAV is programmed to perform the complete mission and stream video, in real-time, to the ground control station where the defects' detection algorithm is executed. The proposed platform was mathematically modelled in MATLAB/SIMULINK in order to assess the behaviour of the system using a path following method during the aircraft wing inspection. In addition, two defect detection algorithms were implemented and tested on a dataset containing images obtained during inspection at Airbus facilities. The results show that for the current dataset the proposed methods can identify all the images containing defects.

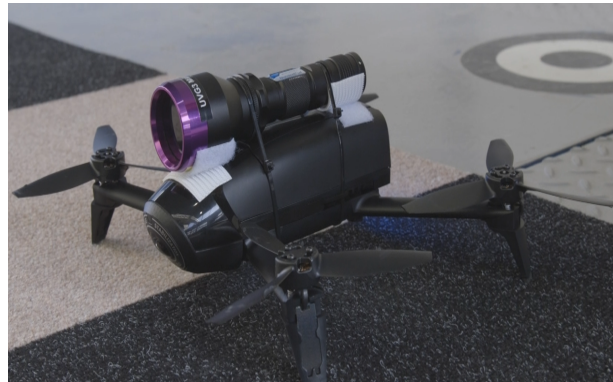
**Figure 1.** The aerial vehicle used in the proposed inspection methods.

Taking into consideration the aforementioned benefits of the aerial inspections, this work assesses the feasibility of using UAVs to automate the inspection of a metallic panel of an Airbus A320. Although research has been carried out on automated aerial inspection and maintenance on aircraft parts by using UAVs, no studies have been reported so far in the literature. In fact, the majority of the published papers, in this field, report the use of autonomous ground vehicles [16,17] or robotic arms for defects detection [18]. However, such autonomous systems might not be suitable for all the applications, because ground vehicles might not inspect high facilities, while robotic arms might require expensive equipment and appropriate infrastructure. In parallel, the main purpose of NDT is to check the airworthiness of a component without damaging it. In general, several NDT methods are available, including techniques such as visual inspections, borescope, liquid penetrant, eddy current, ultrasonic, acoustic emission, magnetic particle and radiography. For a comprehensive review, please refer to [19,20]. Among these NDT methods, the present study focuses on the visual and liquid penetrant inspection of metallic wing panels. In particular, is taking place prior to anodising, in order to check the wing panels for cracks and corrosion. First the penetrant is coated on to the part where capillary action pulls the penetrant in to any defect. Excess penetrant is washed off and the part is dried. Developer powder is the applied which absorbs an penetrant liquid left in the defect. Then under UV lighting the defect area is clearly visible. In this paper the automation of the final procedure of the defect recognition is proposed with the use of a small quadrotor (Figure 1), carrying a UV light, performing preprogrammed missions.

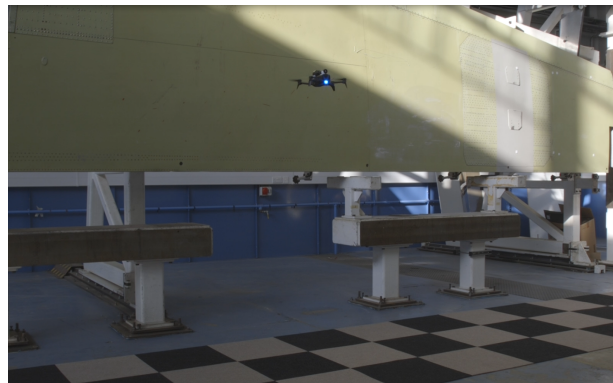
**Figure 2.** Aerial inspection.

In this section, an overview of the proposed UAV system is described. The setup mainly consists of the aerial vehicle, the Ground Control Station (GCS), and the wing panel for inspection. For the experiments a Bebop 2 was selected carrying a UV-light that fulfils the Airbus standard for the penetrant liquid inspection. The system can be seen in Figure 1. Detail information regarding the system can be found in [21]. For the testing a wing panel was utilised to examine the fidelity of the proposed aerial NDT methods. A 6 m long wing panel was vertically mounted to perform the visual and flow penetrant inspection methods, as shown in Figure 2.

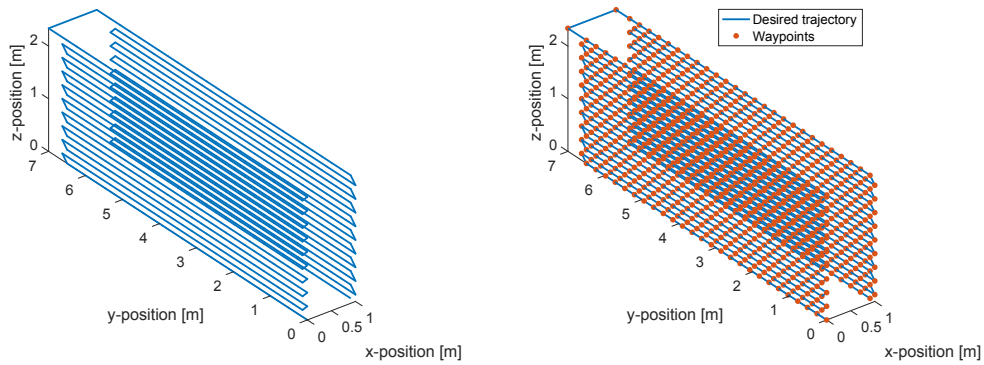
Figure 3. Desired waypoints and trajectory used for the simulations.

Figure 3 presents the waypoints and trajectory that need to be followed in the simulation of a two-sided inspection. The total inspection time for two-side wing panel was estimated at 1200 s, for a total approximately flight distance of 252 m. The velocity of the vehicle is considered constant. In the simulation model, a wing panel with 6.5 m span, 2.33 m chord, and 0.3 m thickness, is considered. The wing panel is assumed as a rectangular surface for simplifying its design complexity.

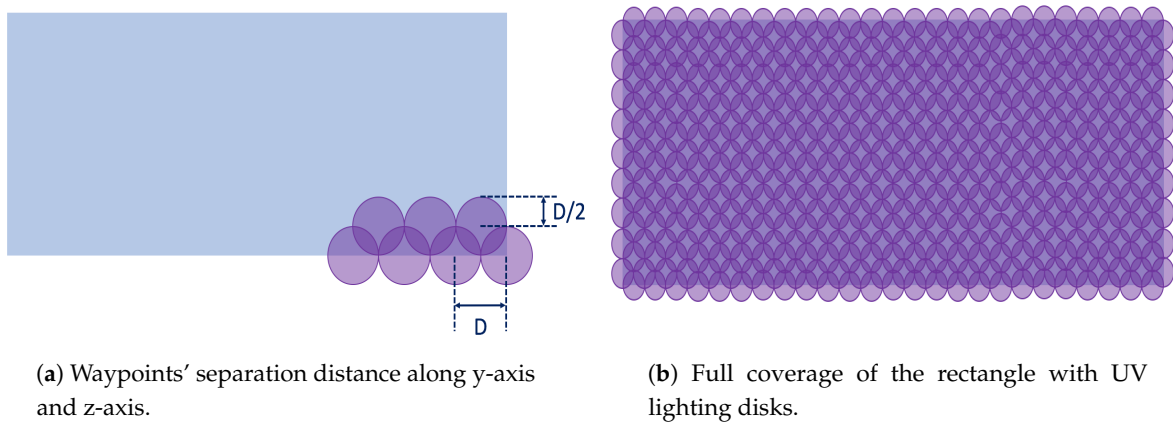
Figure 4. NDT simulated inspection.

The proposed inspection method is based on the full coverage of the rectangle with UV lighting disks, as is shown in Figure 4. The UAV keeps 1 m separation distance from the wing panel ( $x$ -axis) and hence the UV lighting diameter, which expresses the disks, is about 0.26 m. In the simulated mission, the UAV follows waypoints that have separation distance ( $D$ ) 0.26 m along  $y$ -axis, 0.13 m in  $z$ -axis, as is shown in Figure 4a. An example of a wing panel that is completely covered by UV lighting disks is illustrated in Figure 4b. In this example, the number of waypoints for one-side inspection is set at 494 waypoints.

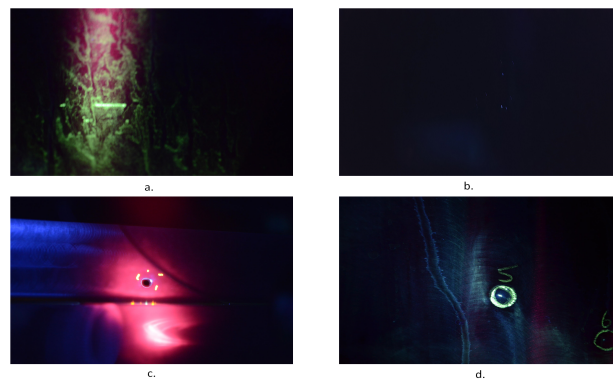
Figure 5. Images from the dataset (a) Image with green areas, (b) Image without green areas, (c,d) Images with possible defects.

The dataset which is used for validating the defect detection algorithms was created from images taken during inspection of wing panels in Airbus facilities. The photos were taken under UV light inside the black booth during an actual inspection. The equipment used was a DSLR camera of 24-megapixel and a mobile phone camera with 16-megapixel resolution. The dataset that was built has 119 images containing 25 images from 4 possible defects, images with green areas with no defects and images without any green. A representative sample can be seen in Figure 5.

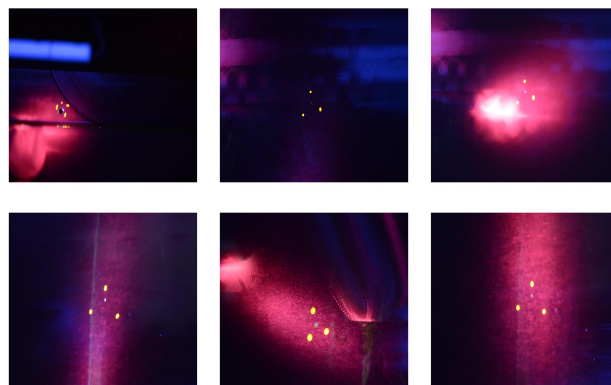
**Figure 6.** Baseline images with defects on wing panels.

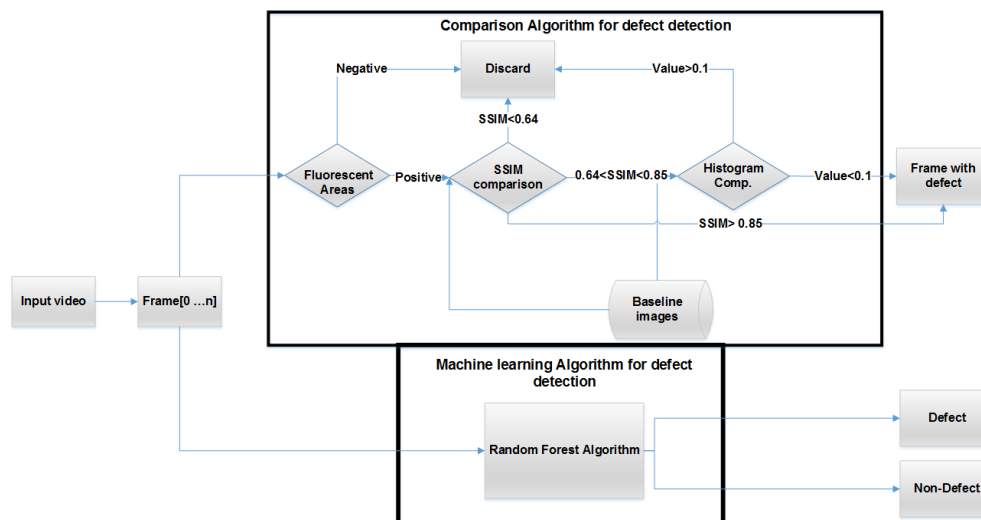
**Figure 7.** Flowchart of both the proposed defect recognition methods, the one with the combine use of SSIM and Histogram comparison and the Random Forest.

Some of the challenges that the algorithms had to address was the conditions of lighting and how to distinguish the fluoresce areas with defects with the ones without defect. During the inspection most of the areas that luminance under UV light with green do not contain any defect. To address the problem, two different approaches were implemented and tested. In the first one, images with defects were compared with image data from inspection and their similarity was calculated by combining two different image processing algorithms. In the second, a Random-Forest algorithm was implemented for classifying the images in defect or not categories. The results of both methods were compared. In Figure 7 the flowchart of the proposed methods can be seen.

In the first method, the software initially filters the images keeping only the ones that contain green areas. Then it uses two different algorithms, Structural Similarity Index Measure [22] and Histogram Comparison, to classify if these images contain any possible defects. In a step by step description of Figure 7 the algorithm first discards any images that do not contain any green area. Then the remaining images are compared with the baseline images using the Structural Similarity index Measure (SSIM) [22]. The outcome of this comparison can be either positive (defect was found), negative (no defect) or further investigation is needed. The outcome depends on the different values of the SSIM. If further investigation is needed a histogram comparison with the baseline images is taking place. In the second method the images are fed to a Random Forest Classifier. Detail description of both methods is given in the rest of the section.

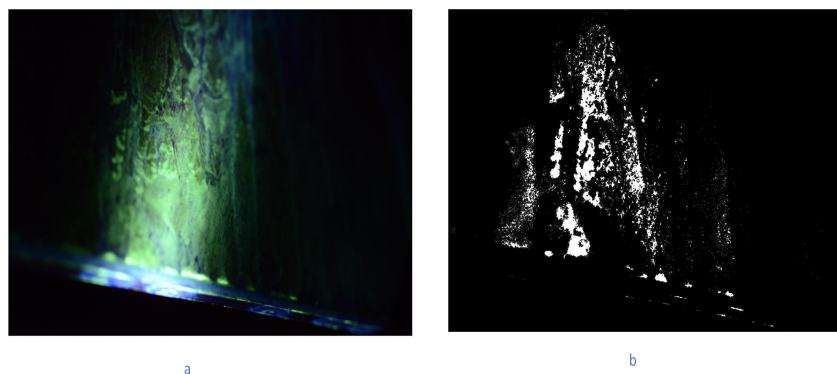
**Figure 8.** (a) Initial Image containing green areas, (b) Image after masking.

For this reason, a mask was implemented. The mask covers all the pixels that do not have value in the range of green in the RGB and colours with white the green ones (Figure 8).

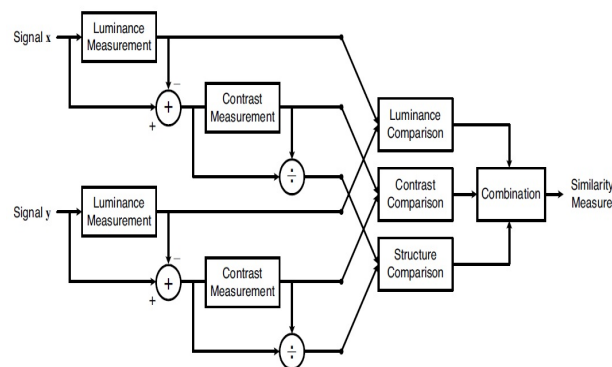
Figure 9. Diagram of the structural similarity (SSIM) measurement system.

Then the algorithm finds the contours in the images. Contours can be explained as the closed curve joining all the points delimiting an area with the same colour or intensity. If the image contains at least one contour meaning that then definitely has some green colour. After filtering, the remaining images containing green areas are compared with the baseline images that were taken at Airbus facilities. For the comparison, the algorithm of SSIM was used. SSIM is an index used for measuring the similarity of two images. It can be seen as a quality measure of the image that is being compared and it takes values between  $-1$  and  $1$ . If the compared image is completely different from the initial the value will be  $-1$  while if they are identical/very similar it will be  $1$ . The comparison is made by measuring luminance, contrast and structure. Image Structure is an arrangement and organization of interrelated elements in an image. The structural diagram of the algorithm is presented in Figure 9.

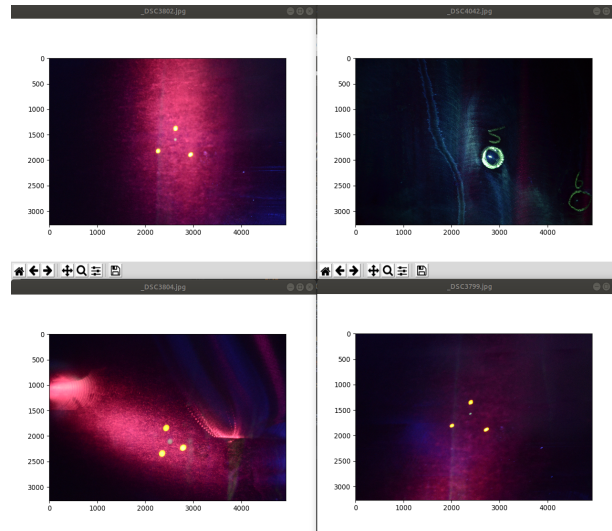
**Figure 10.** Images identified with defect using the combined SSIM and Histogram comparison method.

Regarding the defect detection methods, both were tested on the dataset created during inspection and described above. The results for the first method are very convincing as the software manages to identify all the 25 images containing defects on the specific dataset plus one image with a possible defect. Considering the limited number of images with defects the performance is very good. Images with defects displayed by the software output can be seen in Figure 10.

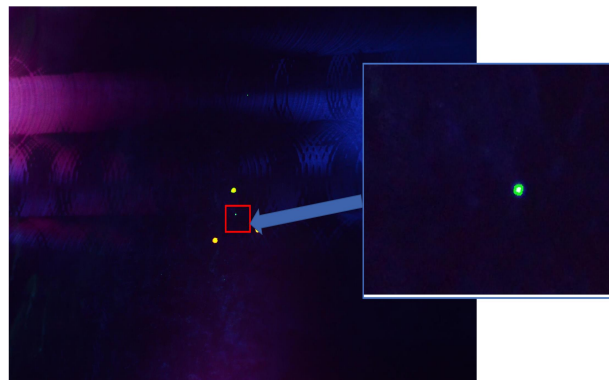
**Figure 11.** Image with possible defect.

In Figures 11 and 12 two images with possible defects can be seen. Image in Figure 11 is one of the 25 images containing possible defect and in Figure 10 is an image without any defect but contains green spots. The images are very similar so the software has classified it as a possible defect. This is due to the limited amount of images containing defects but as more images will be added to the dataset the performance of system will be improved.

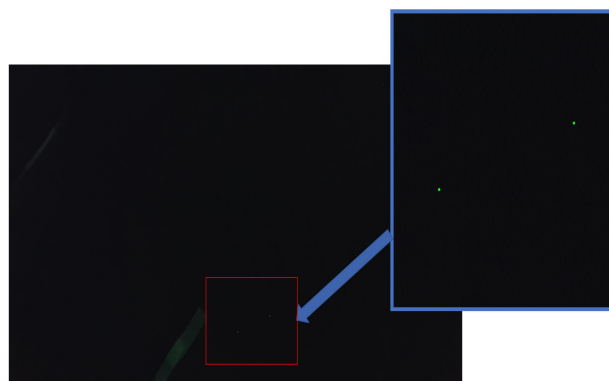
**Figure 12.** Image with false positive defect.

Results show that both defect methods are performing very well in identifying defects. It is worth noticing that the image in Figure 12 that was classified as false positive in the combined SSIM and Histogram method, with Random Forest was classified correct, labelled image H in Figure 13. The comparison method is performs well but the computational time needed for running the whole dataset was 3 min in Intel Xeon 2.66 GHz processor, so as the dataset will get larger it will be even slower as more comparisons will be needed to be performed. On the other hand, testing and validation results of Random Forests are promising and indicate that this approach is able to detect defects even with this small dataset. In addition, the Random Forest algorithm performs faster than the comparison method. The random forest algorithm classified the 10 random images in 5 s which is significantly less than the comparison method which needs 15 s for the same number of images. Though it is not possible to extract solid conclusions in such a small dataset, the machine learning method has an advantage, as once properly trained will be able to generalize better on the data rather and will also will be faster than the comparison method.

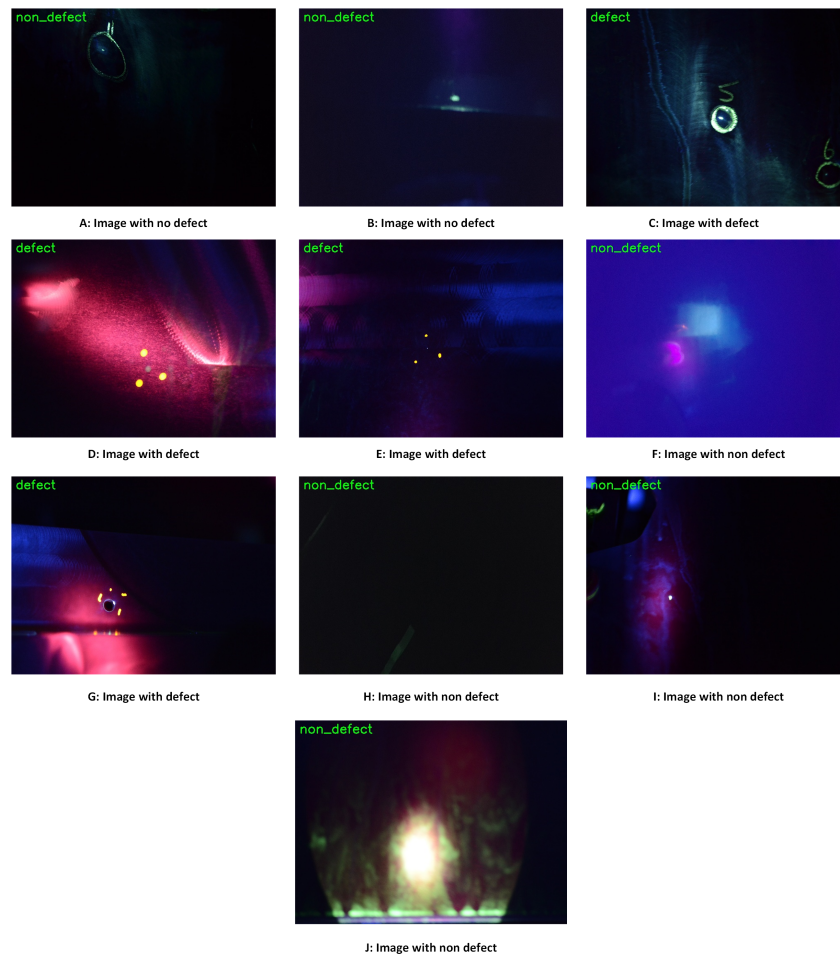
**Figure 13.** Results of the Random Forest algorithm. (A–J) titles are the class were the image actually belongs and the green title on the image is the outcome of the Random Forest algorithm.

The model was tested also in 10 randomly selected images from the dataset. The accuracy of prediction was 100% and the results can be seen in Figure 13.
