A Comparison of Complications in 400 Patients After Native Nail Versus Silicone Nail Splints for Fingernail Splinting After Injuries

Christian Weinand · Erhan Demir ·
Rolf Lefering · Bettina Juon · Esther Voegelin

Published online: 29 April 2014
© Société Internationale de Chirurgie 2014

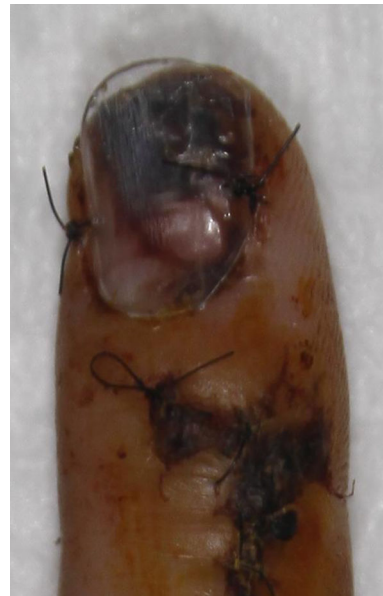
Fig. 1 Silicone nail splint, sutured to the perionychial walls at each side. The splint was constructed from a 10-cc syringe

syringe to match the needed shape. All nail splints were cut to the size needed, trephined before, and sutured to the perionychial wall using 4/0 nonabsorbable suture material, one or two at each side (Figs. 1, 2). Care was taken to keep the eponychial fold open by inserting the splint into it. The splints were left in place until the new nail protruded from under the eponychial fold.

In a traumatically injured nail bed, it is crucial to keep the proximal nail fold open. The fold will obliterate within days if a nail substitute is not inserted, resulting in complete loss of nail growth or nail ingrowth into the fold. In the literature there are few articles on the topic of nail bed injuries and splinting. Some authors suggest the temporary use of metal foil splints or acrylic nails [8, 9]. However, foil splints can lead to staining of the nail bed, which is difficult to remove [10], and they are expensive and not easily available. Ogunro [11] reported on a new nail bed splint, the INRO surgical nail splint. Although results with it seem to be promising, the device has not been used much. Other authors reported on the use of silicone-based materials as splints, such as nasogastric tubes [12] or syringe plastic [4]. These materials are easily available and are ready to shape as nail bed splints. However, the nasogastric tube splint is not as stiff as acrylic or metal splints and may lack the needed durability to armor the distal digit against external forces, where as the metal splints might be too hard for the nail bed and lead to additional injuries. In our study, we used a silicone nail splint made from a 10-cc syringe. This material is easily available and nail splints of various sizes can be readily made. Another advantage we have seen with this splint is that the radius of the syringe comes close to that of the native nail bed. If there is a

difference in size, the splint material can be adjusted by bending. Because of its stiffness it will sustain the adjusted shape. This size difference might be the reason for the higher rate of nail deformities observed, as the shape of the splint cannot be adjusted as finely as needed to shape the repaired nail bed.

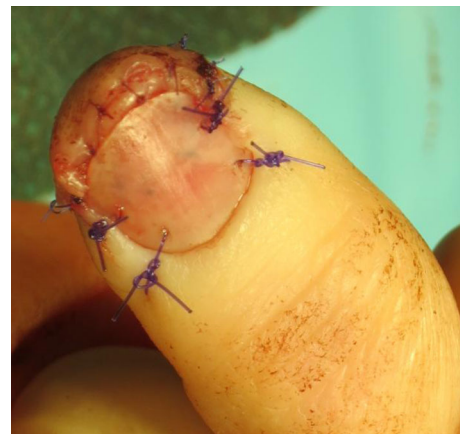
Fig. 2 Native nail splint after nail bed reconstruction. The nail was cut to the size of the nail bed and sutured to the epinychia walls
