# JOURNAL OF DEGRADED AND MINING LANDS MANAGEMENT

ISSN: 2339-076X (p); 2502-2458 (e), Volume 6, Number 2 (January 2019):1697-1704

### Land and water conservation practices in tropical agricultural watershed

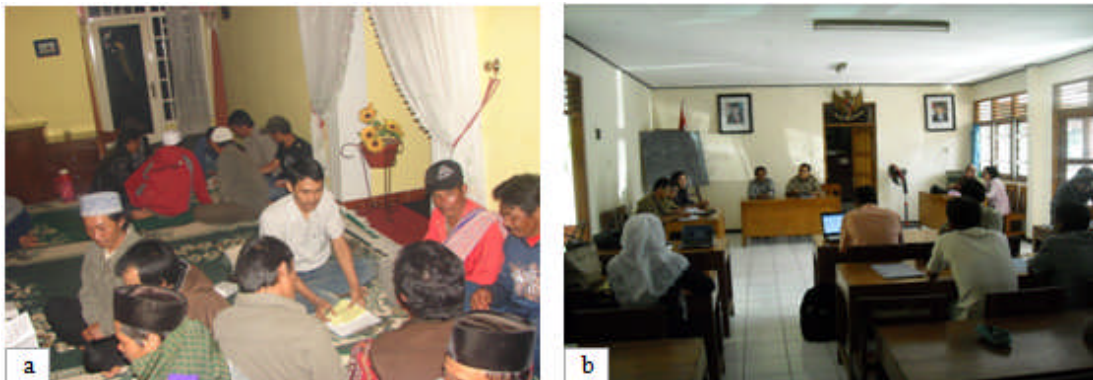
Figure 3. Socio-economic survey in the site of Kejajar Subdistrict, Wonosobo Regency in 2010 (a), and Kebasen Subdistrict, Banyumas Regency in 2011 (b)

LWC practices are mostly applied for land protection in the upland as indicated in previous studies (e.g. Nyssen et al., 2009; Govers et al., 2017). In a critical watershed, the handling of land degradation impacts is required for short and long-term. Therefore, adequate types of LWC practices are required to control land degradation in critical watersheds as applied in the present study. The survey mainly aimed to socialize the program and to assess socio-economic aspects and aspirations of the local inhabitant. Socio-economic surveys were completed by in-depth interviews, questionnaire and village monograph in each site. These surveys were attended by about 30-50 people in each site (representing the whole head of households in the site). Figure 3 shows survey activities in two different sites. The result of the survey indicated that the LWC practices program was fully accepted by the local inhabitant. Mostly, they were people which worked in agricultural fields with limited education and a few skills for working in other fields; therefore, the local inhabitant had a high dependence on the land for farming. Figure 4 shows an example of socio-economic survey result in a site which was conducted in 2010. Education background affected the distribution of work types in the site.

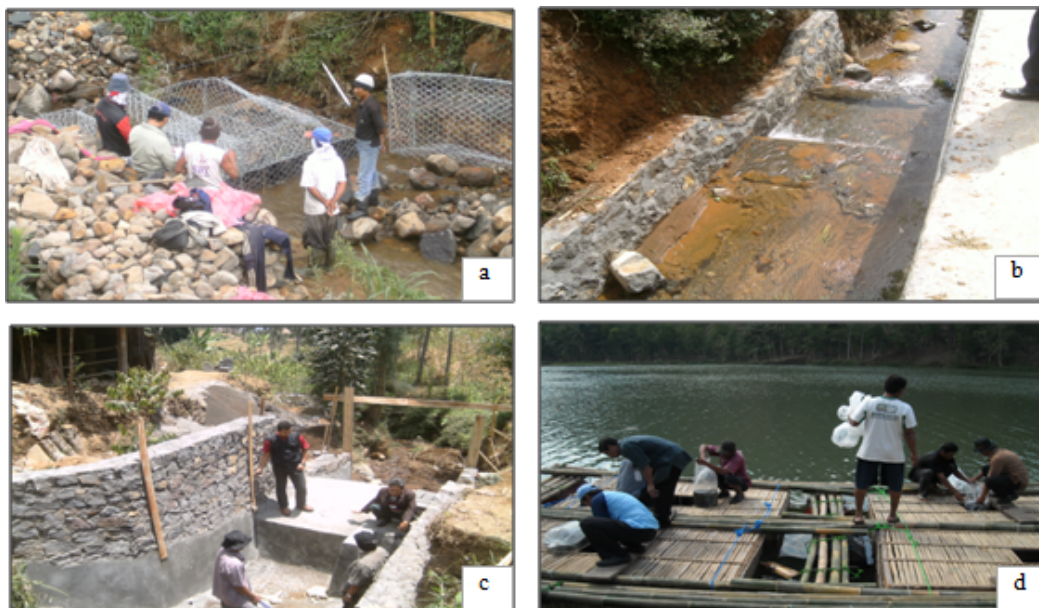
degradation and stream bank erosion. We also introduced fish farming technology in the river (Kebasen Subdistrict Banyumas Regency) by using the fish cage for the local inhabitant in 2011. The field survey revealed that sand and stone mining were uncontrolled; hence the introduction of an alternative livelihood (fish cage) was important to reduce the mining activity. Figure 5 shows some structures in study sites.

Figure 5. Small-scale dam construction from gabion (a) and stone weir (b) in Kejajar Subdistrict Wonosobo Regency, rock small-scale dam in Ngadirejo Subdistrict Temanggung Regency (c) and fish cage in Kebasen Subdistrict Banyumas Regency (d)

Progo watershed) and in the form of gabion dam by the year 2010 in Kejajar Subdistrict Wonosobo Regency (upper of the Serayu watershed). At the same site in Kejajar Subdistrict, we also constructed stone weir. The gabion was provided by the BBWSSO, while, the material of stones for the construction were hugely available in the study site. The stone weir controlled the effect of riverbed's slope and reduced riverbeds

Small-scale dam performance for river sedimentation control was assessed in the site of Serayu watershed. This site was selected due to field measurement data of sediment deposit was available (calculated in the reservoir downstream of the watershed). As reported by PT. Indonesia Power (Marhendi and Ningsih, 2018), the average sediment flow of the Serayu watershed was recorded in a scale of 4 million  $\text{m}^3/\text{year}$  or equal to 3.9 mm/year. Meanwhile, the tolerable sediment deposit from the watershed was about 2.4 million  $\text{m}^3/\text{year}$  for the total of catchment area ( $1,022 \text{ km}^2$ ). Tolerable sediment deposit (flow) from the watershed was determined by considering the lifetime of the reservoir (Mrica reservoir) downstream (60 years). The assessment of small-scale dam performance for river sedimentation control was performed for an upstream area of the Serayu watershed (Figure 8). It covered about  $135 \text{ km}^2$  area with  $530,967 \text{ m}^3$  annual sediment yield and  $318.58 \text{ m}^3$  tolerable sediment flow (gained from the value of total existing and tolerable sediment yield of the Serayu watershed which was calculated by using area weighting method). There were two structures (small-scale dams) in this site (Kejajar Subdistrict Wonosobo Regency) with a capacity  $1,300 \text{ m}^3$  (Figure 5a and Figure 7a).

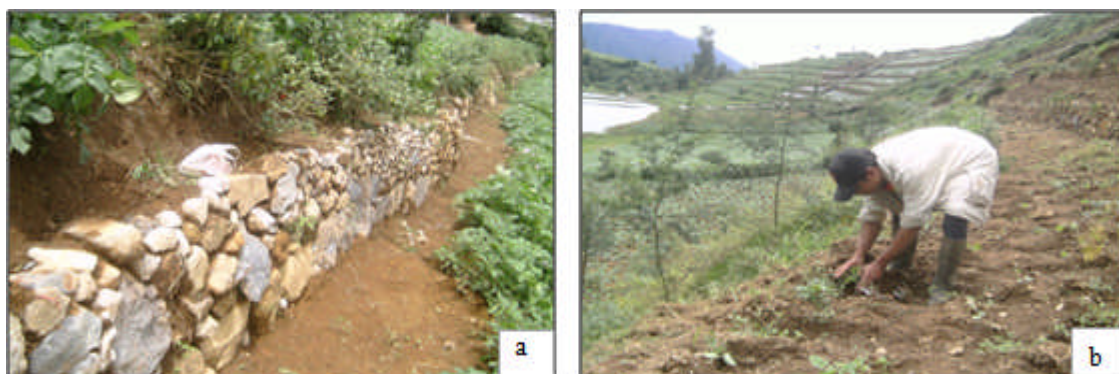
Figure 6. Terracing in the steep sloping area (a) and regreening bare land (b) in Batur Subdistrict Banjarnegara Regency (upstream of the Serayu watershed)

was determined based on river morphology condition in the site. Meanwhile, the regreening bare land was applied in small rivers (stream order 1) and upland (farmland) in Batur Subdistrict in 2010 (Figure 6). Generally, the integrated program for LWC practices was successfully executed as planned. The local inhabitant was fully involved in the regreening bare land through farmer groups in each site.

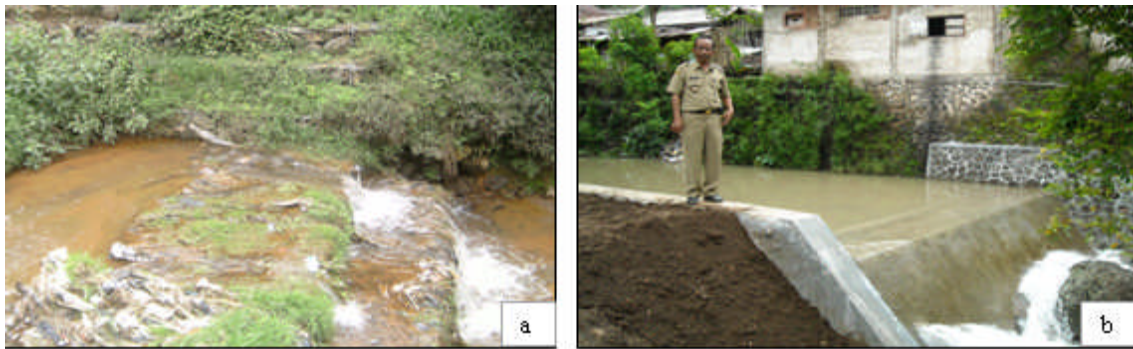
Field monitoring showed that structures (small-scale dams) have a good function in storing water and sediment, especially bed load type (Figure 7). Water inundation upstream the small-scale dam increased soil water storage by increasing infiltration. As characterized by its main material, field monitoring from 2009 to 2018 indicated that rock small-scale dams had a

Figure 7. Gabion small-scale dams constructed in Kejar Subdistrict Wonosobo Regency (a) and rock small-scale dam constructed in Wadaslintang Subdistrict Wonosobo Regency (b)

longer service life ( $> 8$  years) than gabion small-scale dam ( $\pm 5$  years). The lifetime of structures was affected by the environment condition.
