In-vitro Comparison of NiTi Tee, RaCe and Protaper Instruments in Dentinal Crack Formation

Saberi E, Mohammadi A, Ebrahimipour S, Baniasadi S. *In vitro* Comparison of Niti Tee, RaCe and Protaper Instruments in Dentinal Crack Formation. *J Dent Mater Tech* 2017; 6(4): 152-8.

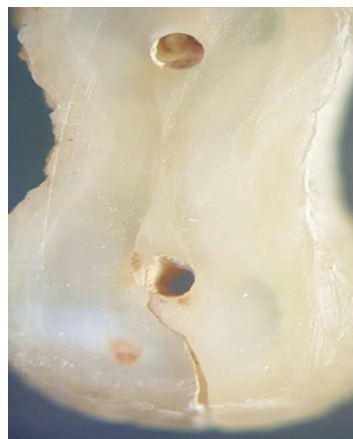
Figure 1. Microscopic view of complete crack in the dentinal wall

Dentinal defects were observed in 3 samples (20%) of Protaper group that two cases of them were as complete crack (figure 1), 2 samples (13.3%) of RaCe group and 4 samples (26.7%) of NiTi Tee group.
