## ECOLOGICAL RECONSTRUCTION OF TAILING DUMP

**Plesa P.I., M. Dirja**

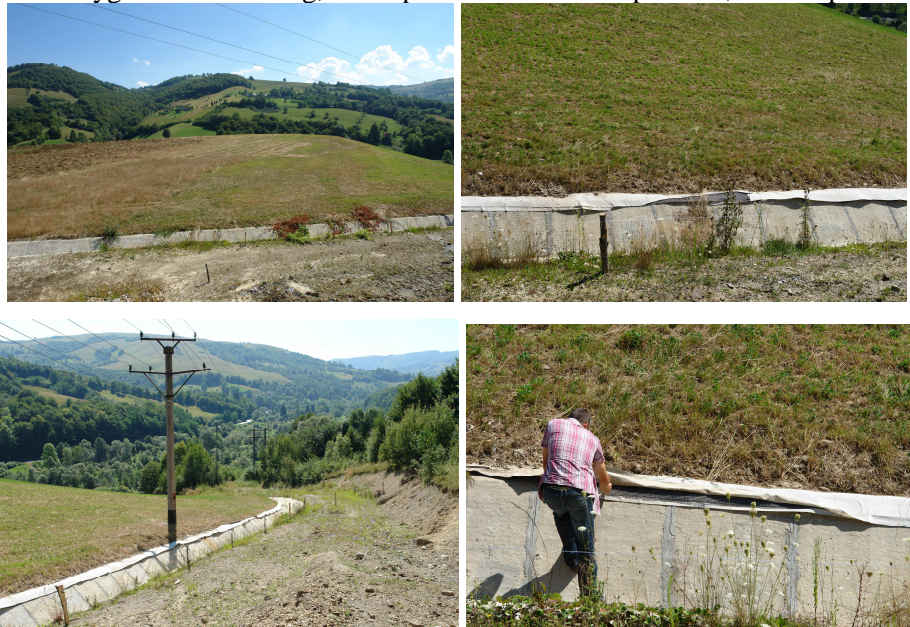
Fig. 1. Revegetation of Gura Roșiei tailing dump – Roșia Montană

The dump site located on the mouth red test surfaces was intended effect it is geosynthetic material herbaceous vegetation installed on the site, ie the soil water balance, transport of oxygen in the coating, the depth at which develops roots, frost depth.

From the observations and measurements made during the growing season (spring - autumn) culture is considered successful, developing normal (ground cover 85% of the soil), requiring minimal maintenance.

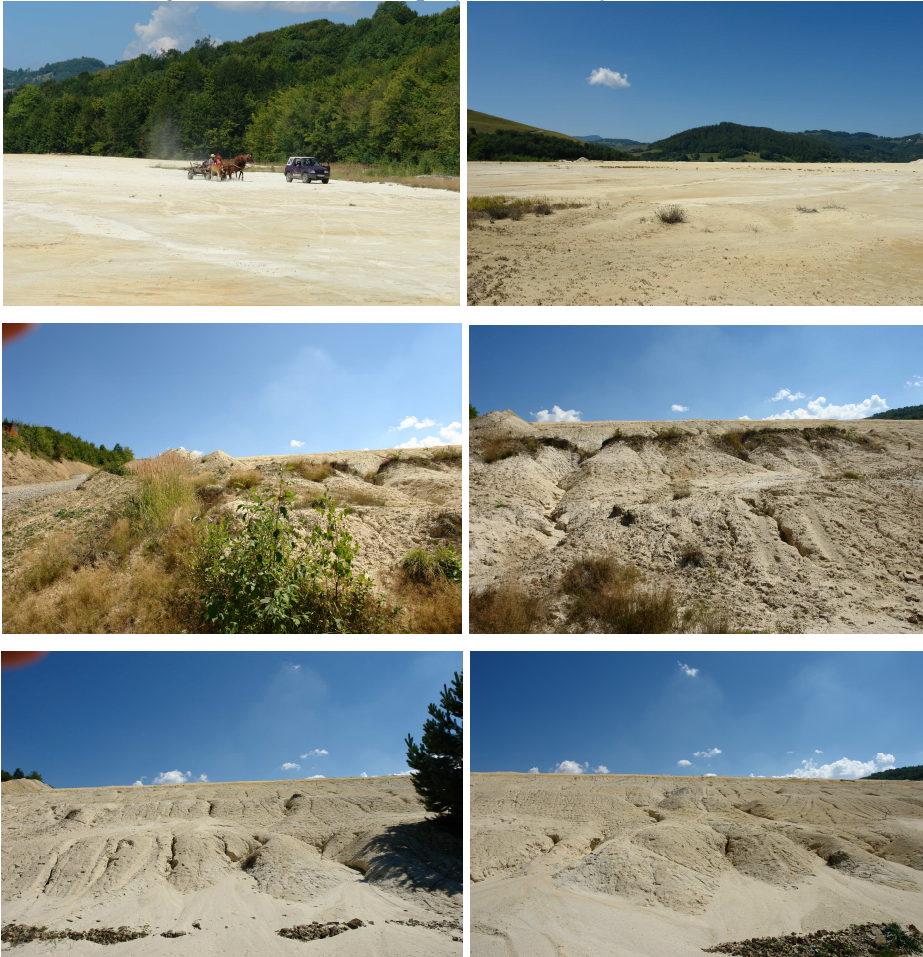
Fig. 2. aspects of the site regarding stationary types from Poaiana Roșiei tailing dump

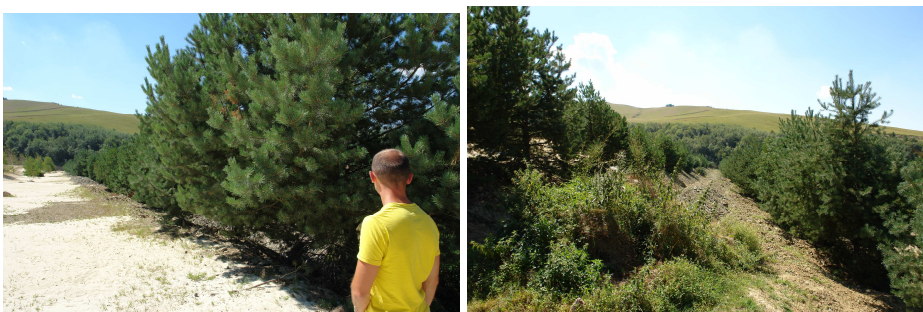
Fig. 3. Pine alignment on tailing dump slopes (T1)

- T1 - 70 % - PiS - heavy duty - degraded land from erosion surface of the substrate on slope instability, upstream accumulation of sterile cultures natural pine seedlings (Fig. 3);

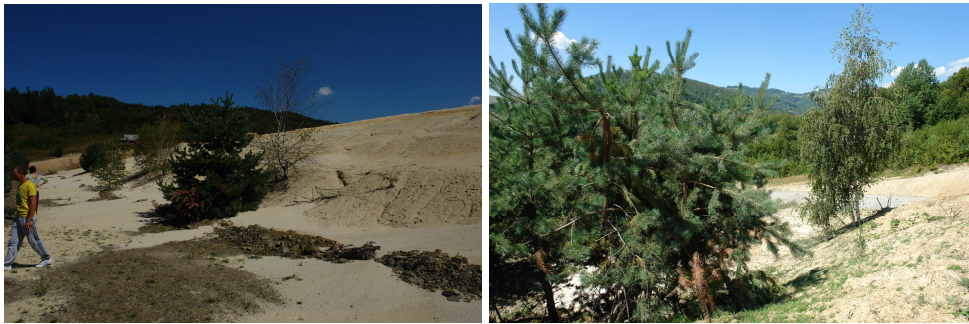
Fig. 4. Pine and birch alignment on tailing dump slopes (T2)

- T2 - 45 % - PiS + Me - under very heavy - very degraded land from erosion depth of the substrate on slope instability, leaks to downstream sterile cultures of pine and birch natural seedlings (Fig. 4.);

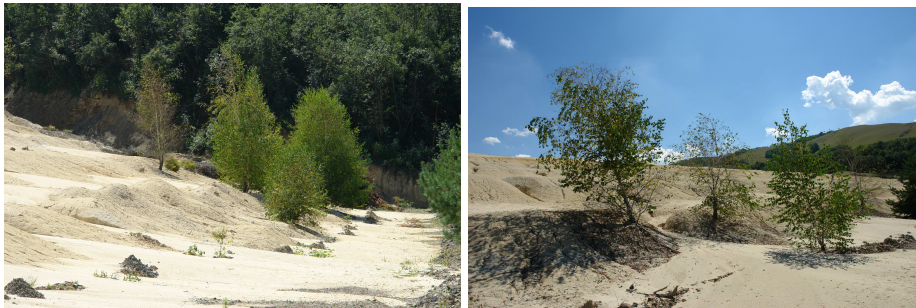
Fig. 5. Birch alignment on tailing dump slopes (T3)

- T3 - 45 % - Me - in extreme conditions - very degraded land from erosion depth of the substrate on slope instability, natural cultures of pine seedlings (Fig. 5.)
