Fracture toughness and toughening mechanisms of unsaturated polyester-based clay nanocomposites

Mushtaq T. Albdiry^{1*}, Belal F. Yousif¹, and Harry Ku¹

¹Centre of Excellence in Engineered Fibre Composites (CEEFC), Faculty of Engineering and Surveying,
University of Southern Queensland, Toowoomba 4350, QLD, Australia.

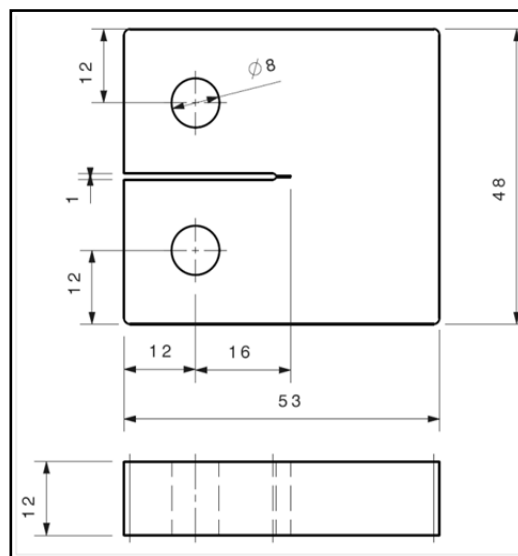
Fig. 1 Dimensions of the compact tension (CT) specimen.

CT specimens were prepared according to ASTM D5045 as shown in **Fig. 1**. A pre-crack was created by tapping a fresh razor blade into the notch tip with a drop weight to maintain an accurate K_{Ic} values. The loading rate was adapted at 5 mm/min and the following relationships were used to measure the K_{Ic} :

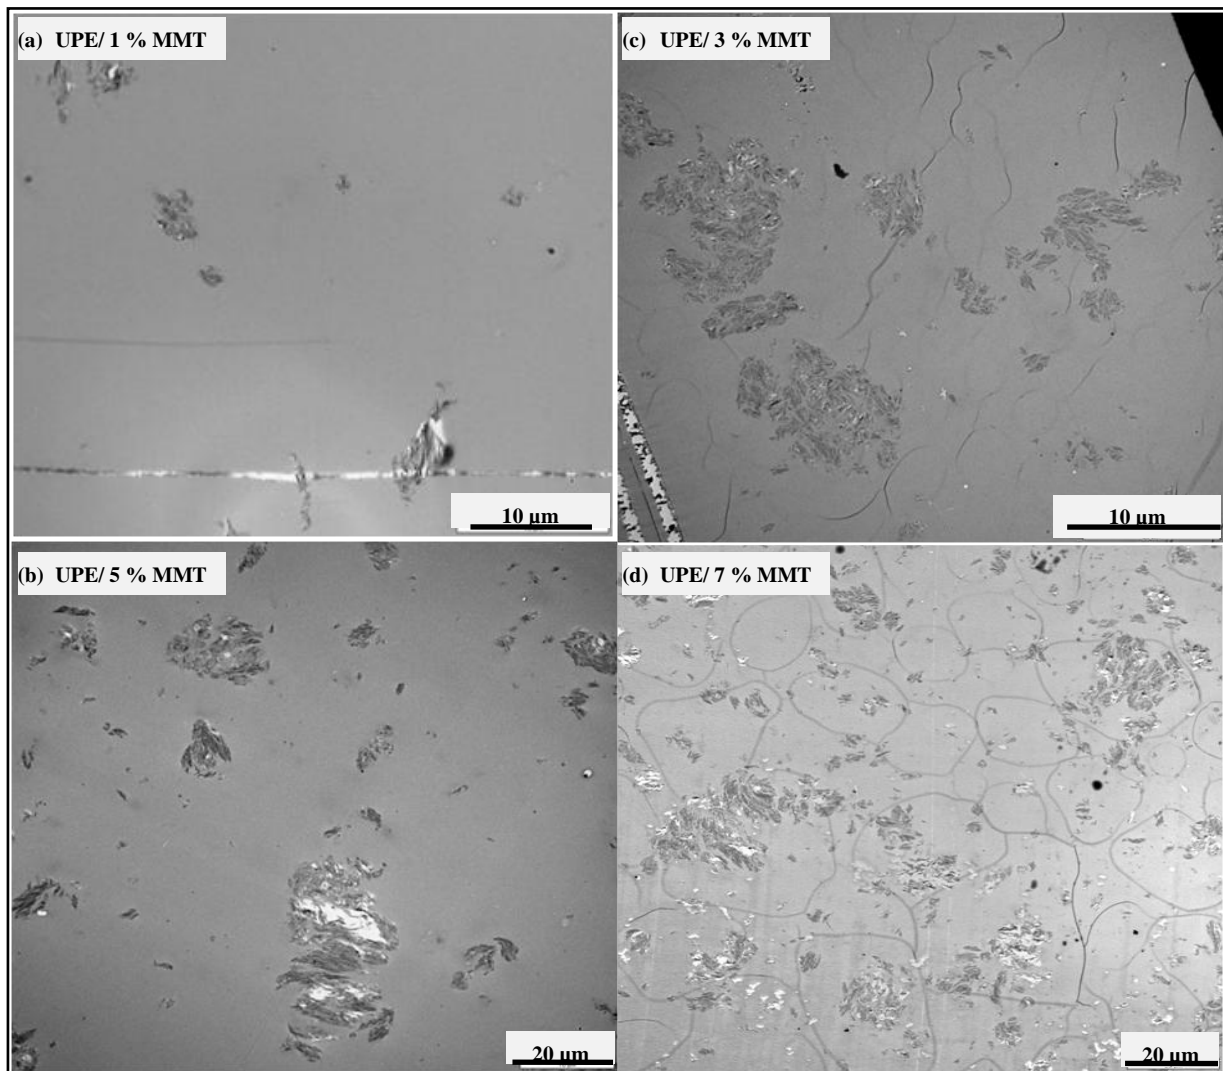
Fig. 2 TEM photomicrographs of UPE-based different MMT nanocomposites.

Fig. 2 (a-d) illustrates representative TEM micrographs of the cured UPE/MMT nanocomposites. They show a number of clay clusters in the liquid resin and there are more of these clusters appear in the higher filler nanocomposites. The appearance of clay aggregates may be attributed to the structure of the clay platelets that composes of an inner octahedral layer surrounded by two silicate tetrahedral layers, or may be to the natural state of clay that exists as stacks of many platelets at several hundred nanometres, those long and wide separated by an interlayer distance of ~1-3 nm which might not be separated by using direct mechanical mixing [5, 17].

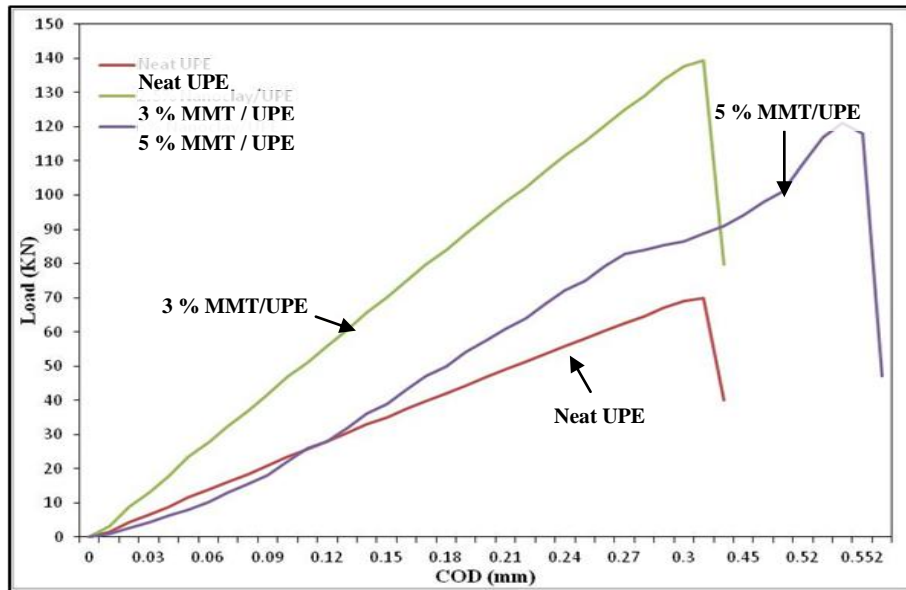
Fig. 3 The typical loads versus crack opening displacement (COD) curves.

Fig. 3 shows a set of typical load-crack opening displacement (COD) curves obtained from the CT fracture tests for the cured neat UPE and UPE-based different MMT nanocomposites. All samples underwent unstable straight line crack propagation when the maximum loading is reached. The addition of 3 wt. % MMT to the UPE resin manifested the highest applied load before fracture of nanocomposite. The fracture toughness (K_{Ic}) values versus different clay loadings (1-9 wt. %) are illustrated in **Fig. 4**. The magnitudes of K_{Ic} of the filled UPE modestly improved after introducing MMT platelets. Three weight percent of MMT addition appears the highest K_{Ic} by 61 % improvement over the neat UPE. Further increasing of MMT induces lower K_{Ic} values due to the appearance of clay aggregates and the weak interaction between clay layers and the polymer resin. These results are in similar with those reported in previous study [18]. A comparison on K_{Ic} values for UPE-based different nanoparticles is reviewed in **Table 1** to better understand the effect of incorporating different nano-sized particles into the crosslinked UPE resins on their fracture toughness.

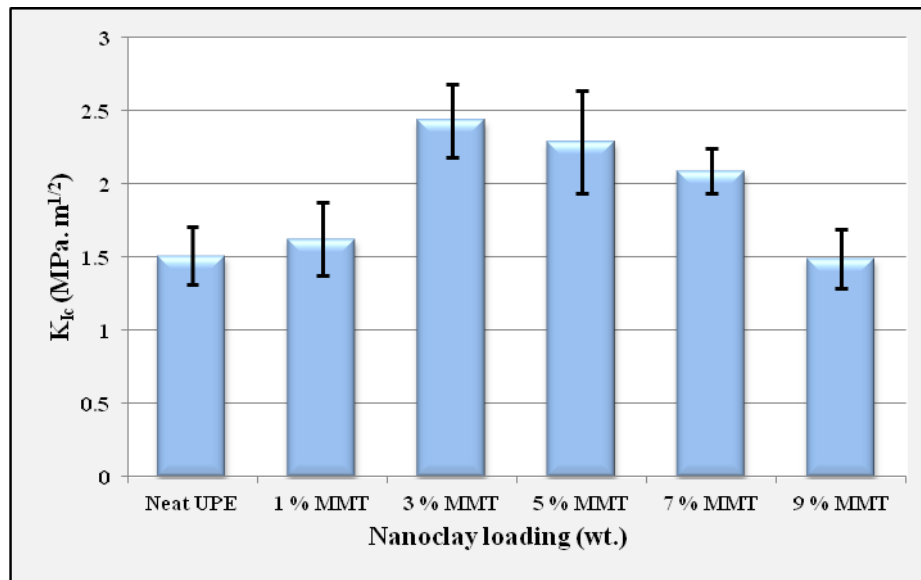
Fig. 4 Fracture toughness of the neat UPE and the UPE/MMT nanocomposites

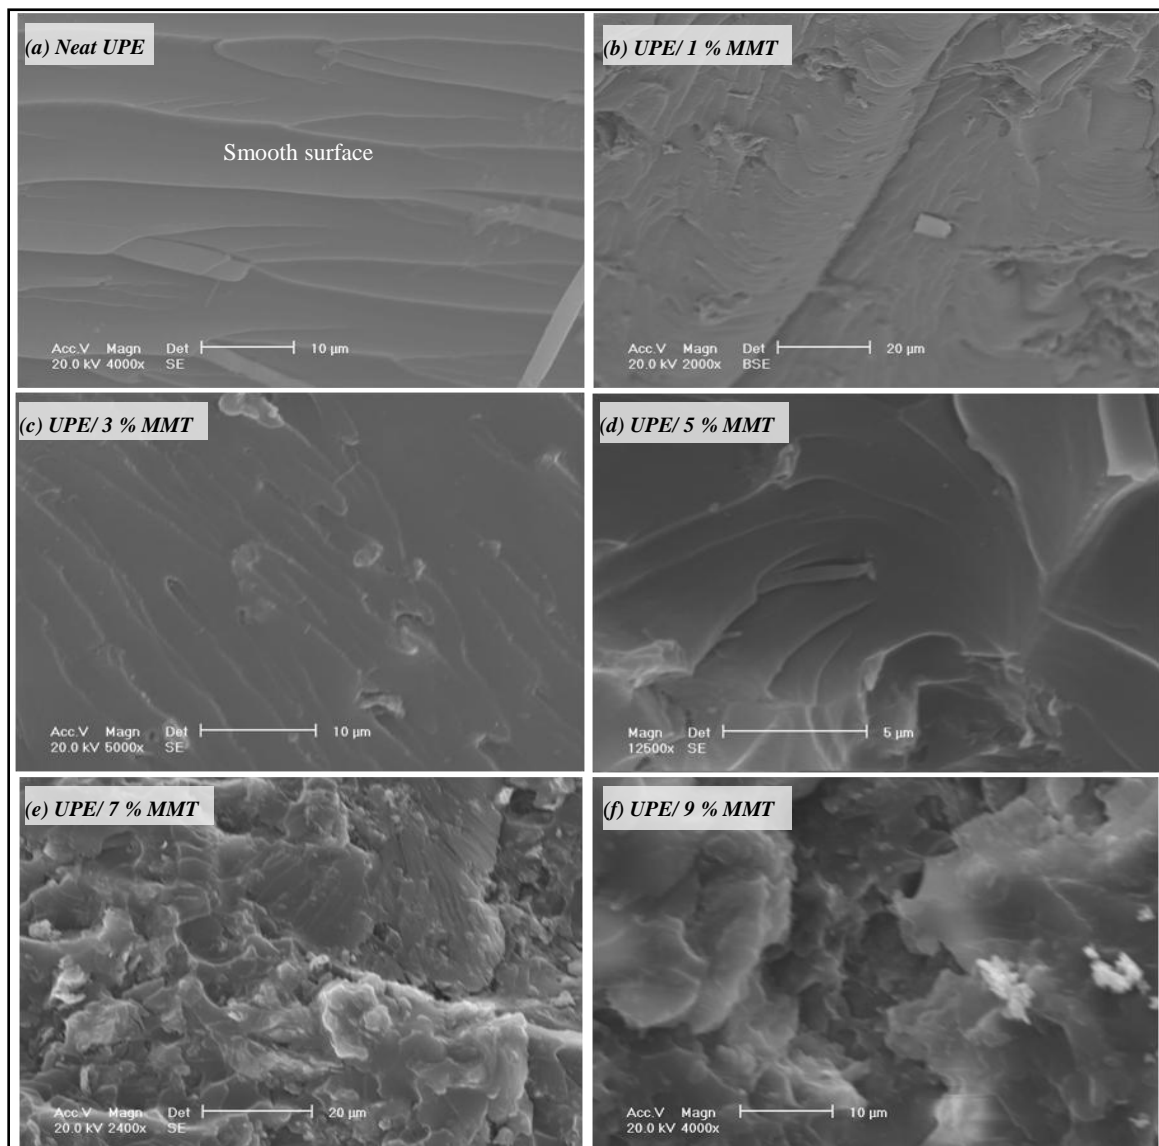
Fig. 5 SEM images showing the failure mechanisms of fracture surface obtained from the CT specimens for the neat UPE and UPE-based different MMT nanocomposites.

SEM examination was used to identify the fracture mechanics and toughening mechanisms of UPE/MMT nanocomposites ruptured at ambient temperature. The fracture mode of the neat UPE (**Fig. 5a**) seems to be a highly brittle failure without crazing. Introducing clay particles to the networked UPE resin tends to form a localized shear yielding mechanism with a better absorbing of energy. The appearance of isolated shear bands as an energy absorption mechanism occurs due to introducing a second phase material into single-phase polymers. This mechanism is associated with a better plastic deformation [21].

The addition of nanoclay platelets to the UPE resin also causes in presence of crack pinning mechanism (see **Fig. 5c**). The fracture surface of 5 % MMT/UPE nanocomposite shown in **Figure 5d**, characterizes various directions of crack propagation on the cleavage surface. These directions of crack advancement oriented from top to bottom with irregular curved paths. Further addition of MMT to the thermosetting UPE induces mixed failure mechanisms of cleavage and void-coalescence mechanisms (**Fig. 5 e and f**).
