# Seismic vulnerability assessment of residential buildings using logistic regression and geographic information system (GIS) in Pleret Sub District (Yogyakarta, Indonesia)

**Background:** The Southeast of Yogyakarta City has had the heaviest damages to buildings in the 2006 of Yogyakarta Earthquake disaster. A moderate to strong earthquake of 6.3 Mw shook the 20 km southeast part of the Yogyakarta City early in the morning at 5:54 local time. On top of extensive damage in Yogyakarta and Central Java, more than 5700 people perished; 37,927 people were injured in the collapse of more than 240,396 residential buildings. Furthermore, the earthquake also affected the infrastructure and local economic activities. The total damages and losses because of the earthquake was 29.1 trillion rupiahs or equal to approximately 3.1 million US dollar. Two main factors that caused the severe damages were a dense population and the lack of seismic design of residential buildings. After reconstruction and rehabilitation, the area where the study was conducted grew into a densely populated area. This urbanistic change is feared to be potentially the lead to a great disaster if an earthquake occurs ag

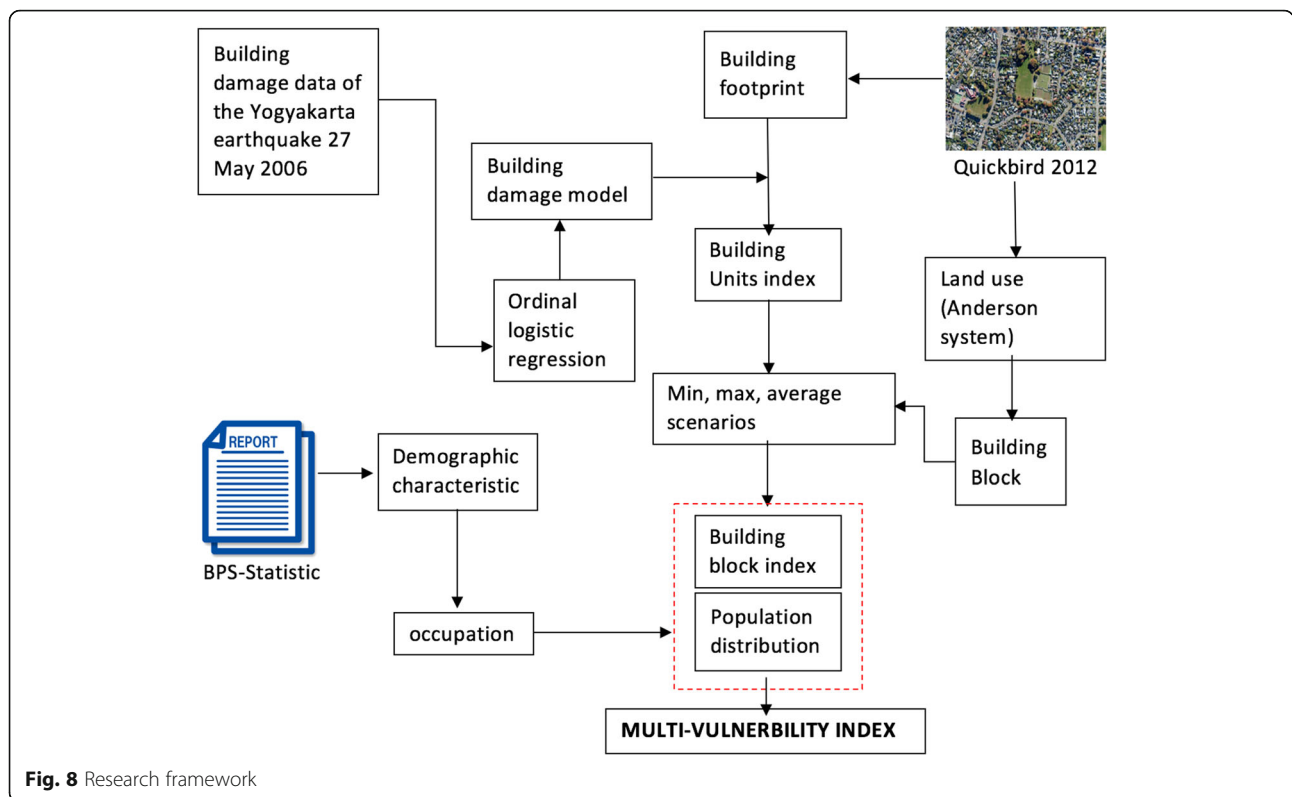
Fig. 8 Research framework

The multi-vulnerability of buildings was determined by adding the building damage category (average scenario) and population distribution class. There are three classes of the numbers of population staying in the particular land use units. Class 1 refers to numbers of population below 100 people, class 2 to numbers of population between 100 and 200 people, and class 3 to numbers of population above 200 people. This classification follows the rule of natural break technique in GIS reclassify tools. The multi-vulnerability value will range between 2 and 6. The values of 2 and 3 are defined as low vulnerability, the value of 3 and 5–6 as medium and high vulnerabilities, respectively. The overall research framework can be seen in the Fig. 8 below.
