## Research Article

# Microbiological Sealing Analysis of a Tapered Connection and External Hexagon System

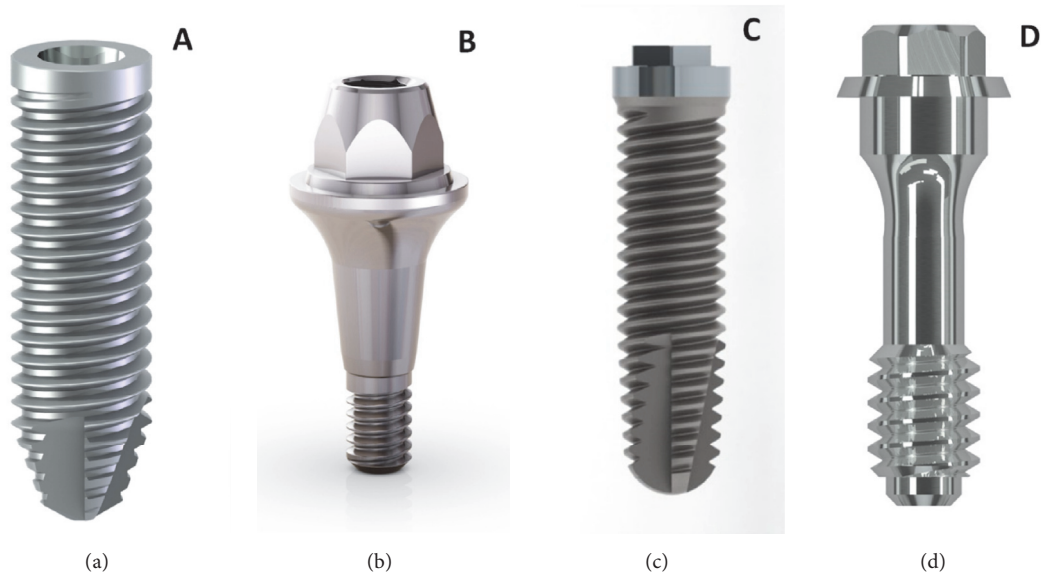
FIGURE 1: Implants and irrespective prosthetic abutments. Titaoss max CMX (a), universal tapered abutment (b), Titaoss external hexagon (c), and mini abutment EH platform 4.1 (d).

Two types of implant-abutment connections manufactured and commercialized in Brazil by the company Intraoss (São Paulo, SP, Brazil) were analyzed. The tapered implant connections were 4.0 mm by 11 mm with a tapered platform

of 11.5°, whereas the external hexagons were 3.75 mm by 10 mm (Table 1). The materials used in this study (implants, prosthetic components, and torque wrench) were provided by the manufacturers with no conflict of interests.

Twelve sets of indexed tapered connection components and twelve sets of external hexagon connection components were used (Figure 1) for microbiological analysis as previously described [10]. For each model, an implant with its respective prosthetic abutment was used as a negative control and a set without the abutment as a positive control of microbial contamination.

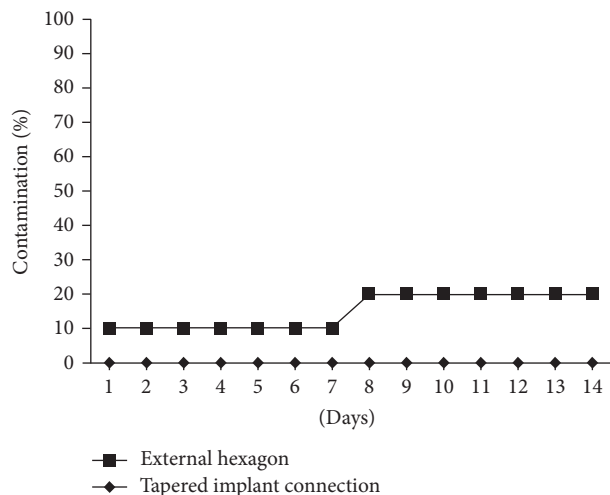
FIGURE 2: Contamination follow-up expressed as percentage over 14 days.

Failure of the abutment/implant interface seal was observed via turbidity or presence of deposits in the culture broth in 2/10 (20%) of the external hexagon interface. On the other hand, 0/10 (0%) tapered implant connections were contaminated, though no significant difference was detected between the groups ( $p = 0.4737$ , Fisher's exact test). No turbidity was observed either in the tubes containing the microbrushes used as the control for abutment/implant interface contamination or in the negative controls.

Figure 2 illustrates the 14-day follow-up of specimen, where the group containing the indexed tapered connection showed no contamination. In the group of external hexagon, one sample was contaminated on the first and the 8th days, whereas two sets (20%) were contaminated at the 14th day.
