SHELL CRACKING IN INVESTMENT CASTING WITH LASER STEREOLITHOGRAPHY PATTERNS

W. L. Yao

Ming C. Leu¹

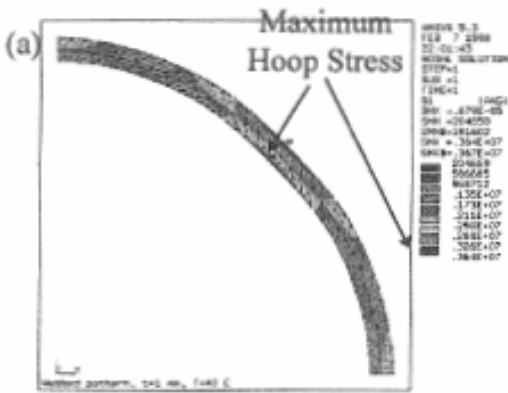
Figure 4 The stress profile from the FEA result for Part1 with 1mm ceramic shell: (a) hoop stress in ceramic shell and (b) compressive stress in webbed pattern.

The numerical result of a part ($L=6.35\text{mm}$, $b=0.3048\text{mm}$, and $h=1.4372\text{mm}$) with 1mm thickness ceramic shell is depicted in Figure 4. The FEA models used in this study are quarter models and they are automatically meshed in level #2 using the PLANE82 element and axisymmetric boundary condition. The σ_c and σ_x (or σ_y) represent the principal (hoop) stress in the ceramic shell and the compressive stress in the epoxy webbed pattern, respectively. The σ_c value is compared with MOR to define the rupture temperature of the ceramic shell. P_{cr} is the critical pressure that causes the web link to buckle. The critical unit pressure of the buckling of square frame, P_{cr} is $16.47EI/AL^2$ [11], where A is the cross-sectional area of web link, E is Young's modulus of the epoxy material, I is the moment of inertia of web link cross-section, and L is the web link space length. $A = b \times h$ and $I = hb^3/12$, where b is the width of web structure, and h is the depth of web structure. This σ_x value is compared with P_{cr} to determine the buckling temperature of the web link. For this part the obtained results are $T_u = 35^\circ\text{C}$, and $T_b = 52^\circ\text{C}$ (refer to Table 1). Note that Young's modulus of the epoxy resin is a function of temperature. Figure 5 shows the effects of the ceramic shell thickness on the generated stresses in the ceramic shell and webbed pattern. It is seen from Figure 5a that the maximum hoop stress decreases as the shell thickness is increased. That is, a thicker ceramic shell can better resist the thermal expansion of the SL epoxy pattern. Figure 5b shows that the shell thickness effect on the maximum

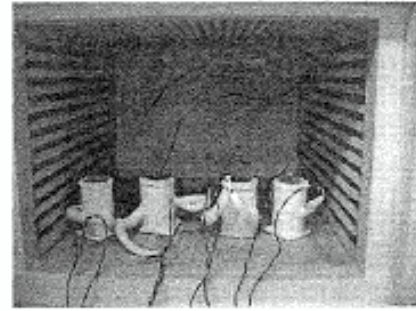
Figure 7 Samples mounted with strain gauges in a temperature controlled oven.

The experimental study consists of two parts. First, experiments are conducted to observe the pattern burnout process. Figure 6 shows an SL pattern without and with the ceramic shell. Second, the induced stresses on the shell are measured by strain gauges. Figure 7 shows strain gauged samples. Both the qualitative observations and the strain gauge measurements validate the prediction of FEA.
