**Assessing the Effectiveness of Instream Structures for Restoring Salmonid Streams**

A Thesis

Concordia University

September 2009

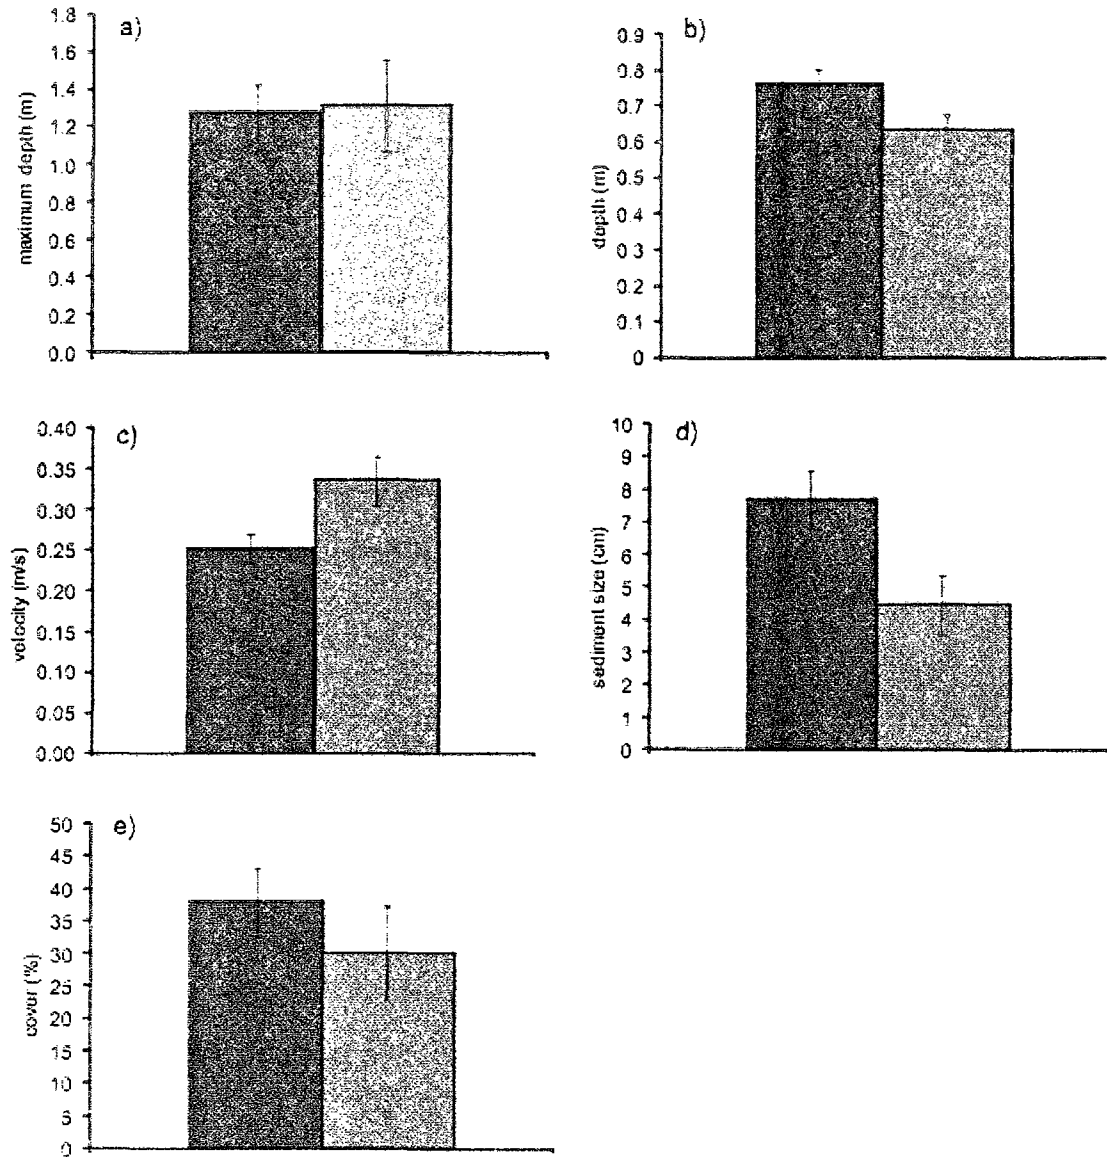
Figure 3. Mean and 95% confidence intervals of the mean of a) maximum pool depth, b) average pool depth, c) average water column velocity, d) sediment size and e) % cover for restored pools (dark grey) and non-restored pools (pale grey).

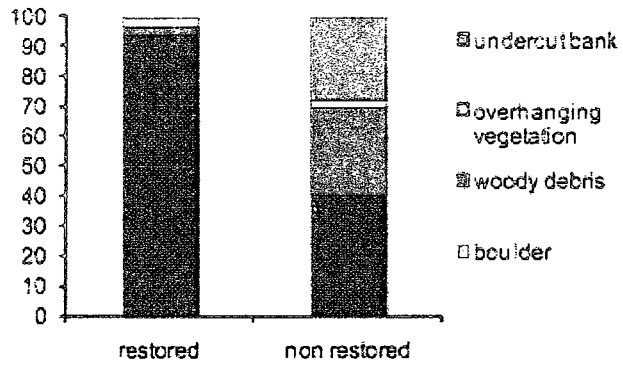
Figure 4. The percent of cover available from various sources in restored and non-restored pools.

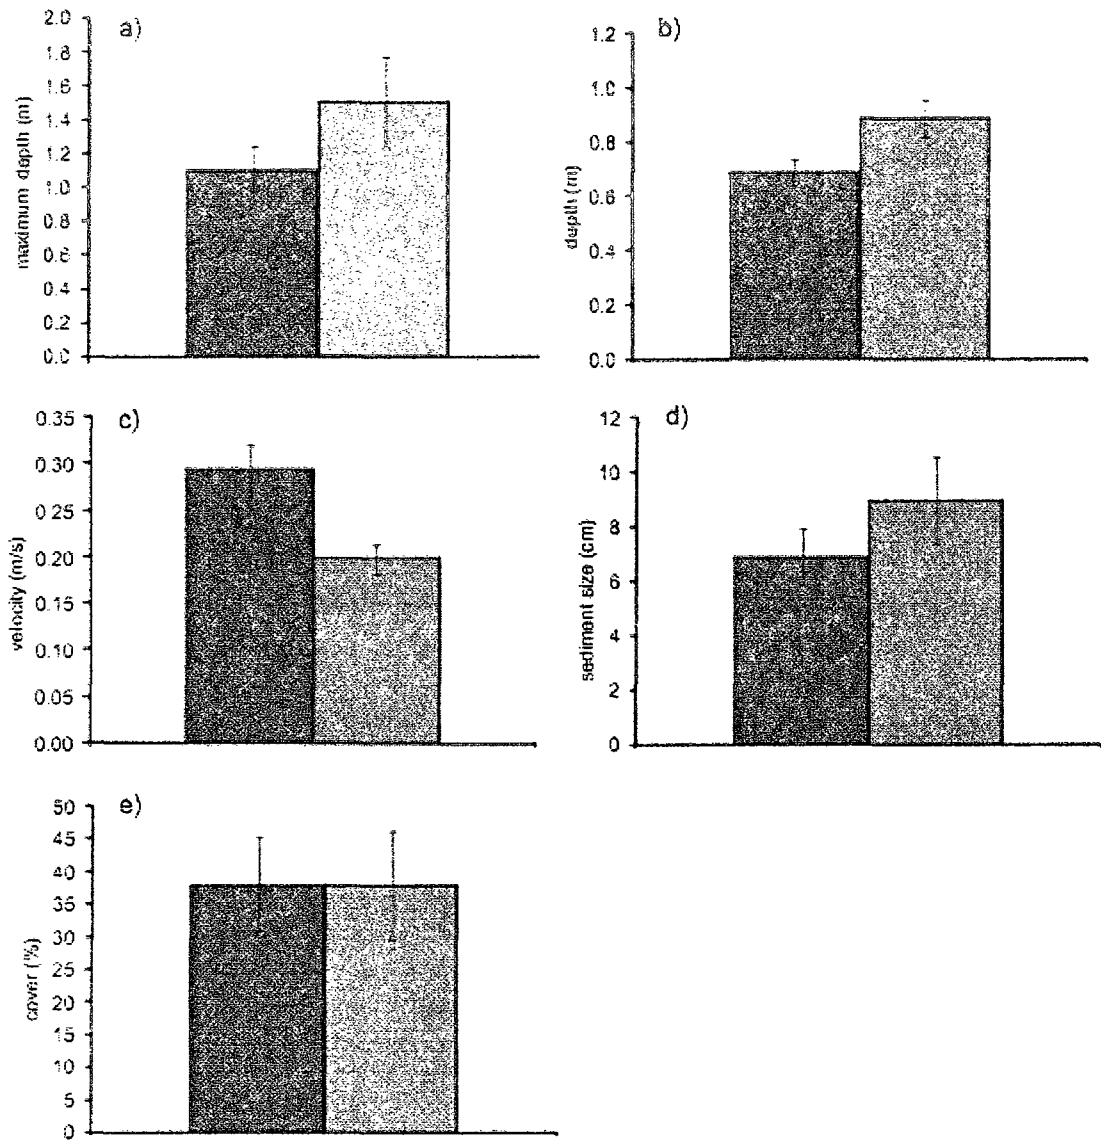
Figure 5. Mean and 95% confidence intervals of the mean of a) maximum pool depth, b) average pool depth, c) average water column velocity, d) sediment size and e) % cover for deflector pools (dark grey) and weir pools (pale grey).

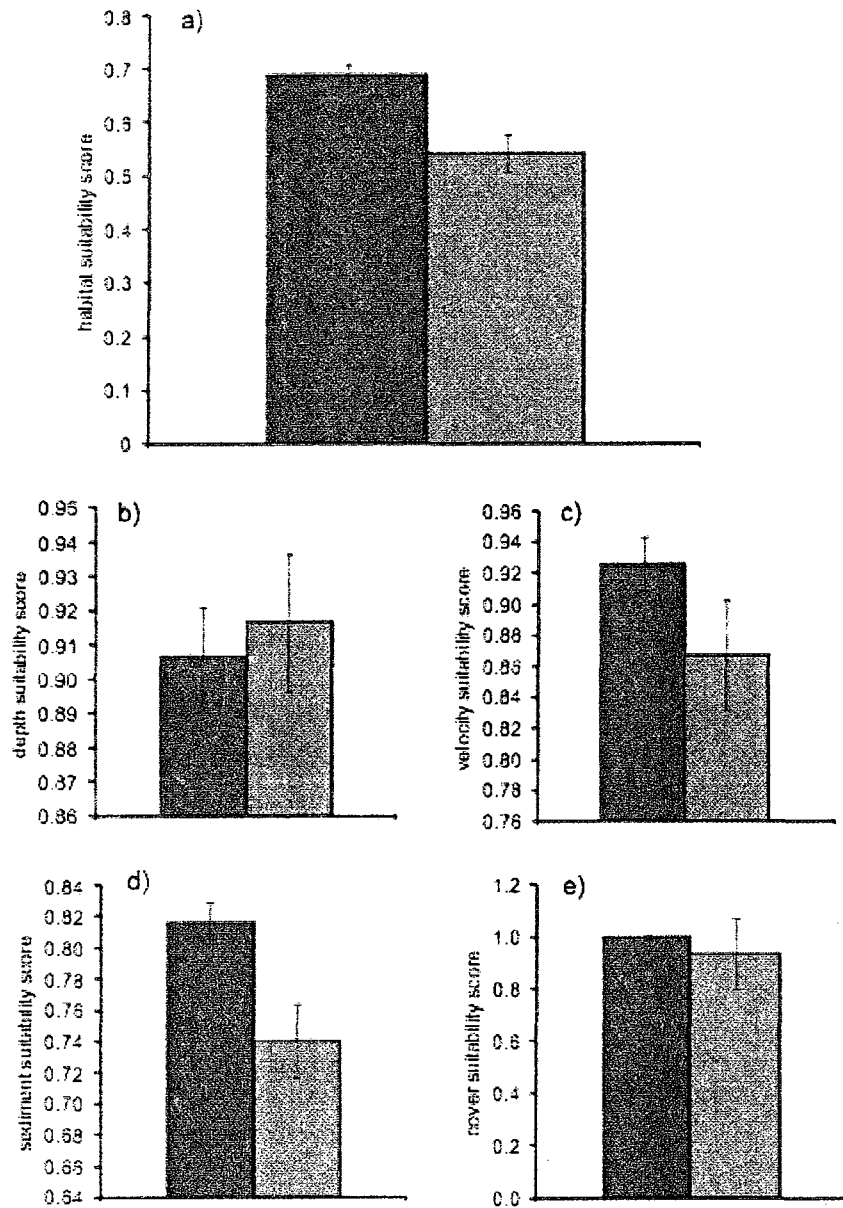
Figure 6. Mean and 95% confidence intervals of the mean from Raleigh et al. (1984) rainbow trout suitability scores, a) total suitability, b) depth suitability, c) velocity suitability, d) sediment size suitability and e) cover suitability. Restored pools are shown in dark grey and non-restored pools in pale grey.

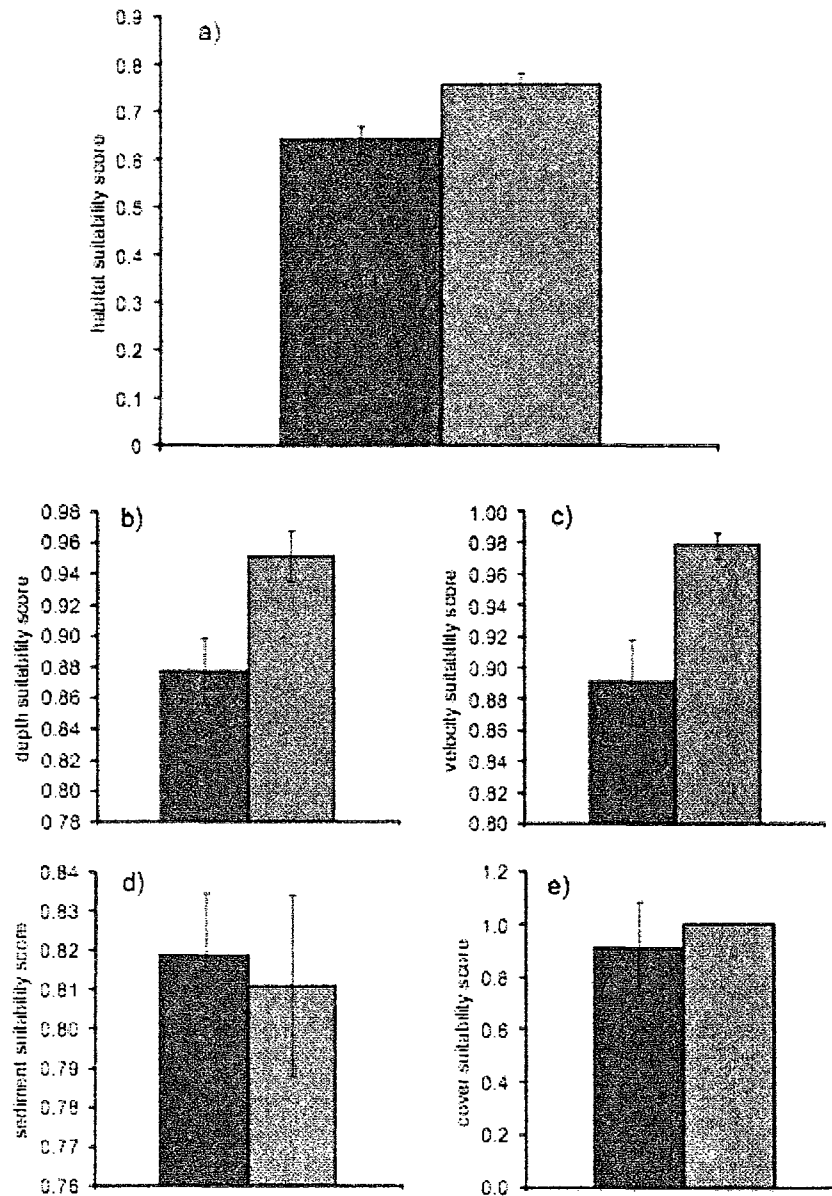
Figure 7. Mean and 95% confidence intervals of the mean from Raleigh et al. (1984) rainbow trout suitability scores, a) total suitability, b) depth suitability, c) velocity suitability, d) sediment size suitability and e) cover suitability. Deflector pools are shown in dark grey and weir pools in pale grey.

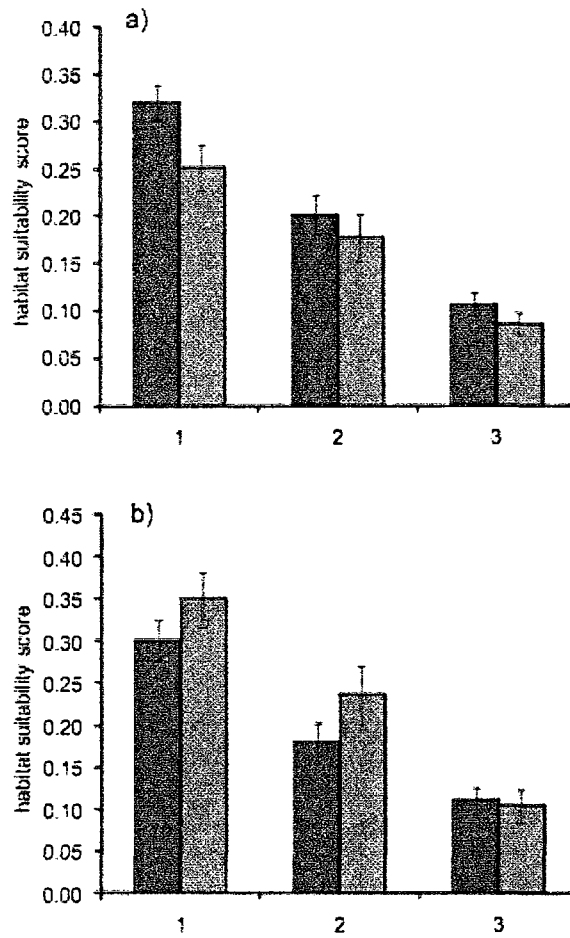
Figure 8. Mean and 95 % confidence intervals of the mean of brown trout total habitat suitability scores of a) restored pools (dark grey) and non-restored pools (pale grey) and b) deflector pools (dark grey) and weir pools (pale grey) using 3 different suitability curves. 1) Raleigh et al. 1986, 2) Vismara et al. 2001 and 3) Strakosh et al. 2003.

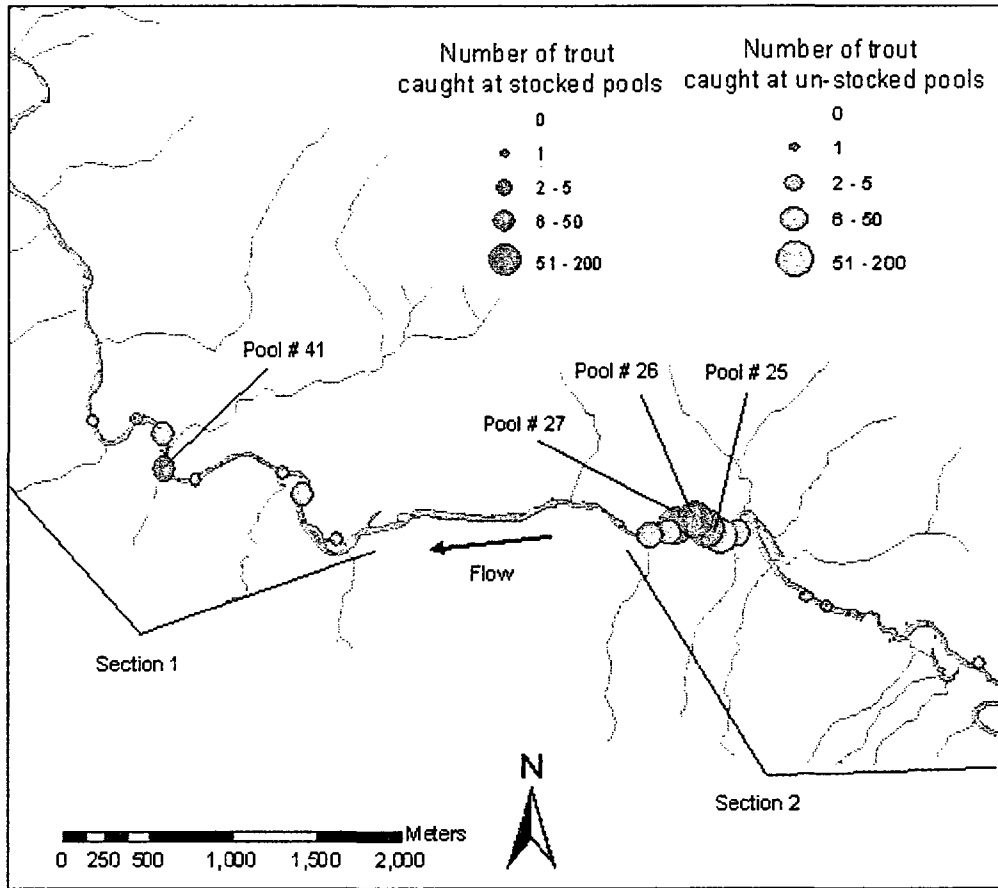
Figure 9. Sections 1 and 2 of the Nicolet River showing the number of trout caught in different pools.

It was hoped that the use of an underwater video camera would allow trout observations in pool #41. This pool was stocked and had a high catch rate (see Fig. 8) – making the presence of trout likely – but was over 3m deep, which prevented snorkelling observations. The video method, however, also failed to locate any undisturbed trout. If trout in the Nicolet River are as easily disturbed as these experiences suggest, permanent underwater cameras may be the only way to determine micro-habitat use. Electro-fishing can not be done, both because of the presence of anglers and the depths of the pools, and

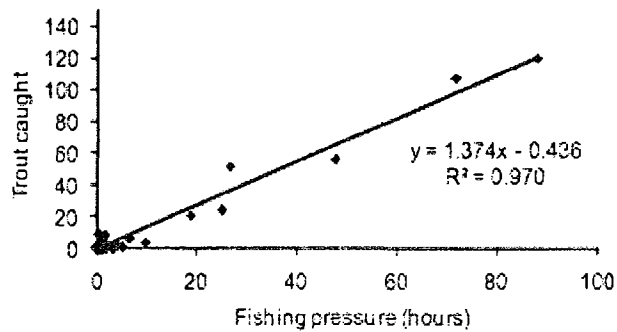
Figure 12. The relationship between hours spent fishing at a pool and the number of trout caught.

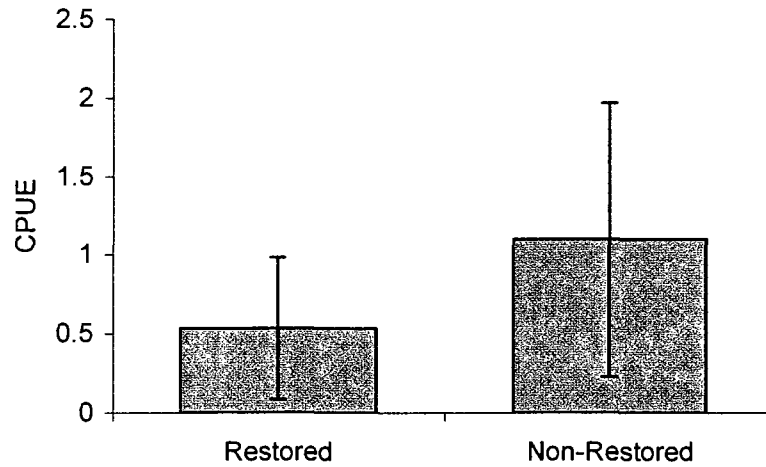
Figure 13. Mean catch per unit effort (CPUE) for restored and non-restored pools and 95% confidence intervals of the mean.

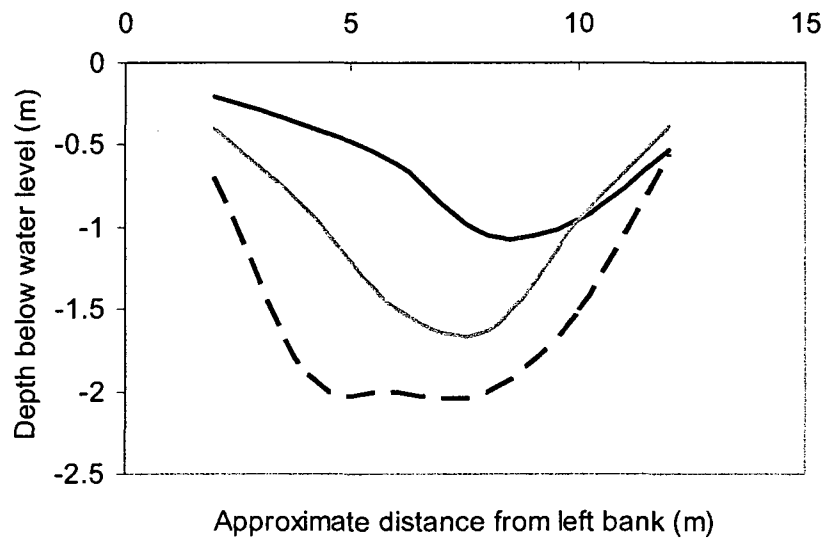
Figure 14. Typical cross section of different pool types. Non restored pools are shown with the black solid line, deflector pools with the grey line and weir pools with the dashed black line.

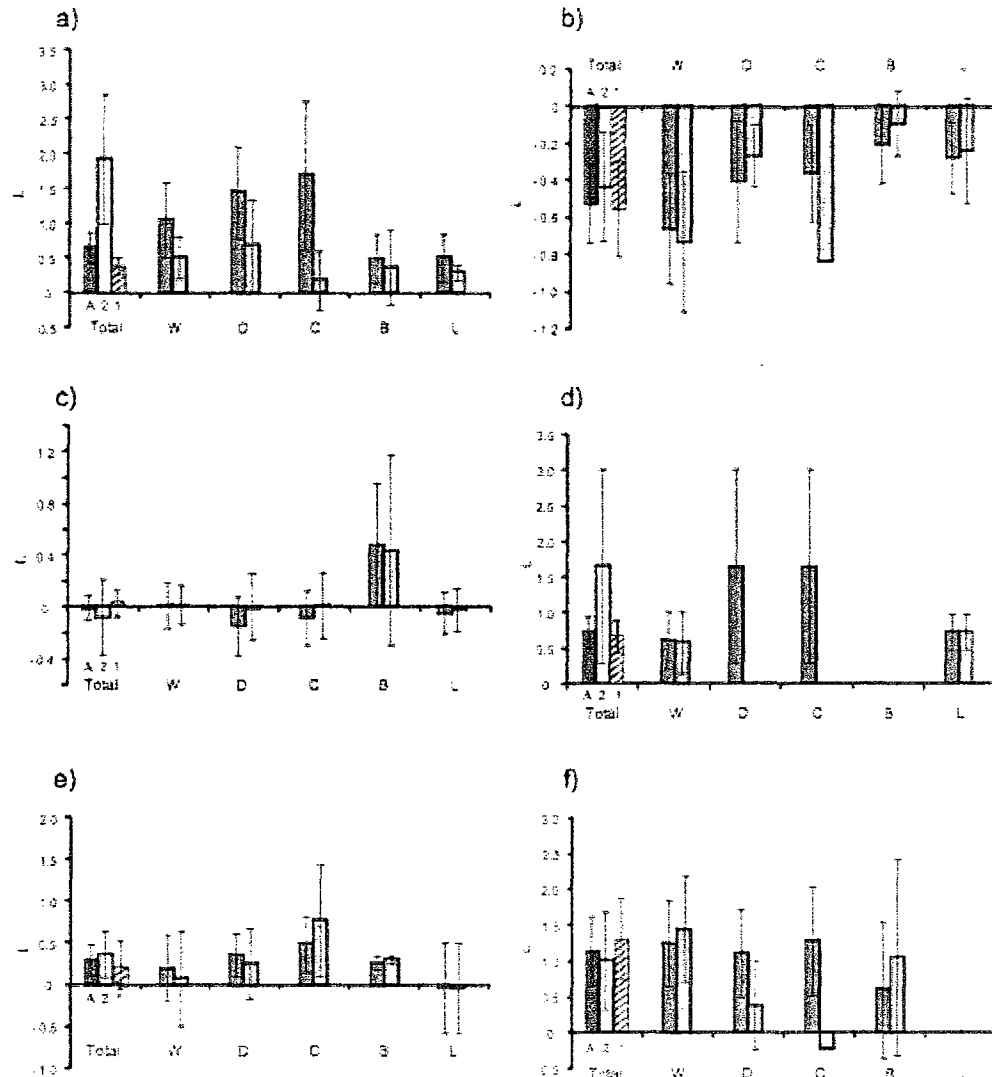
Figure 15. Effect of different types of instream structures (A= all types, 2= projects that used 2 or more structure types, 1= projects that used only 1 structure type, W=weir, D=deflector, C=cover structure, B=boulder placement, L= LWD on the mean ( $\pm$  95% confidence interval) effect size ( $L = \ln(x_{tr}/ x_c)$ ) of a) pool area, b) riffle area, c) stream width, d) pieces of LWD, e) stream depth and f) cover. Within each individual structure type the dark grey bar represents the mean for all projects that used that structure

(whether or not another type of structure was used) and the light grey represents the mean for projects that only used that type of structure.

Surprisingly, despite the clear effect of instream structures on both physical habitat variables (see Fig. 15) and salmonid density (see Fig. 16a), change in habitat variables are not good predictors of changes in salmonid density. This corroborates the results of Pretty et al. (2003) who found few significant relationships between physical and biological variables in their study of thirteen restored streams and raises the question: “what causes changes in salmonid density”? It is likely that multiple habitat changes are required to provide adequate salmonid habitat. As for structure type, habitat variables that contribute to increased salmonid density likely vary from project to project, making it very difficult to establish a causal relationship from a large database which includes rivers in diverse environments.

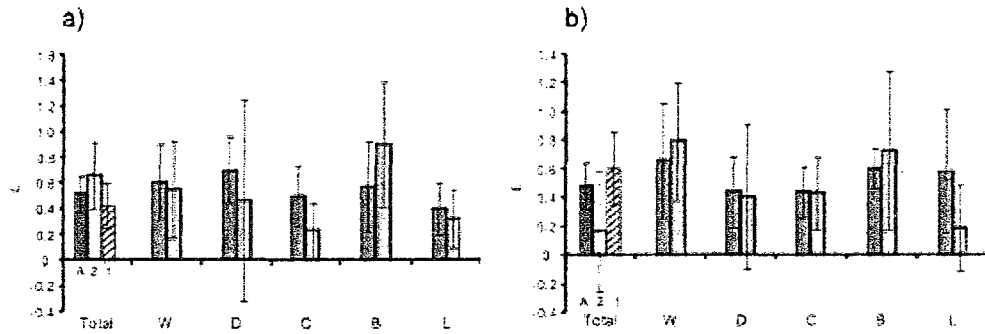
Figure 16. The effect (mean L, 95% C.I.) of structure type on a) salmonid density and b) biomass. A= all types of instream structures combined, 2= projects that used 2 or more structure types, 1= projects that used only 1 structure type, W=weir, D=deflector, C=cover structure, B=boulder placement, L= LWD. Within each individual structure type the dark grey bar represents the mean for all projects that used that structure (whether or not another type of structure was used) and the light grey represents the mean for projects that only used that type of structure.

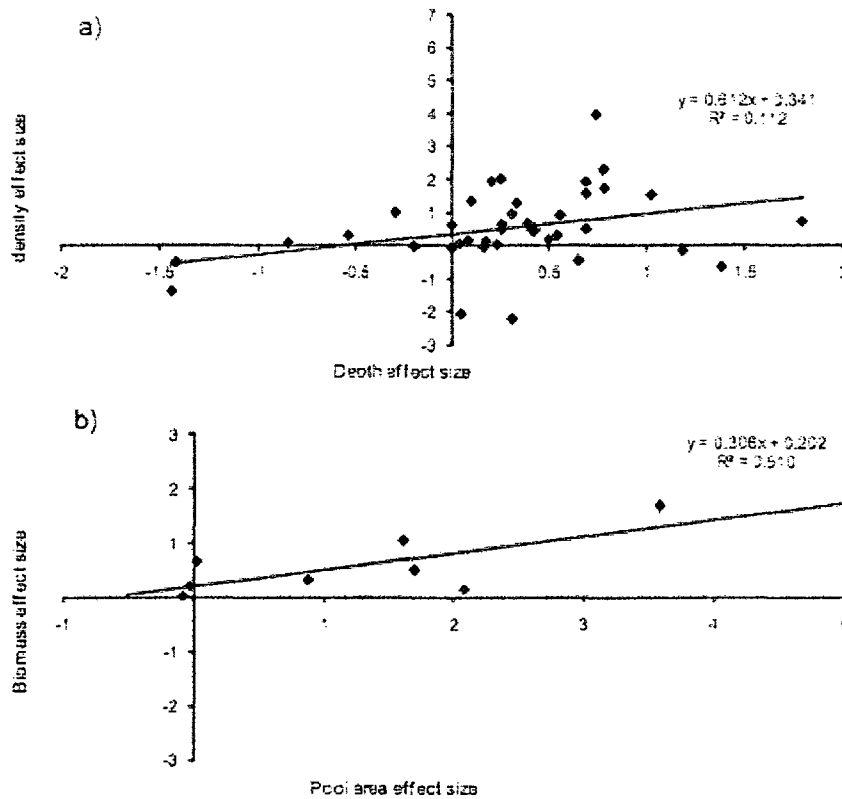
Figure 19. Linear regression of a) salmonid density effect size against depth effect size and b) salmonid biomass effect size against pool area effect size.
