VOLUME 64 | 2015

University of Zagreb Faculty of Electrical Engineering and Computing

#### **Croatian Transmission System Operator Ltd.**

## LIGHTNING DATA UTILIZATION IN POWER SYSTEM CONTROL

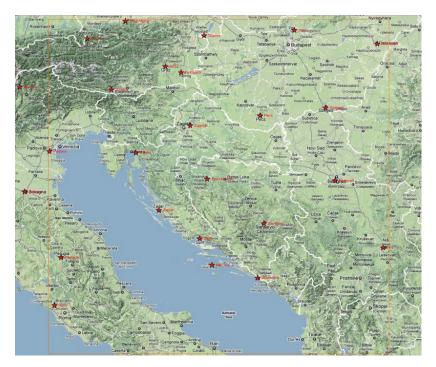
Figure 1. LINET sensors in Croatia and its neighboring countries with monitored area

At the end of 2008, a lightning location system was constructed, covering a wide area of the Croatian territory as part of the LINET network. Six sensors have been installed in Croatia (Zagreb, Rijeka, Nin, Sinj, Dubrovnik, island Korčula). LINET is a modern lightning location system with a network of more than 125 sensors covering most of Europe. LINET sensors utilize VLF/LF frequency ranges and detect magnetic flux at the moment of an atmospheric discharge [6]. Figure 1 shows LINET sensors in Croatia and its neighboring countries [7].

Lightning data gathered by lightning sensors are sent unprocessed through the Internet to the processing center, where data is processed and formatted. Formatted data is subsequently available for download to subscribed clients. Lightning data are taken from the processing center and stored in a local database. Data is available for the period beginning January 1, 2009. The monitored area is shown in Figure 1.

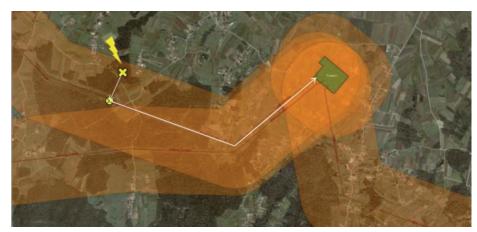
Figure 2. Spatial correlation of lightning stroke with overhead line alarm zones

The system for lightning data utilization in power systems requires interconnection with three external data sources. The system implements various communication interfaces, which can easily be upgraded. For lightning data input the system implements a client service to receive lightning data from lightning data processing center. Data are obtained in 10 second intervals. The delay between the exact moment of a lightning stroke and the time the data is processed is less than 60 seconds. For GIS input, a communication interface is available. GIS data contain geometries (points, lines, polygons) of power system facilities (e.g. overhead lines, substations, power plants, etc.). This enables a real-time interconnection to an external GIS database, making it possible to import and synchronize GIS data directly in case of a change. Where an external GIS database is not available the system utilizes a web based tool for GIS data import and management. GIS data enable the spatial correlation between lightning data and geometries representing power system facilities. It also enables the calculation of the exact distance of a fault location caused by a lightning stroke to the nearest substation (Figure 2). This information can be correlated with data from the distant relay protection.

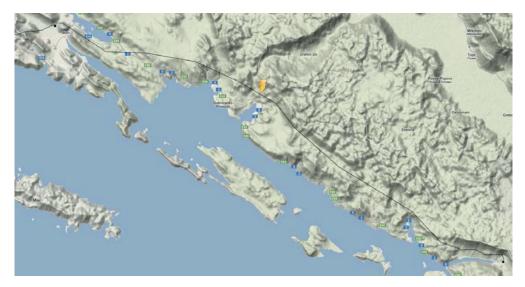
Figure 10. Lightning stroke causing line tripping

One of the observed events on a 110 kV overhead line (marked 1 in Figure 4) occurred on 29th July 2011 (Figure 10 and Table III). Distant protection relays in adjacent substations registered pick-ups at 06:35:12.763 and 06:35:12.769 local time. Pickups were registered on a single (top) phase of the overhead line. Commands to circuit breaker were issued and successful automatic reclosures procedures were executed on both sides of the overhead line. The LLS registered a lightning stroke in the overhead line alarm zone with peak amplitude of -18.7 kA at 06:35:12.754 local time. The lightning stroke precedes the registered pick-ups with a time difference of 9 and 15 ms. The fault locator measured the distance to the fault at 20.3 km / 24.1 km from the substations, where the LLS measured 18.4 km / 25.2 km.
