**University of Zagreb Faculty of Electrical Engineering  
and Computing**

## **ANALYSIS OF SURGE ARRESTERS FAILURES IN THE INSTALLATION OF BROADCASTING TRANSMITTER**

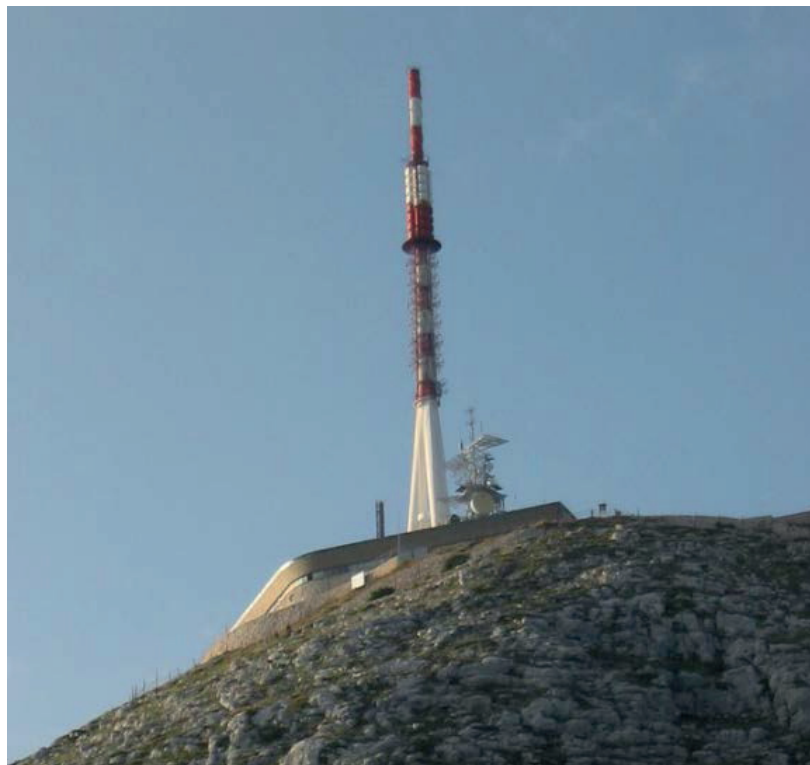
Figure 1. BT on Biokovo maintain 1762 m above sea level

In the operation of the BT, located at 1762 m above sea level, Figure 1, during a lightning storm, comes to frequent SA failures in the switchgear of BT, Figure 2 and along the 10 kV supply cable (SAs in the cable section boxes). BT is power supplied from 35/10 kV transformer substation using 10 kV cable line length 8.455 km. The cable is sectioned by four cable boxes (CB1, CB2, CB3 and CB6), Figure 3. In every CB are installed 2 disconnectors and 3 SA (one in phase). The SAs in CBs are  $U_C=14$  kV, line discharge class 4.

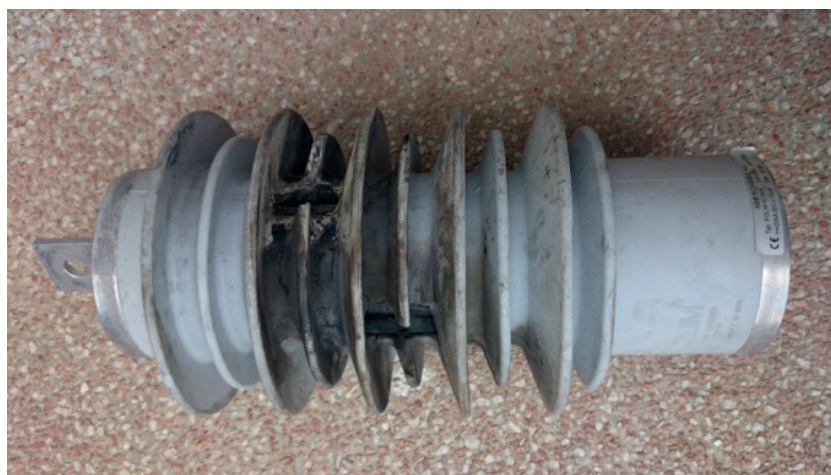
Figure 2. Overloaded SA

SA failures have occurred in the switchgear of BT and in the cable boxes CB6 and CB3.

Failure of the SAs occurs by heating above the thermal stability limit. Therefore, if the SA is heated above the thermal stability limit, it leads to the thermal destruction of the SA and ultimately to earth fault (line-to-earth fault). Thermal destruction of SAs in the switchgear of BT occurs as a result of large number of lightning strokes in a very short time interval, table II. Every lightning stroke increases the temperature of MO resistors. There is not enough time for cooling of MO resistors between the lightning strokes or to return to a stable operating point. It leads to overheating and thermal destruction of the SA.

1. Reduction of earth electrode resistance of the BT, what increases the part of the lightning current flowing through the earth electrode and decreases the part of the lightning current flowing through the SAs. This solution requires considerable financial costs. It includes the rehabilitation of the earth electrode of the BT, replacement of existing and laying new earth rods in adequately prepared channels.

2. Increase the thermal energy absorption capability of SAs (several SAs of the same type in parallel). One set of 3 SAs are installed directly at the power

transformer and the second set of 3 SAs at the point of arrival of 10 kV cable to the BT. These SAs are approximately in parallel, in phases. For this application SAs must be selected and tested in the factory accordingly to verify equal current distribution among them. For example, if the protective characteristics of parallel connected SAs differ only 1% one SA will absorb 64.45 kJ and other one 68.77 kJ (in one scenario of lightning stroke). Therefore, the protective characteristics of SA must be different under 1% in order to ensure equal current distribution in two parallel connected SAs.

3. Increase the cooling of SA (avoid squeezed closed spaces as places for installation).

In the described case, recommendations 2 and 3 are implemented. In the further monitoring of the BT operation will be decided whether to reduce the earth electrode resistance.
