## ABSTRACT

This article explores the critical importance of the proper selection of copper, one of the key raw materials used in the making of continuously transposed conductors for extra high voltage power transformer windings. Windings are one of the most vulnerable components of a power transformer in terms of withstanding various types of electrical disturbances that lead to transformer failure. They have to satisfy complex transformer requirements, but also fit into the economics reasonably well in order to be competitive. Therefore, the expectations about the transformer health and longevity will largely depend on the right choice of its active components and the materials used in their production.

# Role of copper in continuously transposed conductors

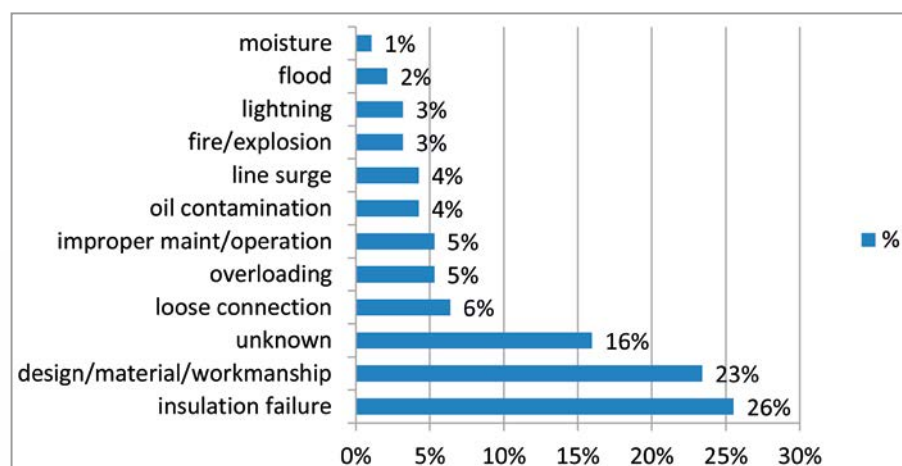
Figure 1. Causes of power transformer failures (1997-2001)

A sharp increase in premature failures of extra high voltage (EHV) power transformers and reactors has forced the energy supplying authorities to run a deeper analysis of the risks involved in such failures and a loss of huge revenue due to the resulting outage. Figure 1 presents an analysis of the main causes of power transformer failures recorded between 1997 and 2001 [1], while a similar analysis for a 20-year period between 1991 and 2010 is plotted in Figure 2 [2].

Insulation failure was the leading cause in the former study. Combined with the design/material/workmanship and unknown causes, these three categories accounted for 65 % of total failures and 85 % of the total amount paid out for the related claims.

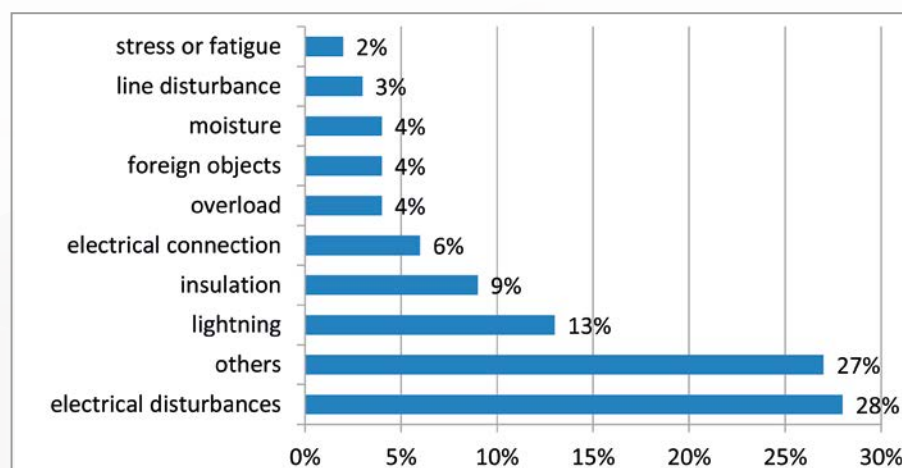
Figure 2. Causes of power transformer failures (1991-2010)

Rearrangement in the categorization of causes in the latter study, both of which were done by the same group, paints a more compact picture.

Electrical disturbances included phenomena such as the switching surges, voltage spikes, line faults/flashovers, and other utility abnormalities, but excluded lightning. Windings (the main current carrying components) are considered to be the most vulnerable components of a power transformer when it comes to withstanding any of these electrical disturbances. All of the listed failures, directly or indirectly, cause huge stress in the transformer windings. While designing the transformer windings, a designer takes enough precautions to take care of such stresses and expects windings to remain healthy for the entire service life of the transformer – which could be at least 35-40 years. The expectation, however, largely depends on the right choice of active components. Out of many reasons of failures, one that is often given less attention is an improper selection of raw materials.

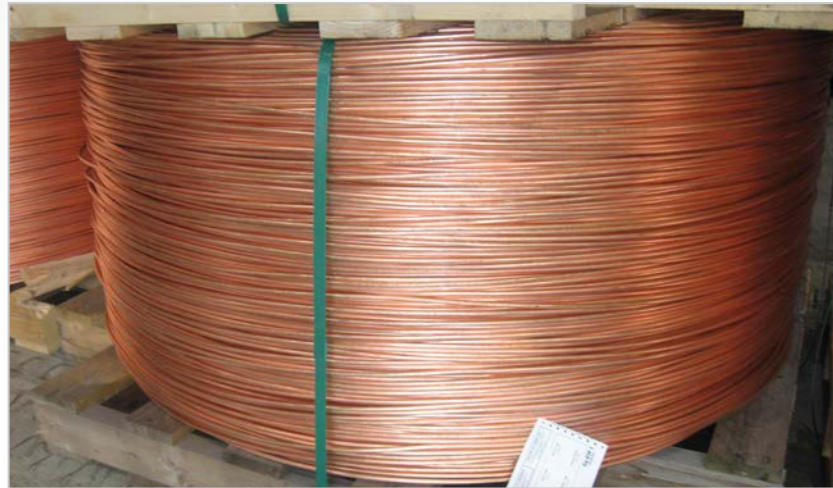
Figure 3. An 8-mm-diameter copper wire rod

An 8-mm-diameter copper wire rod, in coil form, is the most common size for making CTC and is sourced from copper wire rod manufacturers. Depending on the size of the copper strip required by the transformer designer, the 8-mm-diameter wire rod is first drawn into smaller diameter wires during the round wire drawing process, and then cold-rolled to the desired size of the flat strip during the flat rolling phase. The cold-rolled bare strips are hard and need to be annealed (to let the molecular structure recrystallize and allow the strip to become soft) before applying an enamel coating. The desired coating is achieved in steps through the fine incremental thickness of a few microns (in order to get perfect curing and flawless surface). It is done in highly precise temperature controlled vertical ovens. The strip may be further coated with epoxy, when high bonding properties are required in the CTC by the designer. Annealing, enamelling and epoxy coating are, in fact, completed in tandem during the same process, when the proof-stress ( $R_{p0.2}$ )<sup>2</sup> requirement is less than 200 N/mm<sup>2</sup> as in-line proof-stress rollers are good enough to achieve such requirements. However, for higher proof-stress ( $R_{p0.2}$ ) requirements ( $\geq 200$  N/mm<sup>2</sup>), these in-line proof-stress rollers are not adequate and therefore off-line annealing is required. The desired high proof-stress of the strip is then achieved through the controlled re-rolling process, by running the annealed strip, once again, through the flat-rolling machine. In this case, while enamelling, the in-line annealing oven and proof-stress rollers are by-passed. In the final stage of CTC, called transposing, these coated strips are transposed together and covered with insulation paper or sometimes, for LV windings, with netting tape.

The CTC making process is illustrated in Figures 3-8.

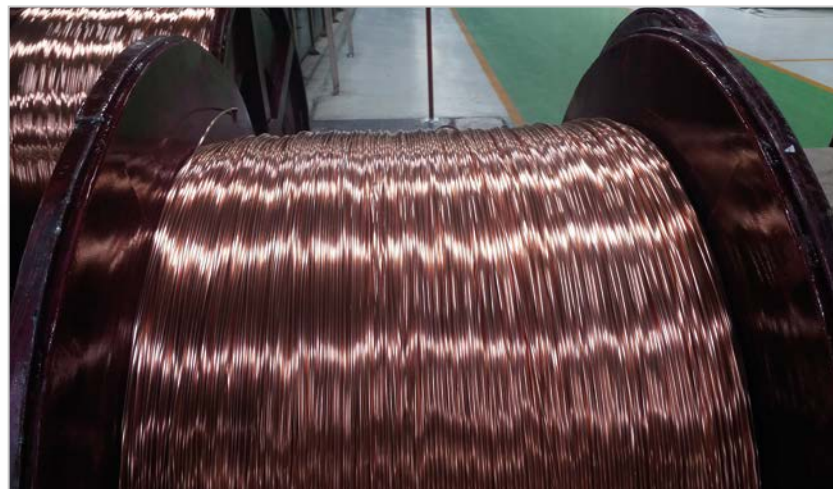
Figure 4. Drawn copper wire after the wire drawing stage

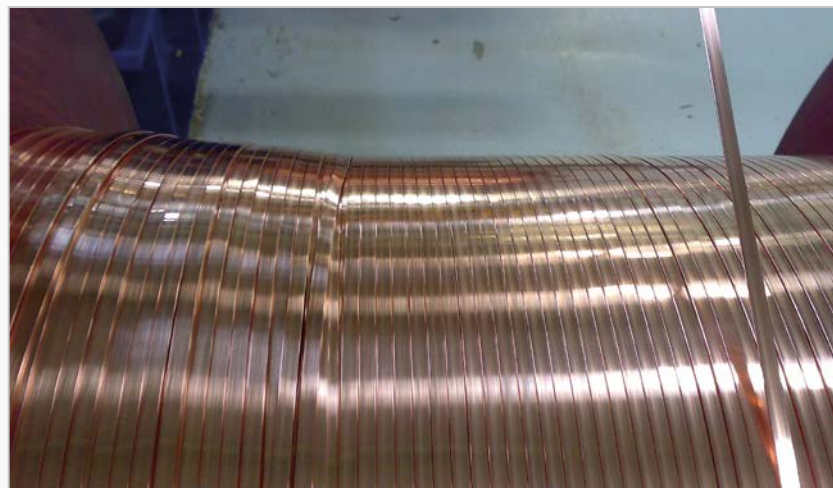
Figure 5. Flat bare strip after the flat rolling stage

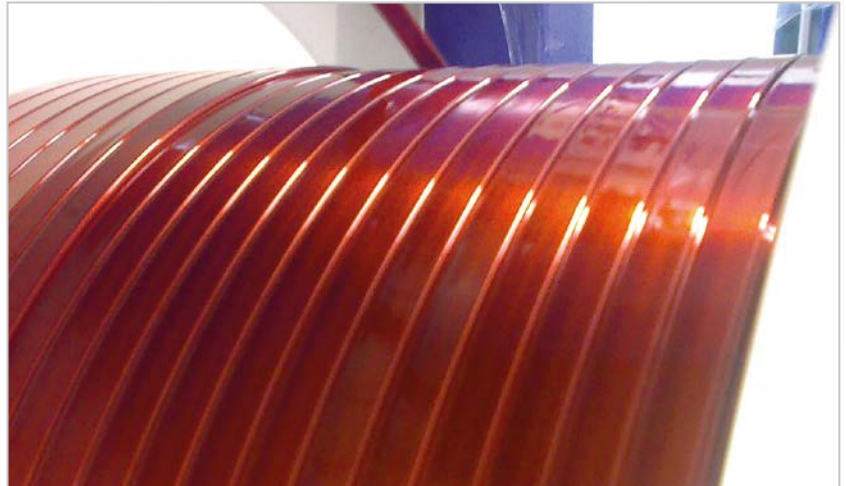
Figure 6. Enamel/epoxy-coated copper strip

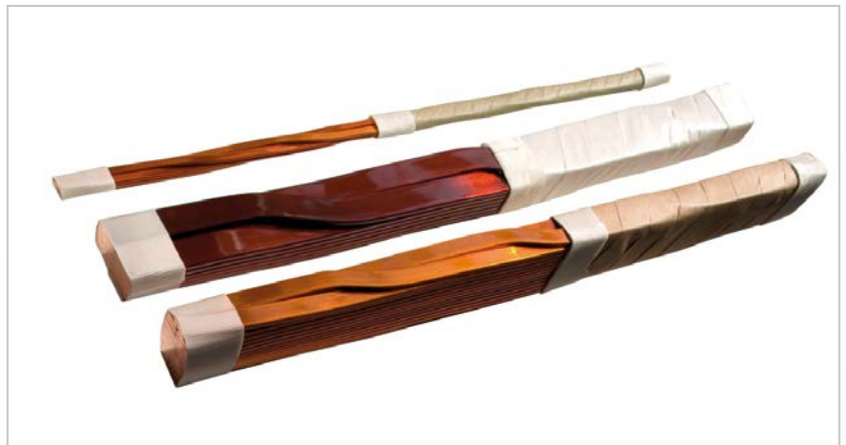
Figure 7. Paper-covered CTC after transposing

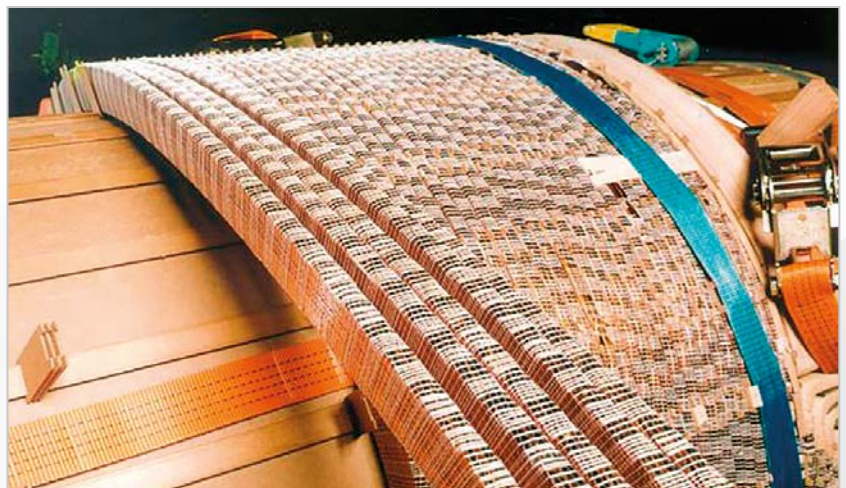
Figure 8. Netting-taped CTC after transposing

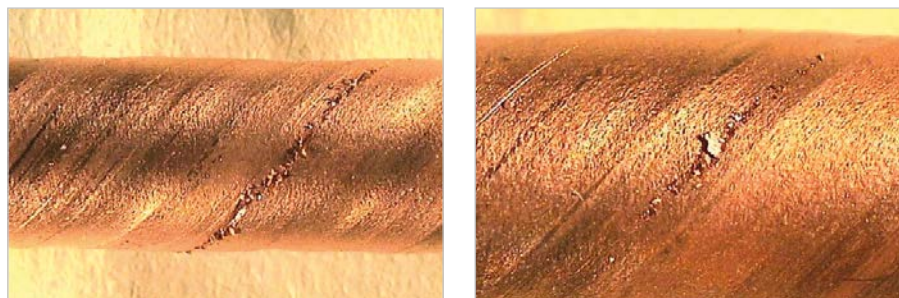
Figure 9. Torsion test failures at the point of receiving a copper rod: images show heavy splintering in an 8-mm-diameter copper rod

Torsion test of copper rods is probably the most revealing test about the supplier's ability to produce quality copper rods for CTC. Any kind of surface defects, whether superficial (dents, grooves, seams, cracks, etc.) or sub-surface (oxide inclusions, impurities, holes, etc.), get exposed in this test. These surface/sub-surface defects are the worst kind of quality hazard that, if go undetected, could be disastrous at any later stage of processing, Fig. 10. Conductors with such defects are susceptible to failure due to electrical stress and may develop hotspot and eventual failure of

Illustrations of such defects and their impact down the line are shown in Figures 9-11.

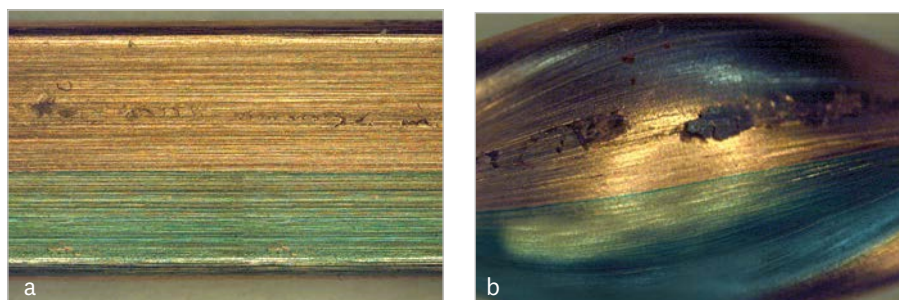
Figure 10. An effect of copper rod torsion test failures on cold-rolled copper strip: (a) before and (b) after the torsion test conducted at the strip stage – a vital processing stage for making CTC

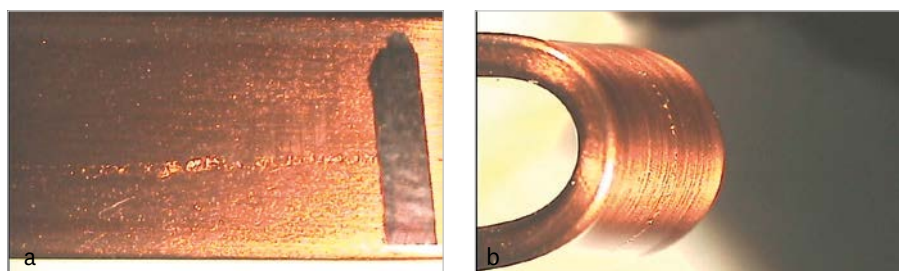
Figure 11. Heavy splintering on an enamelled strip (a) before and (b) after bending – a potential source of electrical failure in transformers

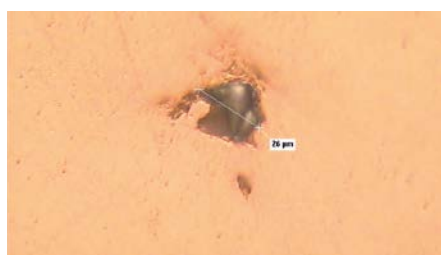
Figure 12. A 26 µm hole in the inner surface

Sub-surface defects in the copper rod can be detected through metallographic inspection of the transverse section specimen of the copper rod. Some of the metallographic images capturing such defects are shown in Figures 12-17. All these defects have deleterious effect on the long term health of power transformers and may shorten their life. They all, in one way

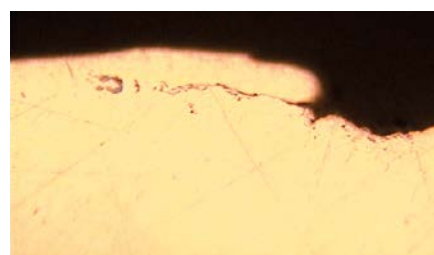
Figure 13. An overlap – a source of serious surface defect on the strip and electrical failure

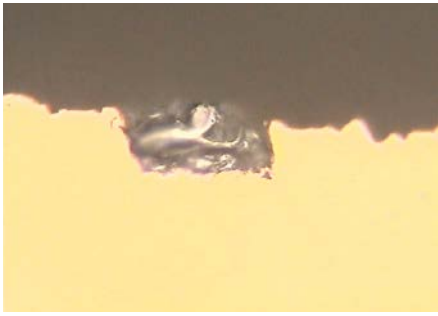
Figure 14. A big oxide lump

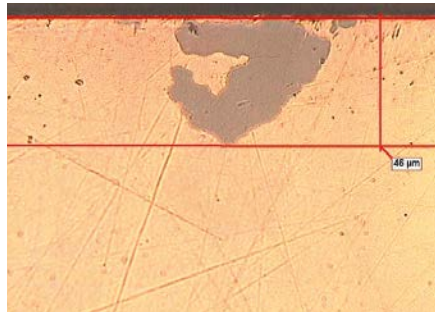
Figure 15. A big oxide inclusion at 46 μm deep

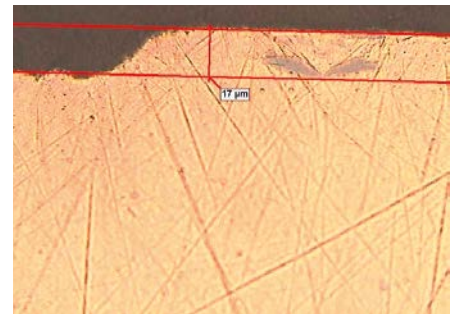
Figure 16. An oxide at 17 μm with a groove

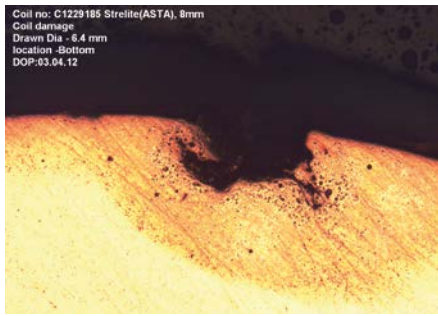
Figure 17. A deep cut on the copper rod

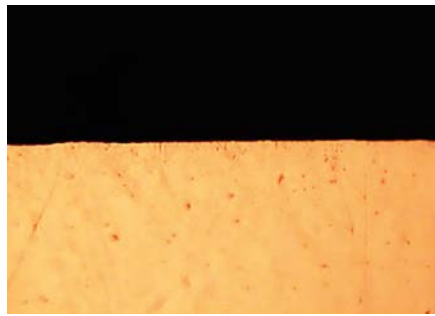
Figure 18. An acceptable Cu-rod after the met test

Proper selection of the copper rod is, therefore, crucial for making fine quality copper strips for CTC. An acceptable copper rod after the metallographic test and after the torsion test is illustrated in Figures 18 and 19, respectively. A cold-rolled copper strip, after the torsion test, made of such copper rod – which is free from any defects shown in Figures 9-17 – is presented in Figure 20.

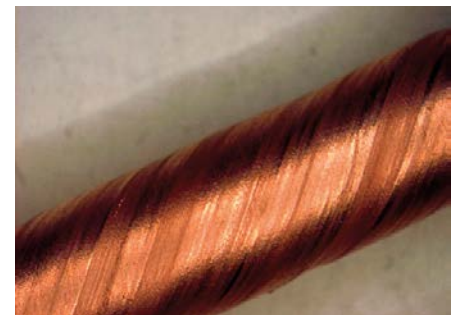
Figure 19. An acceptable Cu-rod after the torsion test

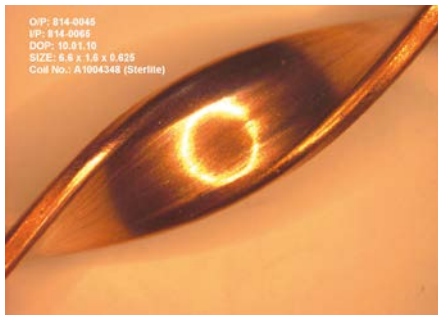
Figure 20. A flawless Cu-strip after the torsion test

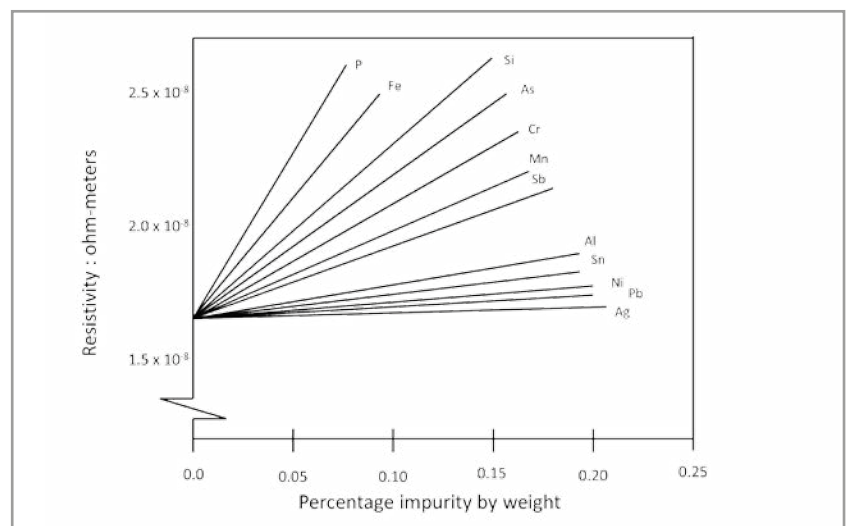
Figure 21. Effect of impurity elements on the resistivity of copper at room temperature

With oxygen-free (OF) copper, according to the standard ASTM B49-10 [3] silver (Ag) content is counted as copper (Cu) in its chemical composition for purity purpose. Any impurity adversely affects the electrical properties, Fig. 21. Typically,

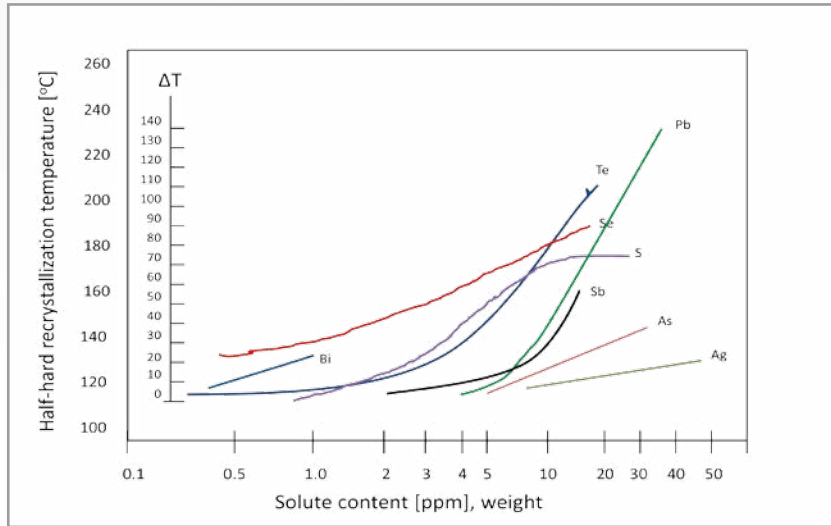
Figure 22. Effect of single-element additions to ETP copper on the half-hard crystallization temperature

during the hot rolling process in the production of rod. Many investigations have shown that very small addition of these impurities can increase the resistivity of copper in a linear manner, Fig. 21, while many impurities increase the half-hard recrystallization temperature in a non-linear manner, Fig. 22.

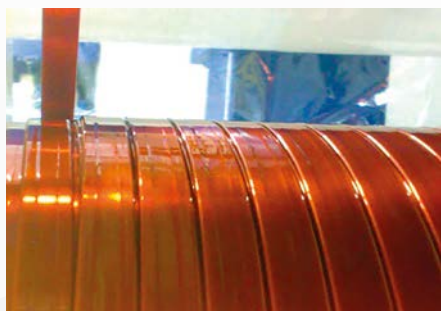
Figure 25. A fine quality enamelled strip

Figure 25 shows the copper strip after it has been coated with enamel. Enamelling process is at the heart of the CTC making process and is responsible for all crucial physical, mechanical, electrical and thermal properties of the final CTC product. Some of its varieties are shown in Figures 7 and 8. All tests mentioned in this article with respect to copper are conducted at

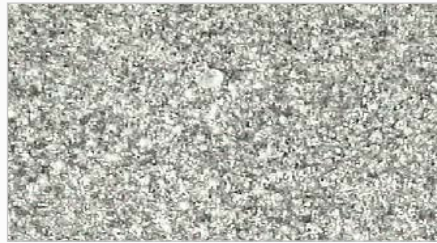
Figure 23. Grain size of a Cu-rod: 10-15  $\mu\text{m}$  (cross-section of copper rod)

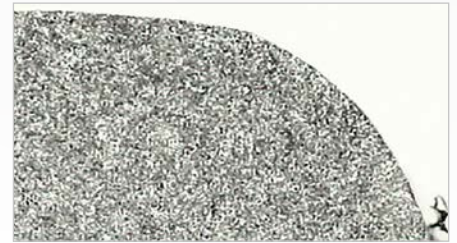
Figure 24. Grain size of a Cu-strip: 10-15  $\mu\text{m}$  (cross-section with corner radius)

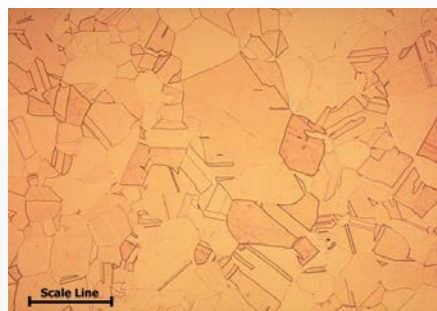
Figure 26. Nom composition – 99.99 %: rod, Cu-OFHC (C10100), where chemical purity is more important

OF copper is valued more for its chemical purity than its electrical conductivity. It is used in the manufacture of semiconductors and super-conductor components. It is critical to use OF copper in applications where the release of oxygen (and other impurities) can cause undesirable chemical reactions with other materials in the local environment, Figs. 26 and 27. For the comparison of ETP and OF copper properties, see Table 2.

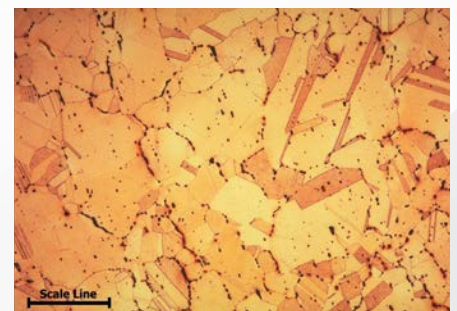
Figure 27. Nom composition – 99.99 %: embrittled, Cu-ETP (C11000) in hydrogen environments
