Coal Operators' Conference

2019

A scientific approach to quantifying the efficiency and efficacy of dust curtains on a Sandvik mb650 continuous miner at kestrel colliery whilst mining a full face of roof stone during an overcast construction

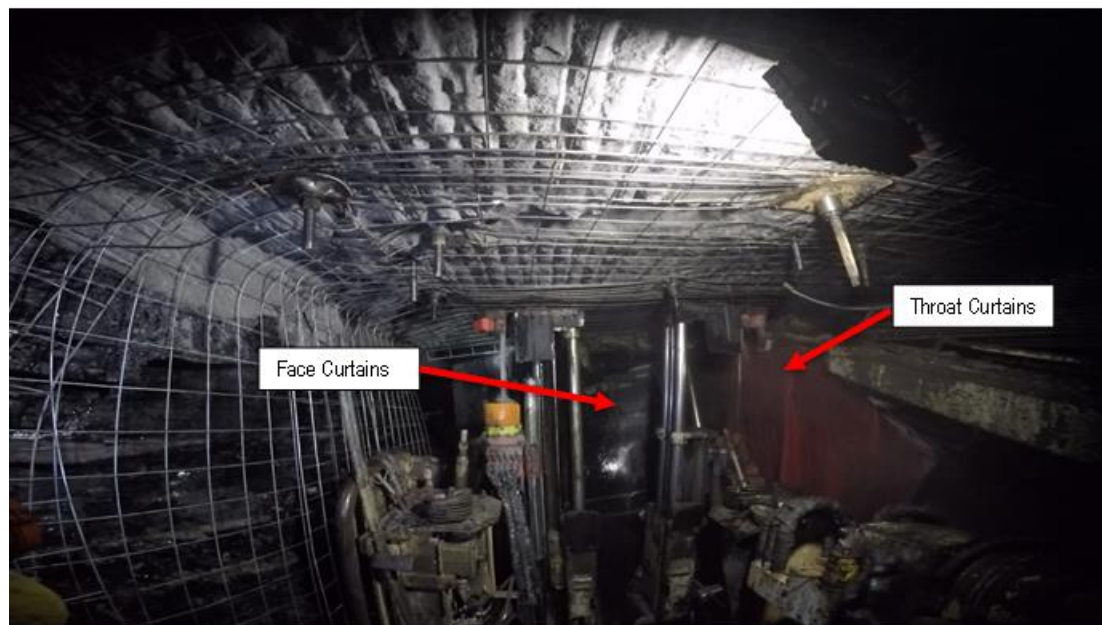
Figure 2: Face and throat curtains

Figure 2 below shows the face curtains and throat curtains in normal operating conditions. The throat curtains are down, and the face curtains are down.

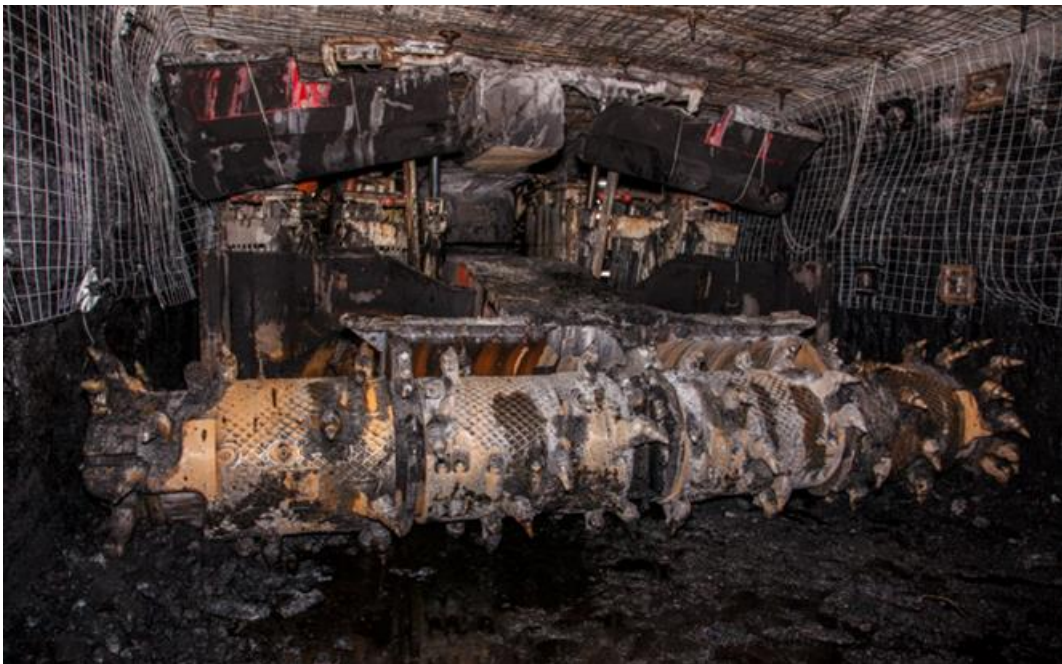
Figure 4: Retracted curtains

- The front curtains were rolled up as high as possible and down as low as possible to allow the produced dust to bypass them. This was achieved by chain blocking the curtains up as high as possible and then securing them as required for the testing. This process was repeated to pull down the curtains to the roof. Figure 4 shows a photo of the retracted curtains.
- The side curtains will be rolled up and cable tied securely on either side securing them as required for the testing.
- All sprays, excluding pick sprays, were turned off. It was anticipated that the other sprays would be disconnected at the back of the sprays to allow the water to flow through the cooling circuit and dump to ground.

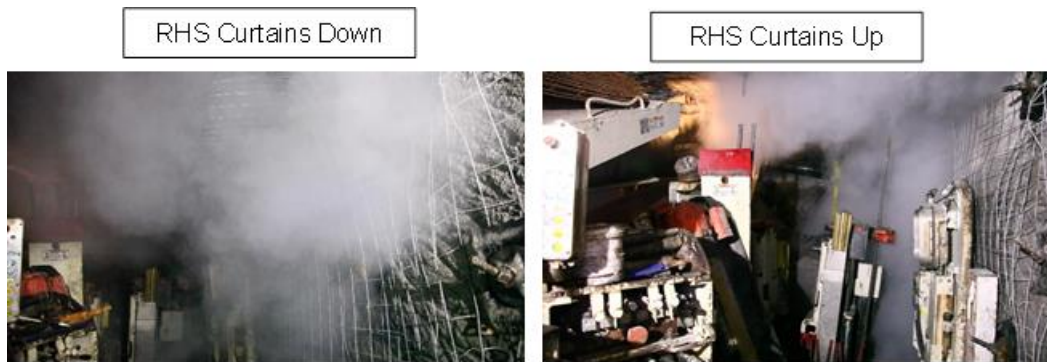
Figure 5: RHS curtains down and curtains up dust migration

During the establishment of the benchmark, it was found that the installed curtains were creating more dust and forcing it to migrate down the platform when they were down as designed. The visible and measured respirable dust was significantly higher with the curtains down as designed compared to when the curtains were rolled up and inoperable. Figure 5 shows the respirable dust being forced around the curtains on the RHS of the continuous Miner (CM) and almost to the rear of the operator's platform with the curtains down as designed. The produced respirable dust remained against the face when the curtains were rolled up.

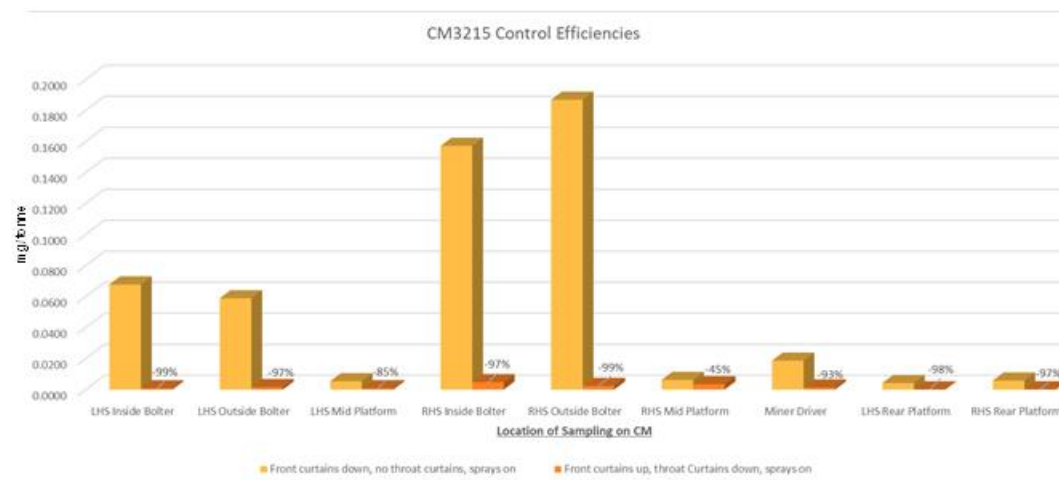
Figure 7: Graph of the respirable dust reduction achieved by removing the front curtains

Figure 7 is a graphical representation of the obtained results.

Date	Location	Location On CM	Front Curtains Down	Front Curtains Up	Control Efficiency
			Throat Curtains Off Sprays On	Throat Curtains Off Sprays On	
22-Jun	Mains	LHS Inside Bolter	0.0678	0.0008	-99%
22-Jun	Mains	LHS Outside Bolter	0.0589	0.0016	-97%
22-Jun	Mains	LHS Mid Platform	0.0054	0.0008	-85%
22-Jun	Mains	RHS Inside Bolter	0.1572	0.0047	-97%
22-Jun	Mains	RHS Outside Bolter	0.1869	0.0024	-99%
22-Jun	Mains	RHS Mid Platform	0.0062	0.0034	-45%
22-Jun	Mains	Miner Driver	0.0186	0.0013	-93%
22-Jun	Mains	LHS Rear Platform	0.0042	0.0001	-98%
22-Jun	Mains	RHS Rear Platform	0.0058	0.0002	-97%
