Improvements to the WPI Powerplant

IMPROVEMENTS TO THE WPI POWERPLANT COAL BIN

Major Qualifying Project

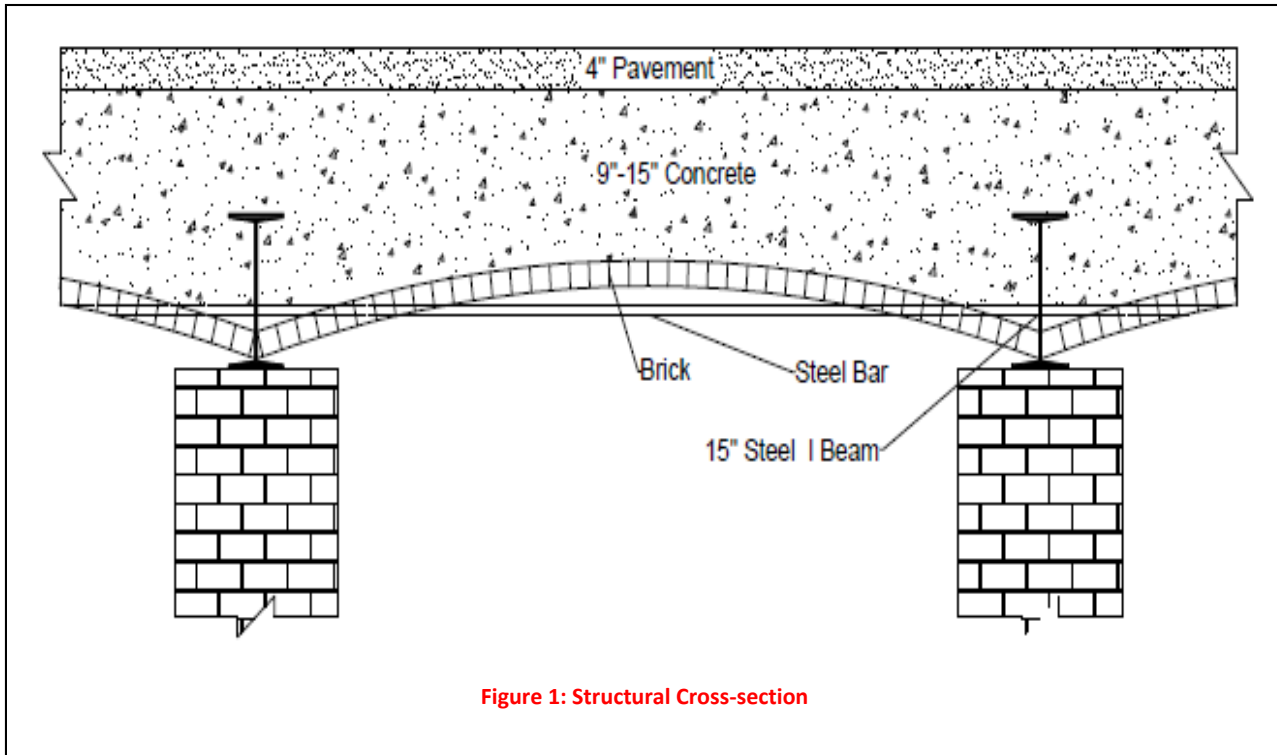
The roof structure of the underground coal bin is comprised of several brick and steel arches which is commonly known as a barrel vault system. A diagram of the cross section of the roof structure can be seen below. The arches span approximately 8 feet in width and extend the length of the room. They have a rise of approximately 8 inches and are supported by 15-inch steel

I-beams. In Figure 1: Structural Cross-Section, the I-beams rest on brick columns, which are approximately 20" on each side. The bottom flanges of the beams are coincident with the springing lines of the arches so that the bricks are seated on the top of the bottom flange. Between the I-beams, 3/4" diameter steel bars add additional support and resist the horizontal thrust forces from the arches. Above the brick arches there is 9" to 15" of concrete fill topped by approximately 4" of pavement. An engineering report conducted by Johnson & Seaman Engineering (2004), estimated that the approximate load bearing capacity on the pavement above is 40 lbs. /ft².

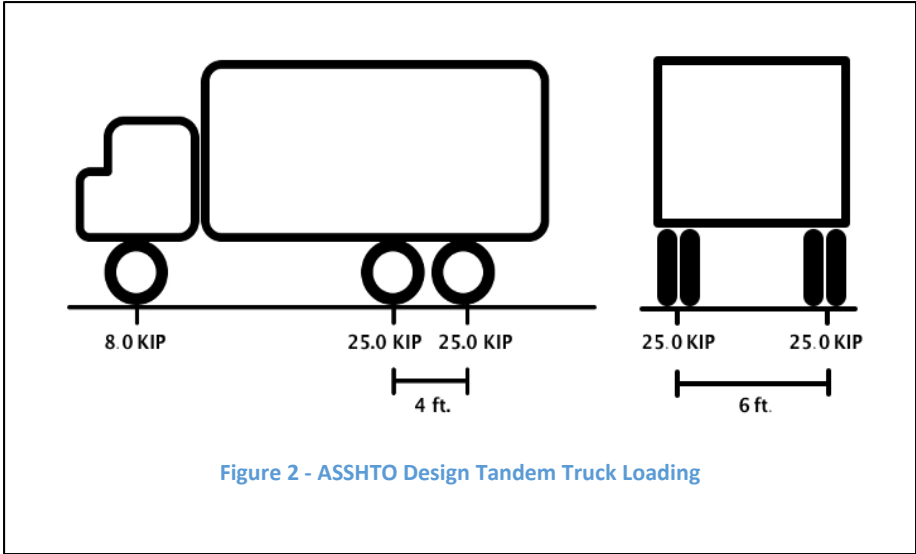
The first step in the design process was to determine the design loading that the structure would need to be capable of supporting. A dead load of 1130 lbs. per linear foot was used as a starting point for loading requirements. This value represents the weight of an 8-inch reinforced concrete slab as well as 4 inches of pavement above the concrete. AASHTO² bridge design was then used as a reference for vehicle design loads. It was determined that the minimum design load would be for the design tandem truck as this was the most likely representative of the delivery trucks that use the space. The design tandem is a tandem axle 58,000-pound truck which is used for design purposes. The loads from the truck were idealized as an 8,000-pound point load for the front and then spaced 14ft back are two 25,000-pound point loads for the rear axles, spaced 4ft apart as seen in Figure 2.

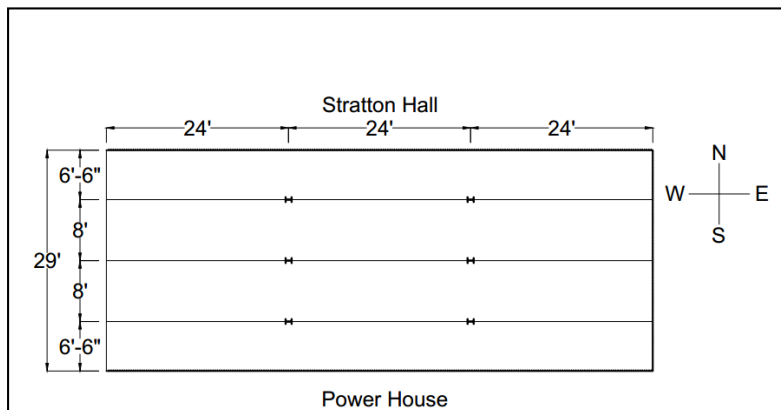
Figure 3: Basic Layout for Options 1 & 2

foundation walls on the North and South sides of the site will be used to support the new structure. The basic layout of the area can be seen in Figure 3 and Figure 4. A summary of the design loads that were used for the design of the first two options can be seen in Table 1, which shows the maximum loads for both a column and non-column design. Below the three options for a new structure are explained.

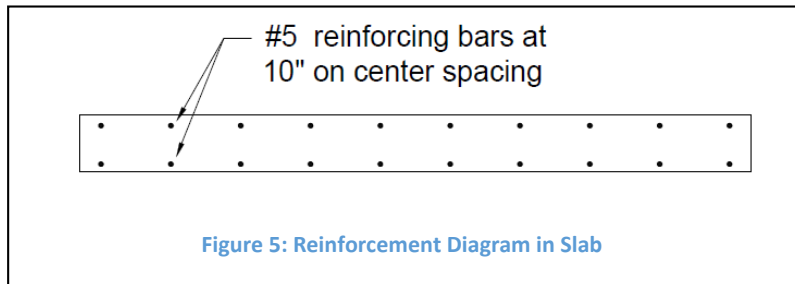
Figure 5: Reinforcement Diagram in Slab

The same concrete slab is used for all of the options proposed below. It is comprised of an 8 inch deep, cast in place slab using normal weight, 3500 psi concrete. The slab features

5/8" reinforcing bars at 10 inches on center for both the positive and negative reinforcement. On the top there is 1.5 inches of concrete cover above the reinforcing steel while there is 1 inch below the bottom reinforcing steel. An 8 foot cross section of the slab can be seen in Figure 5, and the calculations that were used for slab design can be seen in Appendix B. This slab design is used for all of the following options with the reinforcing running in the in the east west direction. Above the slab will be 4 inches of asphalt paving which will help protect and extend the life of the concrete.

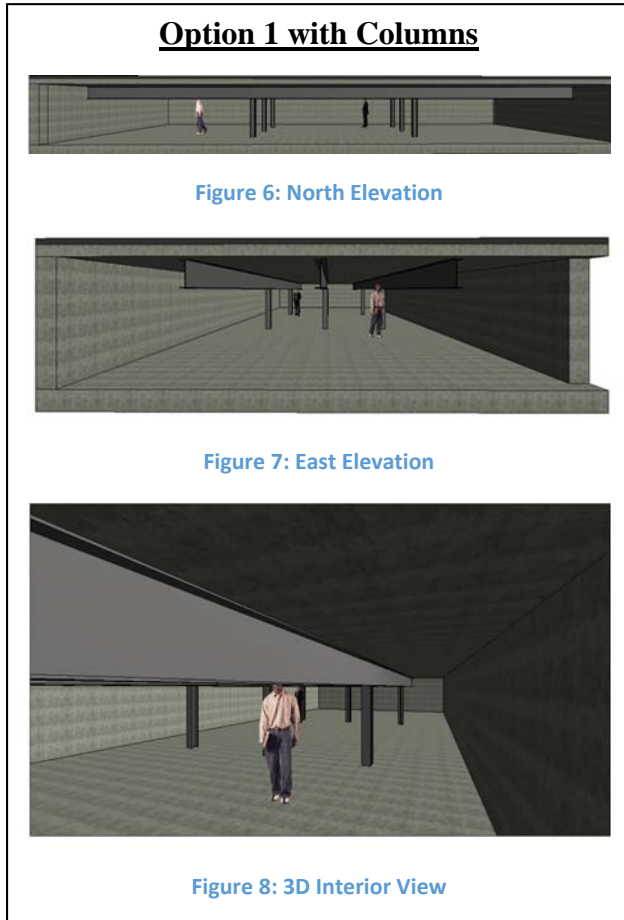
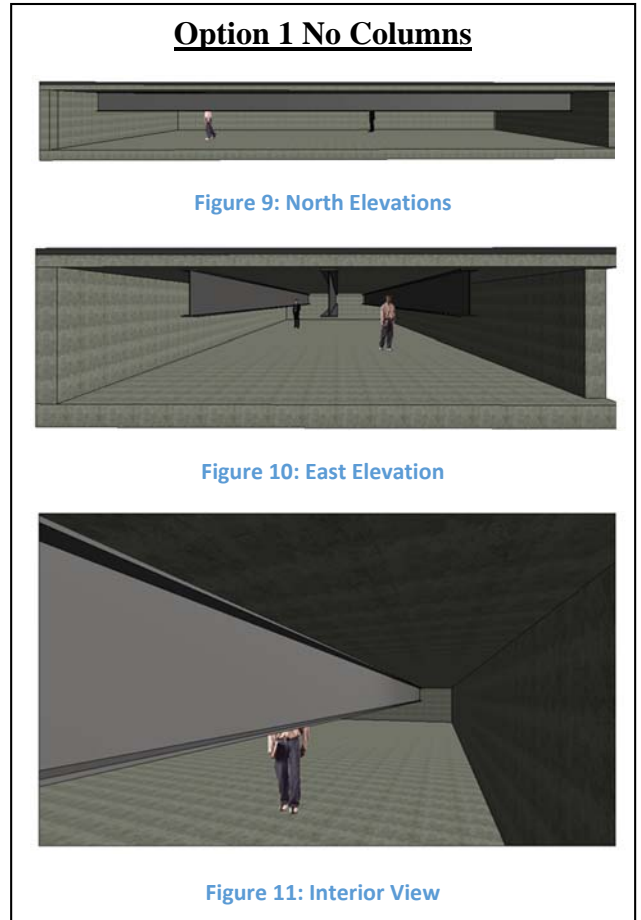
Renderings of both the column and non-column designs can be seen in Figure 6 through Figure 11 which show a north elevation, east elevation and an interior view from inside the structure for both designs.

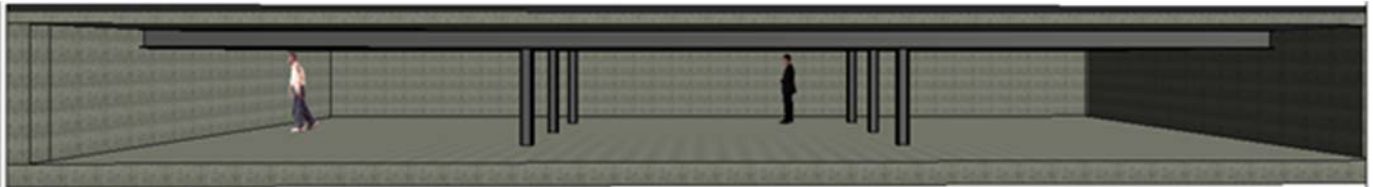
Figure 14: North Elevation

Option 2 is similar to option 1. However Option 2 is designed to optimize the head room at the expense of heavier beams. This was achieved by selecting beams with smaller depths yet thicker web and flange sections. The advantage of this option is that the versatility and usability of the spaced is increased because of the increase ceiling height. A summary of the selected members can be seen in Table 3. Renderings of this option can be seen in Figure 12 to Figure 14.

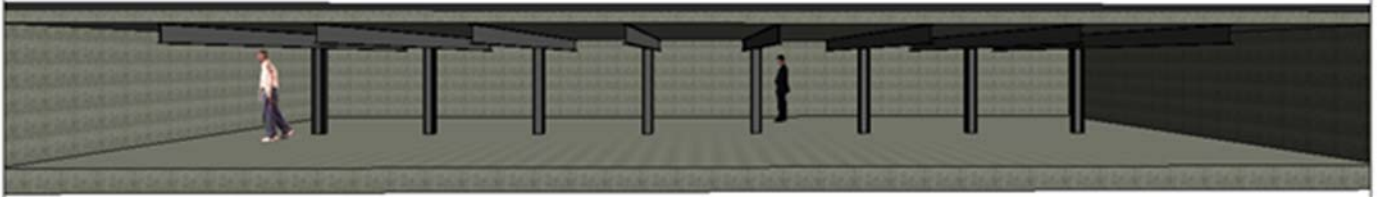
Figure 17: North Elevation

This option allows for a smaller steel member because it utilizes the compressive strength of the concrete. This is achieved with the use of steel shear studs welded to the beams before the concrete is placed. Again this option is broken down into a column and no column design. A summary of the full composite member size required can be seen in Table 4. Renderings of this design option can be seen in Figure 15 to Figure 20.

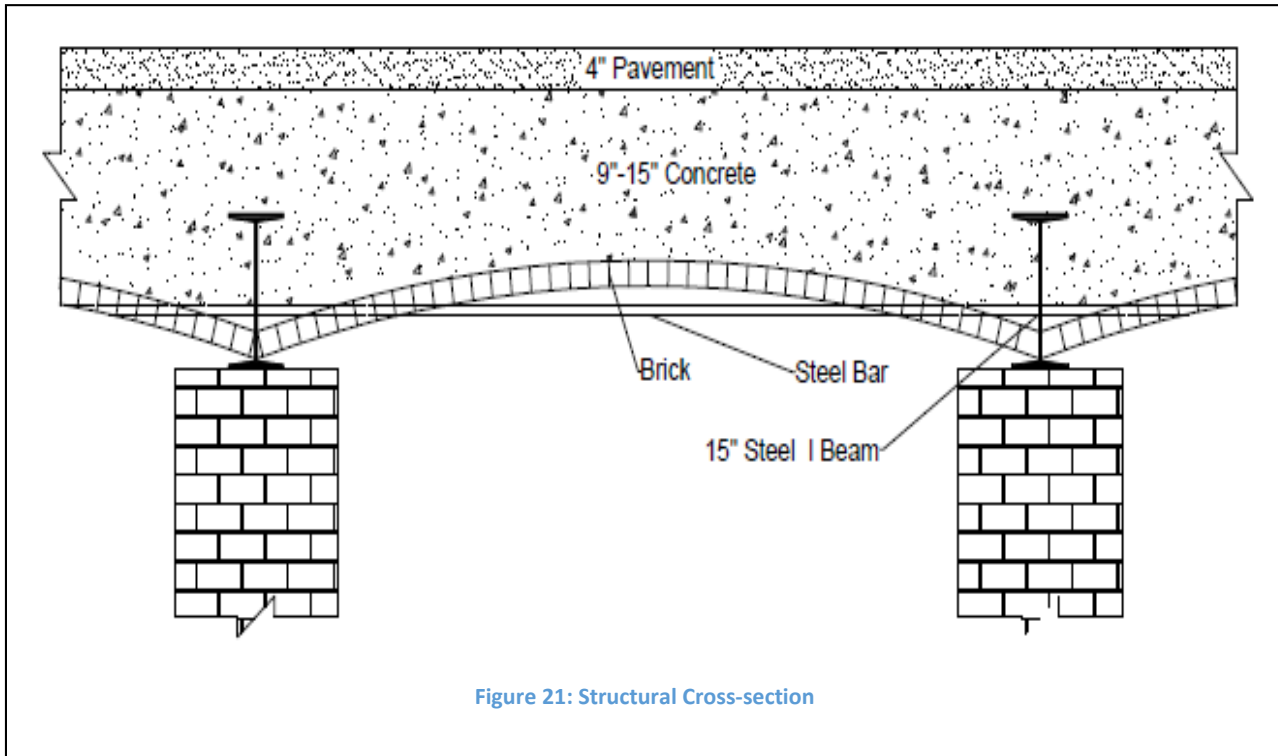
The roof structure of the underground coal bin is comprised of several brick and steel arches which are commonly known as a barrel vault system. A diagram of the cross section of the room structure can be seen below. The arches are approximately 8 feet wide and run the length of the room. They have a depth of approximately 8 inches and are supported by 15-inch steel I-beams. The I-beams rest on brick columns, which are approximately 20” on each side. The bottom

flanges of the beams are level with the bottom of the arch so that the bricks are seated on the top of the bottom flange. Between the I-beams, 3/4” steel bars add additional support and prevent the arches from kicking out at the bottom. Above the arches there is 9” to 15” of concrete and about 4” of pavement on top of that. A diagram of the cross section of the room structure can be seen below. From past engineering reports the approximate load bearing capacity on the pavement above is 40 lbs. /ft².

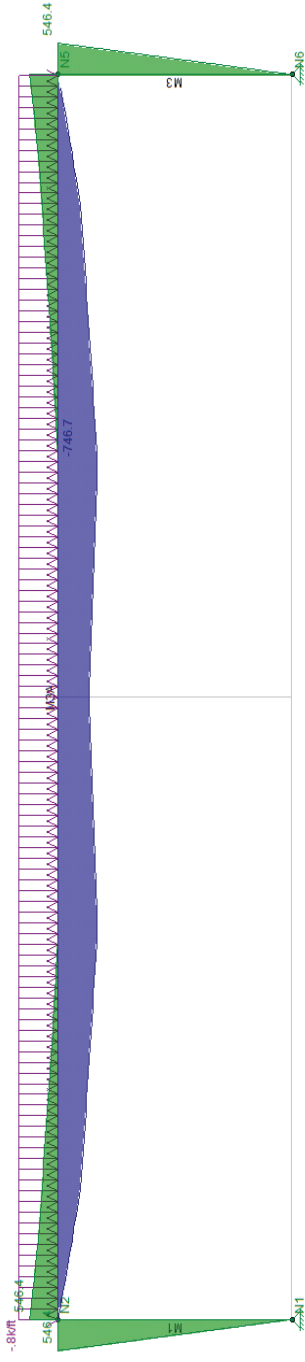
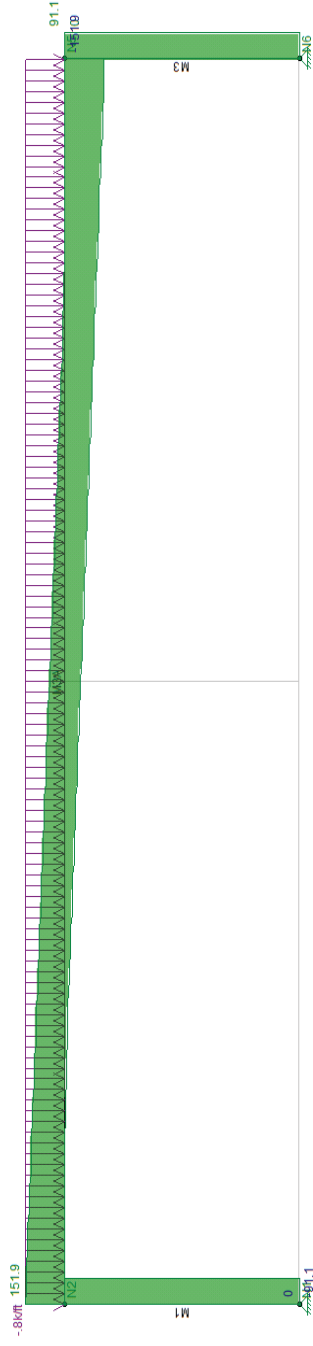
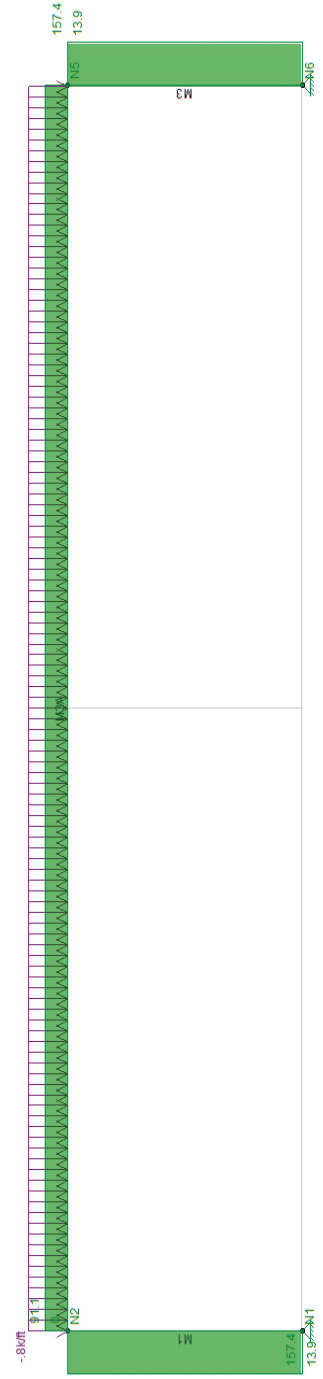
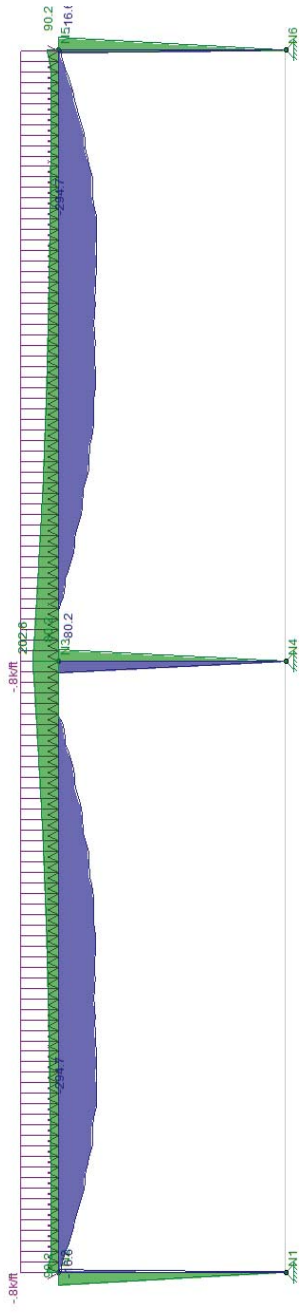
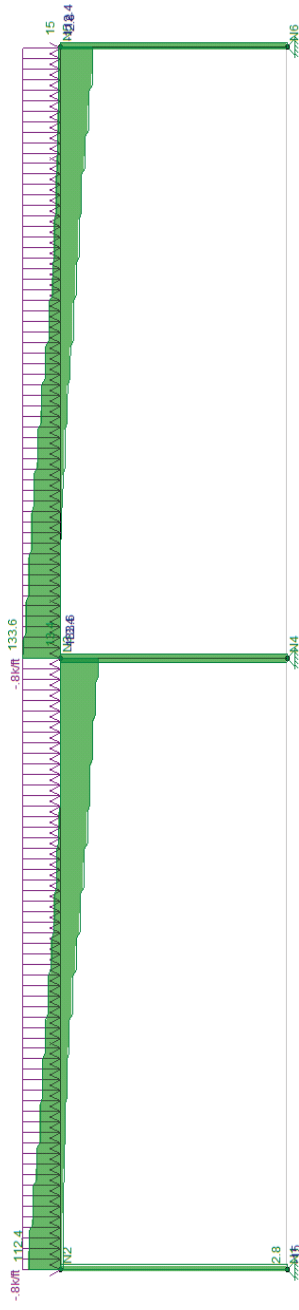
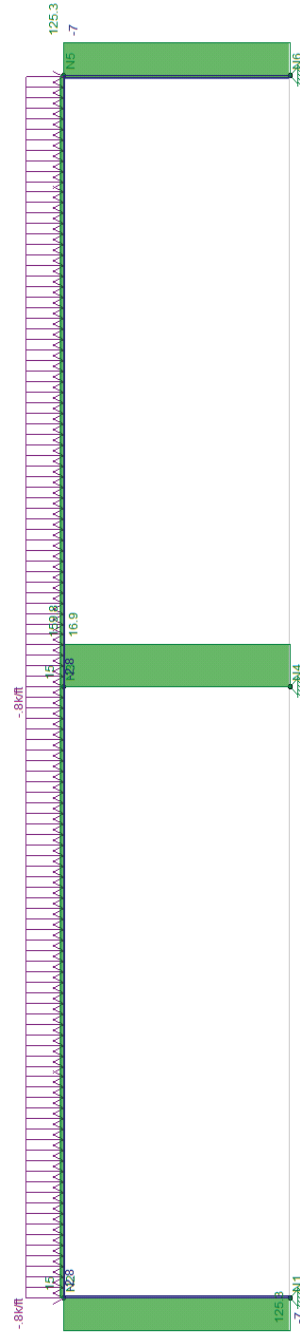
North - South Loads - No Columns

used for design option 1 & 2
