# Copper Pipe Leak Detection

## **Copper Pipe Leak Detection**

*Investigated in coordination with Ayotte Plumbing*

A Major Qualifying Project Report

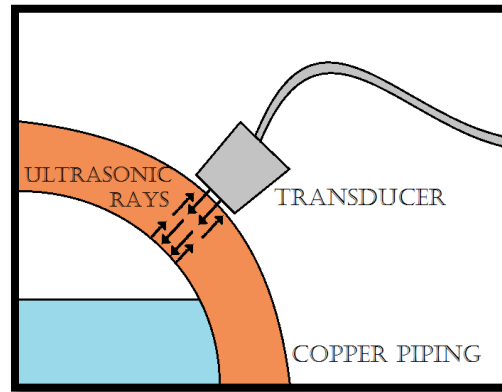
The operational process of this service is to compare the original wall thickness with the current wall thickness. An operator knows the starting wall thickness, based on the pipe diameter. An instrument can be used to determine the current wall thickness. A comparison would be made between the starting thickness, the corroded (measured) thickness, and the

number of years the system has been in use. These numbers can be used to estimate the remaining useful life of the pipe(s).

**Figure 7:** Ultrasonic Thickness Gauge Measuring Wall Thickness

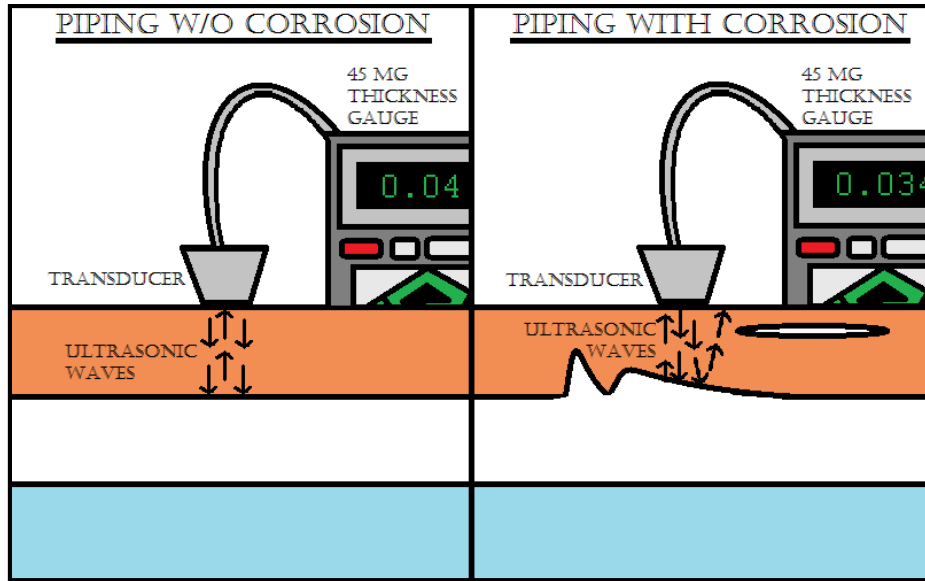
The Olympus Corporation has an informational pdf for the 45MG Thickness Gauge that is accessible online; the project team could not include this file into our Appendices because of copyright issues. The manual provides specifications, instructions, and information necessary to utilize the product. The 45MG Thickness Gauge satisfies all needs of the project and it is possible to successfully implement for any plumbing company.

**Figure 8:** 45 MG Thickness Gauge Testing Process

When operating the 45 MG Thickness Gauge, the tester must use a reference page in order to determine the acceptable width for the piping and to determine whether the piping needs immediate removal. The reference page must provide starting pipe thicknesses for all pipes that are used in housing facilities. This reference page is coupled with the 45 MG Thickness Gauge's results in order to determine if the pipes need replacement. The 45 MG Thickness Gauge determines the width of the piping by inputting the frequency of sound for copper (3500m/sec) and then sending a wave of that frequency through the piping. These ultrasonic waves bounce back after hitting a surface that is no longer that frequency of sound. The transducer then receives the wave back and calculates the time it took to travel from the outer diameter to the inner diameter and back. This time multiplied by the frequency of sound calculates the thickness of the copper pipe. The generic equation is:

There are minor issues with this test when attempting to receive consistent measurements on corroded copper piping. This lack of consistency is due to the transducers inability to be perfectly perpendicular to the piping’s inner diameter when the tester is conducting the tests. When the transducer is not perpendicular with the piping, some of the ultrasonic waves may not send back an accurate response, creating inconsistent measurements and wave results. This inconsistency can still yield a reading, but multiple tests on the same spot will give a more confident and precise pipe-thickness measurement.

If the 45 MG Thickness Gauge does not read out a response, then the copper piping is too corroded and pitted to receive waves back into the transducer. Alternatively, no response will be given if the pipe is below the 45 MG Thickness Gauge’s minimum tolerance. These are warning signs that that the piping needs replacement immediately.
