Analysis of Flexural Strength and Monotonic Load to Failure Following Simulated Chairside Adjustments and Repair in a Lithium Disilicate Glass-Ceramic

Analysis of flexural strength and monotonic load to failure following simulated chairside adjustments in a lithium disilicate glass-ceramic

A Thesis submitted to the Faculty of the Graduate School,
Marquette University,
in Partial Fulfillment of the Requirements for
the Degree of Master of Science

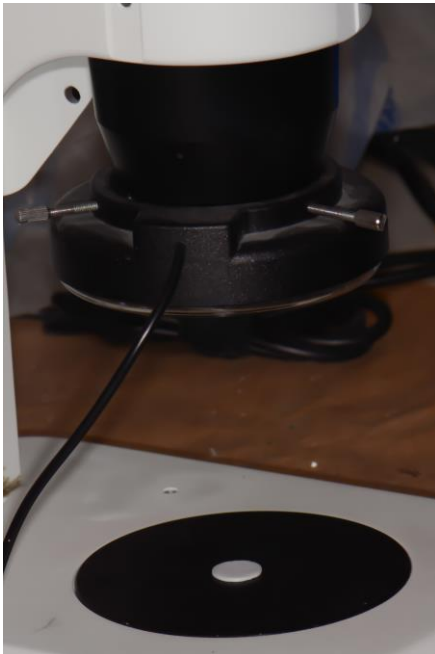
Figure 4 Microscope evaluation.

Wax patterns were inspected under 10× magnification (Fig. 4). Only specimens with a homogenous surface, free of voids and imperfections, were selected for inclusion in the study. Specimens were examined by two examiners.

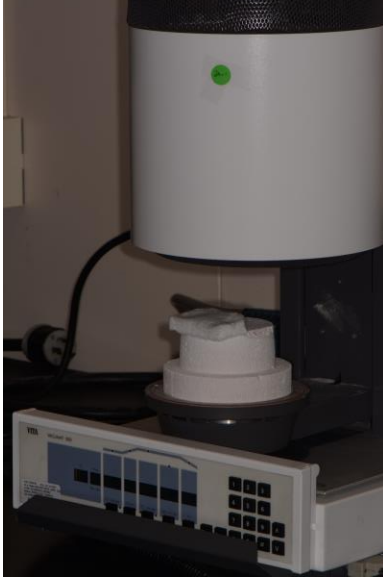
Figure 7 Glazing furnace

Group 4 and 7 were placed in the furnace (Vita Vacumat 500, Zahnfabrik H.Rauter GmbH &Co.KG) for glazing treatment following the simulated clinical adjustments. The glazing protocol followed the manufacturer's recommendations (Table 5).

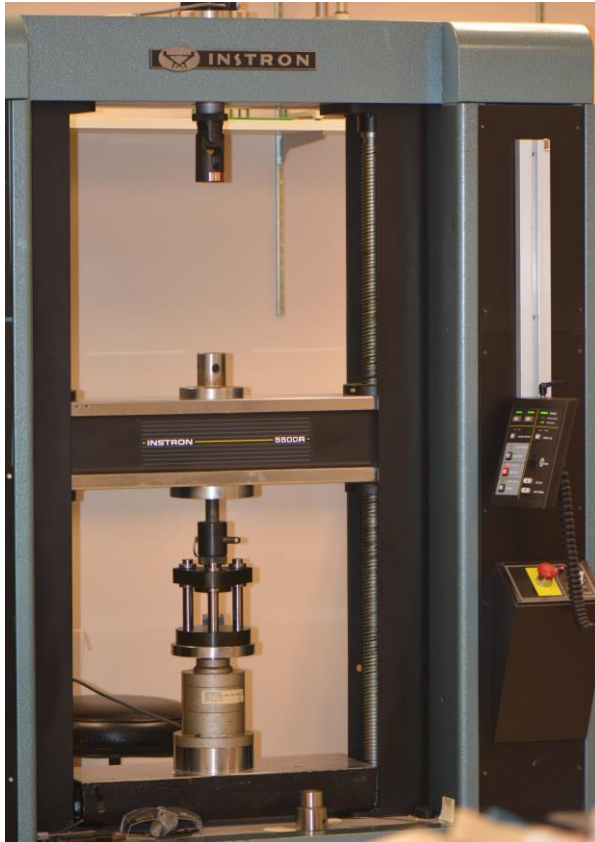
Figure 8. Instron machine.

Specimens were loaded with a 6.5 mm diameter piston with 50-mm radius on the loading point. Specimens were cushioned with a clear sticker of 0.05 mm thickness at a cross head speed of 0.5 mm/min. The loading cell was a 5-KN (Figure 9). Because peaks loads are not always visible on the load versus time plot or because loads oftentimes increase following failure, a measuring microphone is necessary. Acoustic events were recorded with a precision measuring microphone (Model M53; LinearX Systems, Inc, Tualatin, Ore). The microphone was used and positioned as shown in Figures 18 and 19. The microphone was situated very close to the specimen but did not contact it. Most humans can hear sound frequencies between 1-5 kHz. Fracture sound frequencies are often greater than 20 kHz. An amplitude-versus time graphs will be generated using noise analysis software (pcRTA, Version 2.30; LinearX Systems Inc). In the noise-analysis control panel, the pink noise generator will be selected, and an American National Standards Institute-A (ANSI-A) weighted filter will be used with the dynamic range fixed between -60 to 120 dBm. The noise analysis was started simultaneously with the monotonic load to failure test. The recording was used to detect crack sounds and assisted with determination of the failure load.

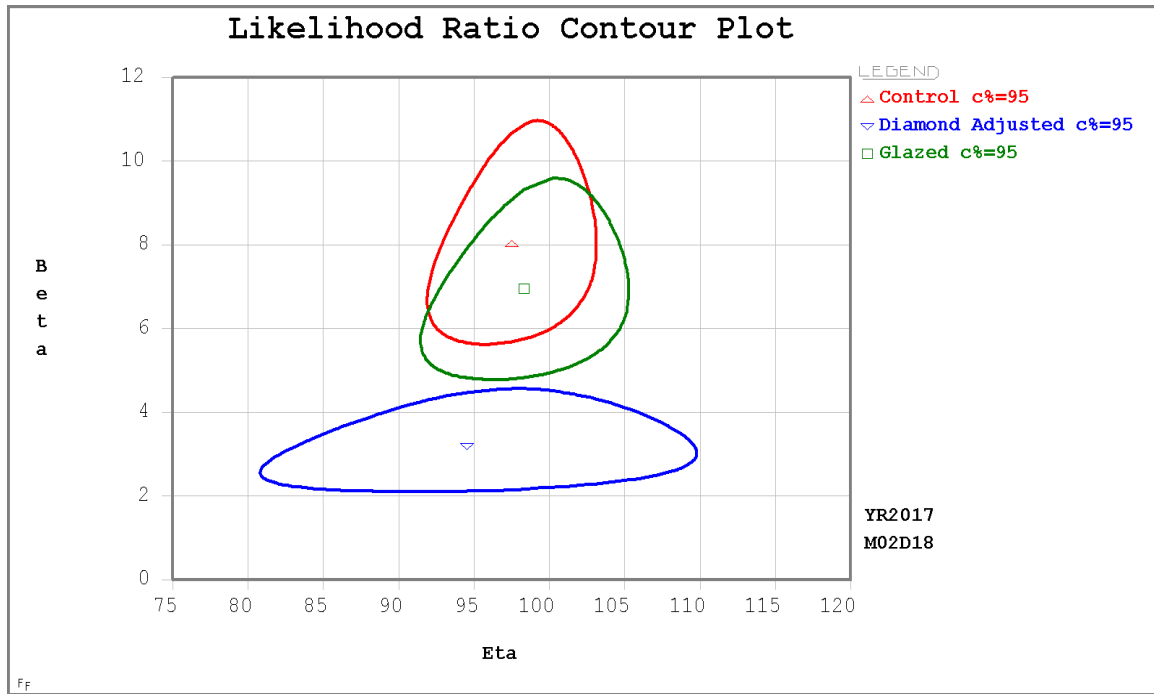
Figure 14. Likelihood Ratio contour plot Monotonic load to failure part I.

Monotonic load to failure data is presented in Table 7. Regarding the monotonic load to failure group, Part I, the 2-Parameter Weibull Plot and likelihood ratio contour plot revealed no significant difference between the control and glazed groups. The diamond adjusted group was significantly different from the control group and the glazed group (Figures 13 and 14).

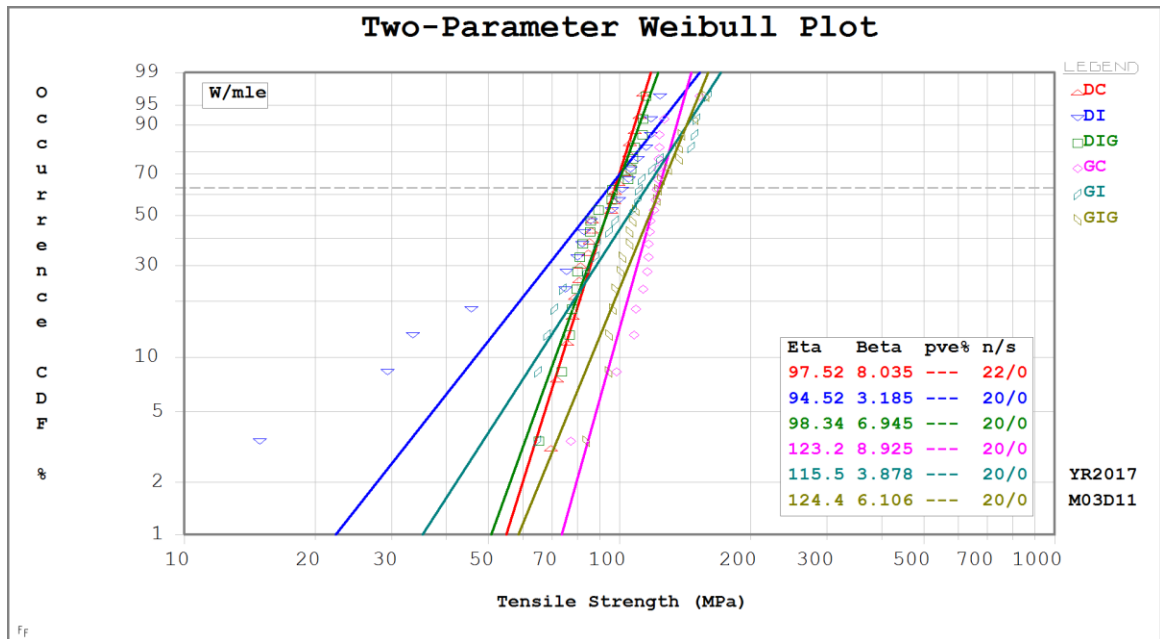
Figure 17. Two-parameter Weibull plot Monotonic load to failure Part II.

Regarding monotonic load to failure (Table 9), and the 2-Parameter Weibull Plot and likelihood ratio contour plot (Figures 17 and 18) it was found that no significant difference existed between G12 and G13. There was a significant difference between G12 and G14. The control group in Part II exhibited a higher Weibull modulus compared to the control in Part I. G13 has a slight decrease in the Weibull modulus. The contact pressure of all the groups in Part II increased compared to the groups in Part I.
