An Analysis Of The Conventional Wire Maintenance Methods
And Transition Wire Integrity Programs
Used In The Aviation Industry

A thesis
presented to
the faculty of the Department of Technology
East Tennessee State University

Keywords: Aircraft wiring, Aging Wiring,
Wire Integrity Programs

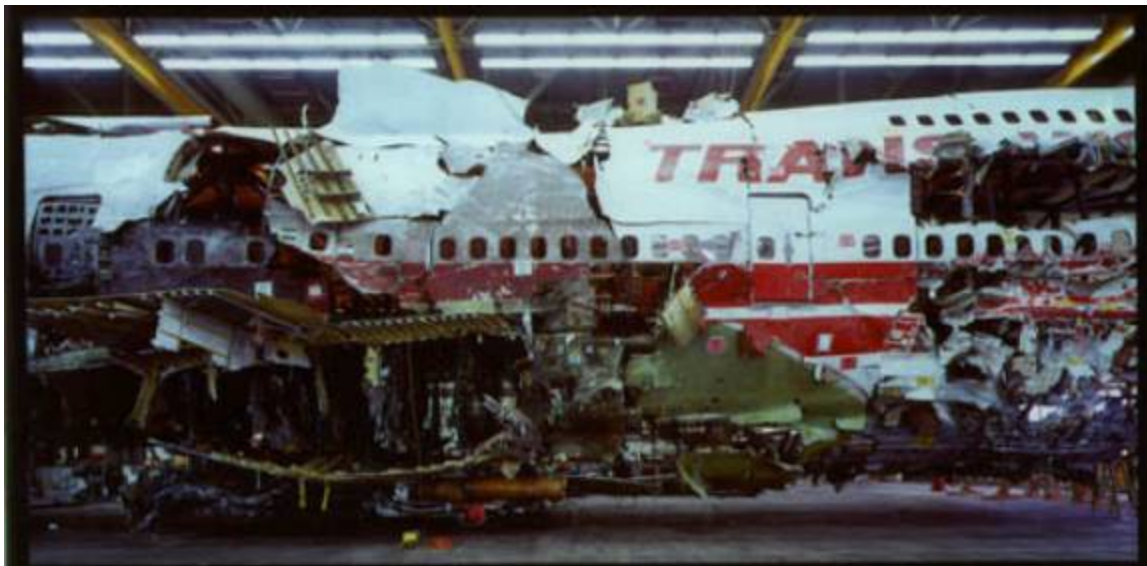
Figure 1. TWA Flight 800: The Reconstruction (1999).

Figure 1 shows the wreckage from TWA flight 800 (TWA flight 800: The Reconstruction, 1999).

The investigation of the TWA Flight 800 fuel tank explosion uncovered possible damaged and degraded wiring. Following this mishap, President Clinton established the White House Commission on Aviation Safety and Security (WHCSS) on August 22nd 1996. The Commission was chartered to study matters involving aviation safety and security, including air traffic control, and to develop a strategy to improve aviation safety and security, both domestically and internationally. The commission, whose membership included representatives from the aircraft and air travel industry, government agencies, and organizations of crash victim families made several recommendations. Recommendation 1.9 stated: “In cooperation with airlines and manufacturers, the FAA’s Aging Aircraft program should be expanded to cover nonstructural systems (White House Commission on Aviation Safety and Security, 1997).”

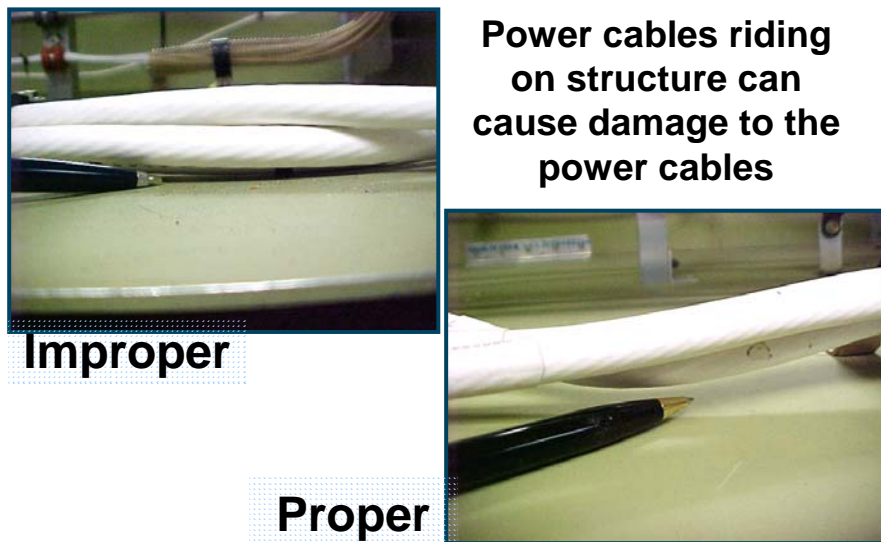
Figure 3. Wires Riding On Structure (Aircraft Wiring Practices, 2002).

Figure 3 shows an example of wire chafing (Aircraft Wiring Practices, 2002).

1. Eliminate potential for chafing/abrasion against structure or other components.
2. Position to minimize use as handhold or support.
3. Reduce exposure to damage by maintenance crews or shifting cargo.
4. Avoid battery electrolytes or other corrosive fluids.

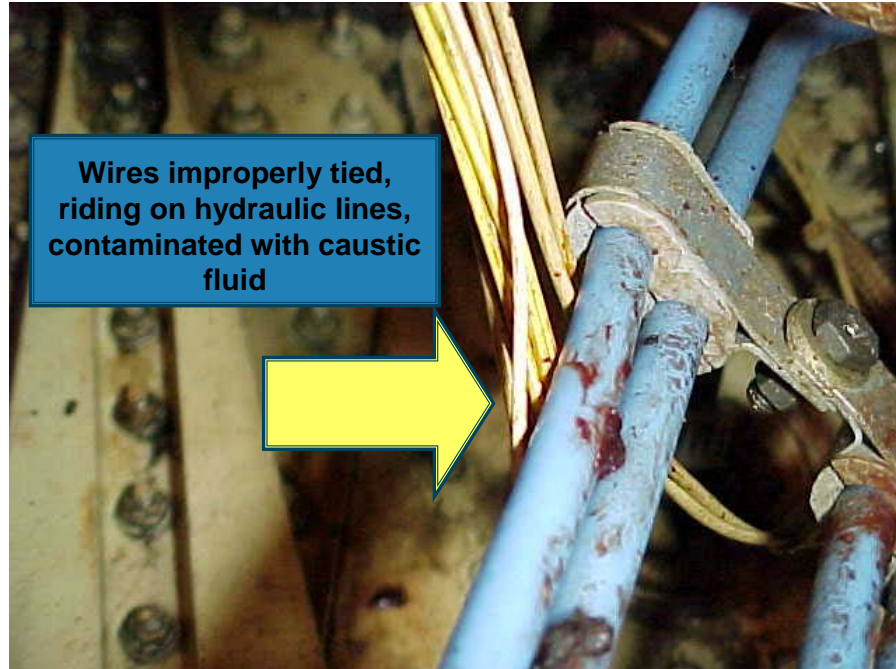
Figure 4. Wires Improperly Routed (Aircraft Wiring Practices, 2002).

Figure 4 shows wires in a bundle not properly routed (Aircraft Wiring Practices, 2002)

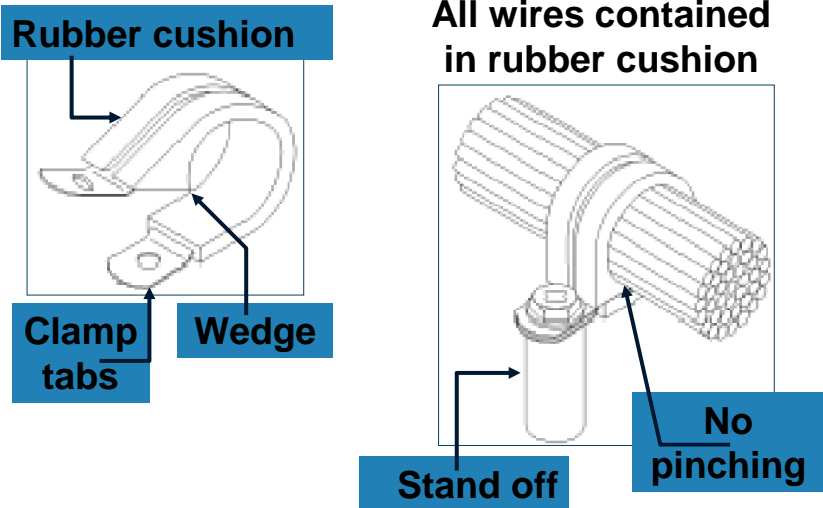
Figure 5. Typical Rubber Clamp (Aircraft Wiring Practices, 2002).

Figure 5 illustrates a typical rubber clamp (Aircraft Wiring Practices, 2002).

Clamp pinching is a frequent problem in aircraft wiring. This takes place when there is too much wiring in a clamp or when the clamp is not properly installed. To solve this problem, clamps on wire bundles should be chosen to have a snug fit without pinching wires (Aircraft Wiring Practices, 2002).

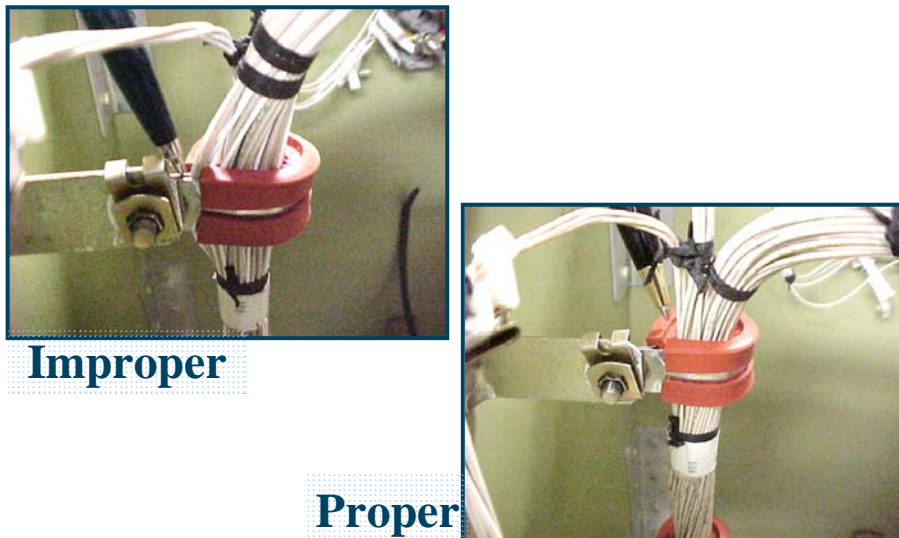
Figure 6. Clamping (Aircraft Wiring Practices, 2002).

Figure 6 shows the correct method for clamping wires (Aircraft Wiring Practices, 2002).

Clamps lined with nonmetallic material should be used to support the wire bundle along the run. Tying may be used between clamps but nonetheless it should not be regarded as a substitute for adequate clamping. Adhesive tapes are prone to age deterioration and are not acceptable as a clamping means.

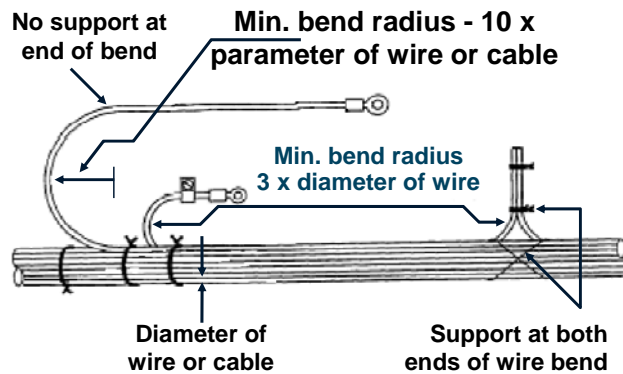
Figure 7. Minimum Bend Radii (Aircraft Wiring Practices, 2002).

According to Advisory Circular (AC) 43.13-1b, the minimum radius for bends in wire groups or bundles should not be less than 10 times the outside diameter of the largest wire or cable. The only exceptions are at terminations (3 times the diameter), RF cables (6 times the diameter), and thermocouple wires (20 times the diameter).

Figure 7 illustrates the proper bend radii for three different wiring scenarios (Aircraft Wiring Practices, 2002).

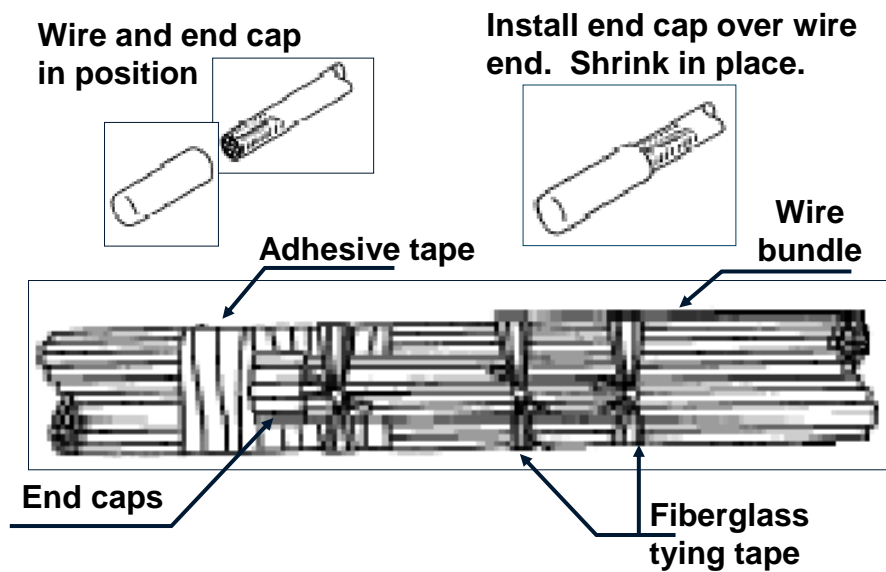
Figure 8. Spare Wire Termination Using Endcap (Aircraft Wiring Practices, 2002).

Installing prefabricated end caps is an efficient way of protecting unused wires with exposed conductors. Coil and stow methods are utilized to secure the excess length of a wire bundle or to secure wires bundles that are not connected to any equipment for future installations (Aircraft Wiring Practices, 2002).

Figure 8 illustrates an example of the use of a prefabricated end cap (Aircraft Wiring Practices, 2002).

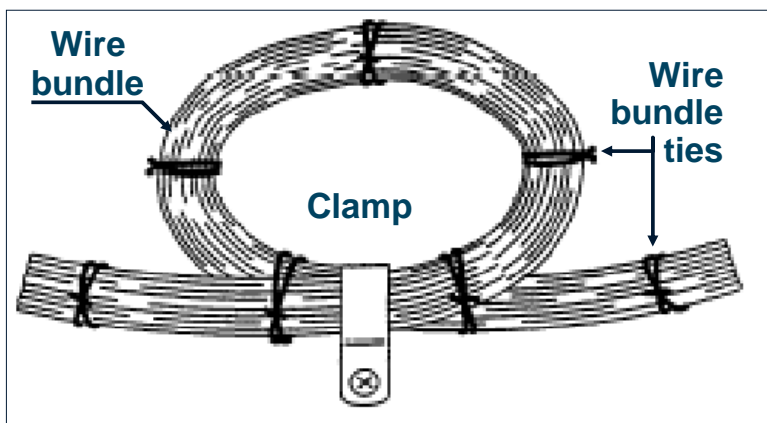
Figure 9. Coil and Stow Methods (Aircraft Wiring Practices, 2002).

Figure 9 shows coil and stow methods used to secure wire bundles (Aircraft Wiring Practices, 2002).

Coil and stow short/long wire bundles in low vibration areas

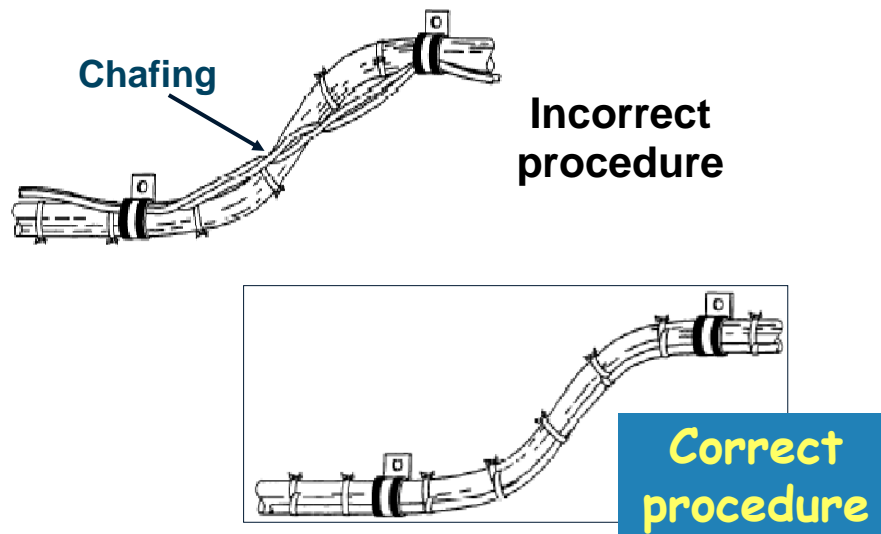
Figure 10. Adding or Replacing Wires on a Bundle (Aircraft Wiring Practices, 2002).

Wires that are added or replaced on a wire bundle should be routed in the same way as the other wires in the wire bundle.

Figure 10 illustrates the correct procedure for wire replacement (Aircraft Wiring Practices, 2002).

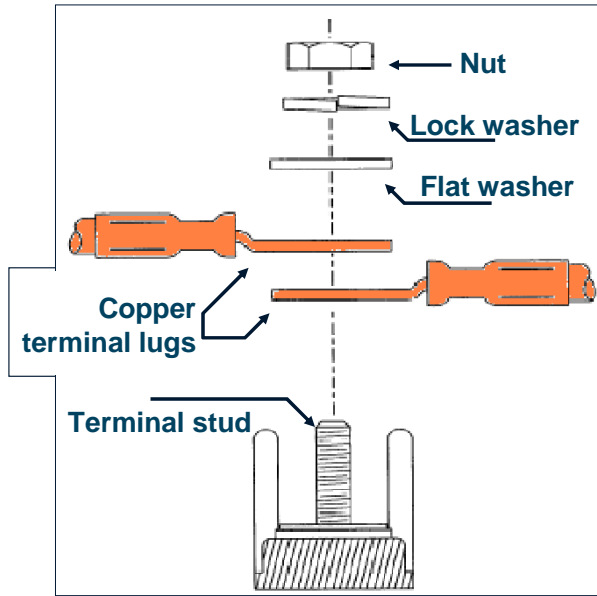
Figure 12. Terminal Stacking Like Materials (Aircraft Wiring Practices, 2002).

Terminals that are made of like materials can be stacked directly on top of each other. On the other hand, terminals that are made of unlike materials, for example aluminum and copper a cadmium-plated flat washer is used to isolate the dissimilar metals. A terminal that is completely assembled should have a minimum of two to three threads showing on the stud when the nut is torqued properly.

Figures 12 and 13 illustrate terminal stacking materials and methods (Aircraft Wiring Practices, 2002).

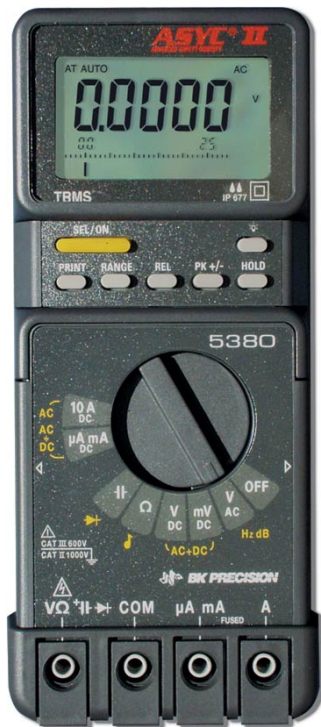
Figure 14. BK 5380 Digital Multimeter

chip testing modes. Digital multimeters display measurement values on a digital screen. In general, the multimeters have between three and six digits but some units will have larger screens that can display seven or more digits (GlobalSpec, 2004).

Figures 14 and 15 show examples of digital and analog multimeters (Tequipment.net, 2004).

Handheld multimeters are used in aircraft wire testing for identification of open or short circuits, indication of fault, indication of wire insulation degradation, and isolation of intermittent faults (D'Angelo et al., 2001).

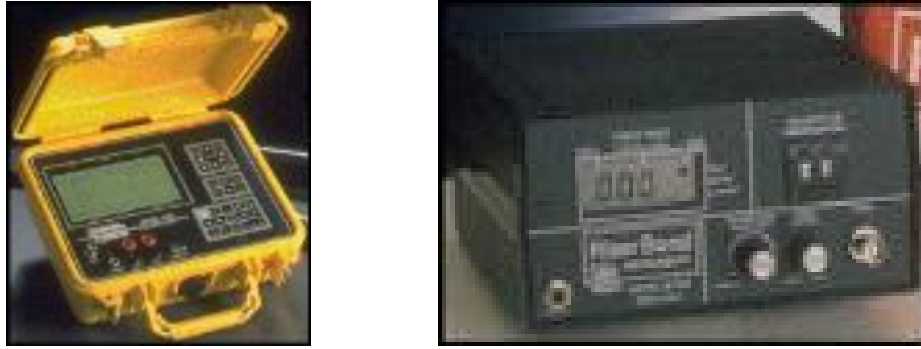
Figure 16. Types of Time Domain Reflectometers (Riserbond, 2004).

A time domain reflectometer can display the information it receives in two formats. The first and more conventional method is to display the actual waveform of the wire. The display, which is either a cathode ray tube or a liquid crystal display, will show the transmitted pulse generated by the time domain reflectometer and any reflections that are caused by impedance changes along the length of the wire. The second method is a numeric readout that specifies the distance in feet or meters to the first major reflection caused by a fault along the wire. Some time domain reflectometers will identify if the fault is an open or short circuit.

Figure 16 shows the different types of time domain reflectometers (Riserbond, 2004).

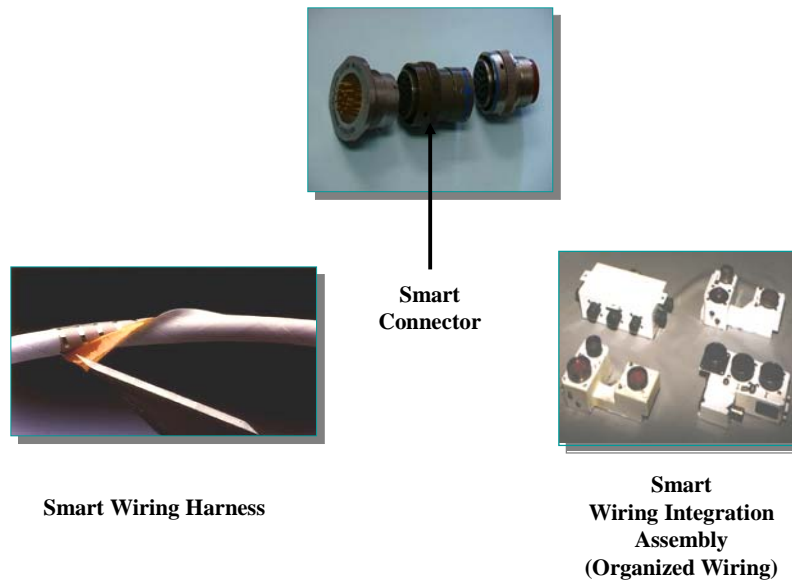
Figure 18. Smart Wiring Technology Subcomponents (Arnason, 2001).

3. Data collection system – smart wiring technologies carry out baseline measurements and direct readings with sensors to resolve if a wiring connector, the wiring itself, or the unit repaired is at fault or degraded.

Figure 18 shows the subcomponents of smart wiring technology (Arnason, 2001).

Sensors used in the smart wiring technology weigh just a few ounces using Micro Machined Electromechanical Systems (MEMS) and Application Specific Integrated Circuits (ASIC) that weigh just a few milligrams each. Data acquired from the sensors are accessible for either on-board or off-board analysis and is used by prognostic algorithms to determine the health of the aircraft wiring (Tambouratzis, 2001). Data retrieved from the sensors is collected by one of several methods, which consist of RF radio link, infrared link, and direct interface to a technician's personal or hand held computer (Blemel, 2000).

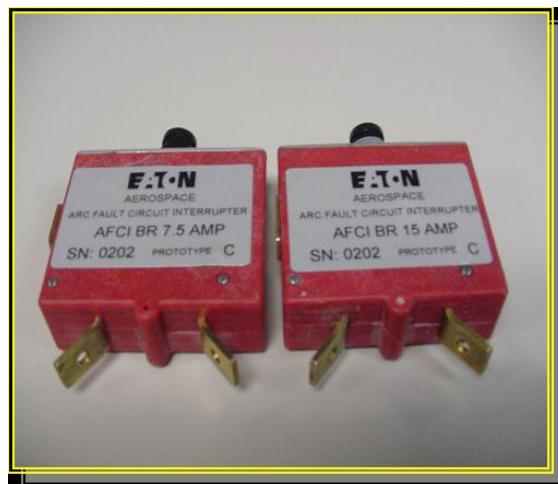
Figure 19. Eaton Arc Fault Circuit Breakers (Arnason, 2001).

Most testing of the arc fault circuit breakers has been carried out by the commercial airline industry with several aircraft firms using them on an experimental basis. Quantas Airlines has flown more than 1,000 hours on an arc fault circuit breaker designed by Eaton Aerospace, whereas Delta Airlines has already started installing them aboard their Boeing 737s (Phillips, 2004).

Figure 19 shows Eaton arc fault circuit breakers (Arnason, 2001).

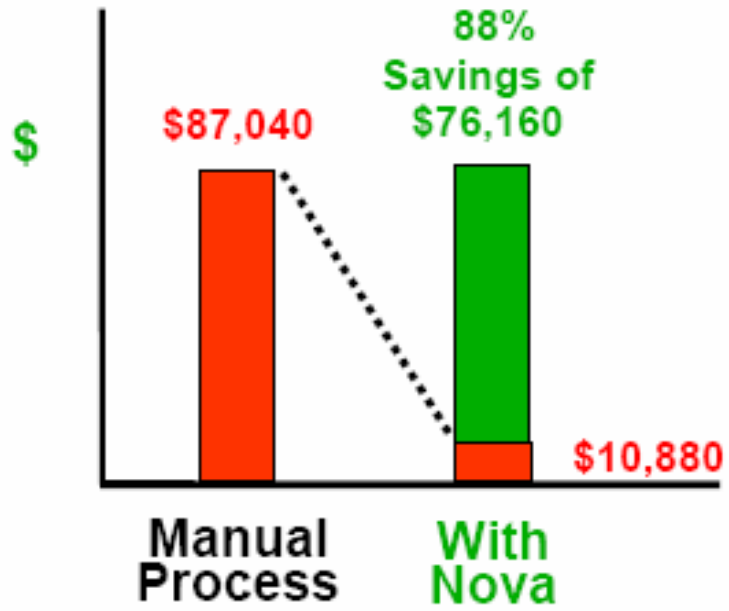
Figure 20. Troubleshooting Time Costs for an Average Narrow Body Aircraft (Overview of Nova, 2002).

Honeywell claims, “ about 3-10% of all maintenance hours are spent on wiring and estimates that manual troubleshooting of an average narrow body aircraft could be reduced by 88% (from \$87,040 to \$10,880) over a period of four years (Rosenberg, 2001). The end result is effective preventive maintenance; locating wiring faults and preventing accidents, while cutting down on operational costs.

Figure 20 illustrates troubleshooting time costs for an average narrow body aircraft over four years (Overview of Nova, 2002).
