*International Journal of Architectural Heritage, 10(4): 499-515 (2016)*

## **“Earthquake Protection of Colonial Bell-Towers in Colima, Mexico with Externally Prestressed FRPs”**

**Preciado, A., Budelmann, H. and Bartoli, G. (2016). “Earthquake protection of colonial bell towers in Colima, Mexico with externally prestressed FRPs.” *International Journal of Architectural Heritage, 10(4): 499-515, ISSN: 1558-3058***

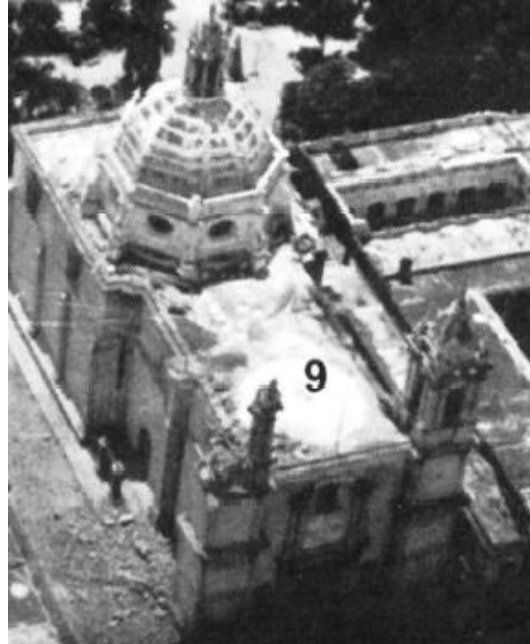
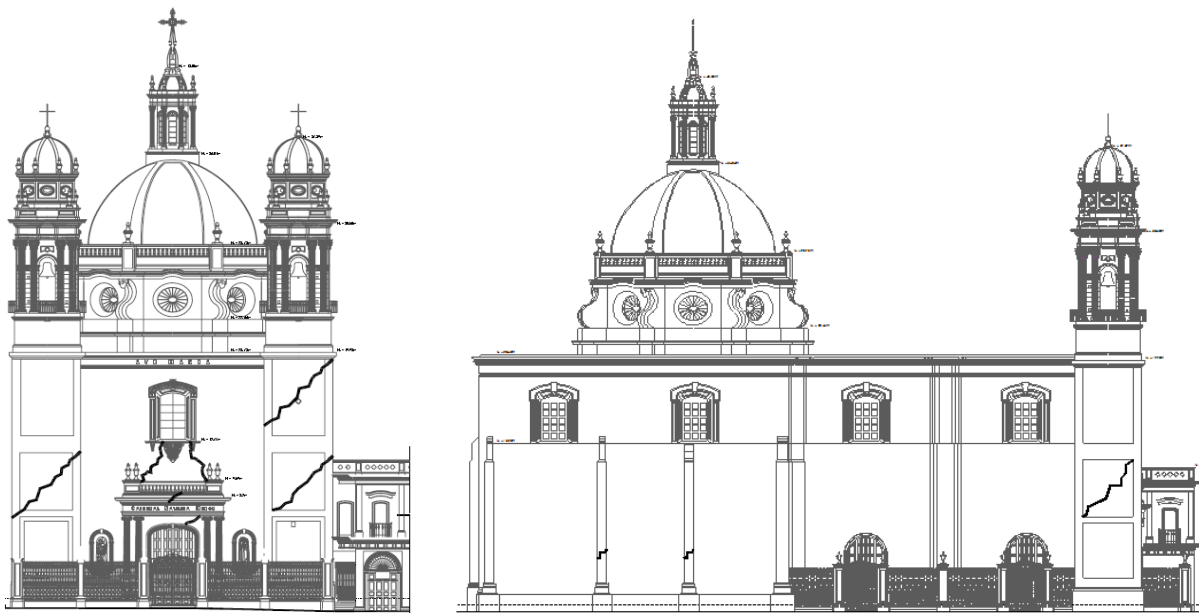
Figure 1: The Cathedral of Colima; (a) observed damage after the 1941 M7.6 earthquake and (b) crack pattern by the 2003 M7.5 earthquake

Both bell-towers of the Cathedral of Colima “*Basílica Menor de Guadalupe*” (Figs. 1 and 3) are selected as case study of this research because of the strong observed damage due to historical EQs, showing once almost a total collapse of the left tower (Fig. 1a). The Cathedral is located in the historical center of Colima City (Fig. 2) and approximately built in 1889 with two bell-towers at the main façade. The building is considered as the most important Colonial monument of Colima by its great historical and cultural value.

About 10 years after its construction the building was damaged by an EQ, presenting moderate damage at both towers and cupola but strong non-structural damage. In 1941 occurred a M7.6 EQ generated by the subduction of the Cocos plate beneath the North American plate. The strong ground motion was felt in the city with an intensity of X (Table 1). It highly damaged the building, generating important cracking at walls, cupola, vaults and the partial collapse of the left tower. The belfry collapsed almost totally, falling down in a highly transited street (see Fig. 1a), causing for luck just small injuries to some pedestrians.

For the tower's reconstruction, materials with similar characteristics were used. Afterwards, in 2003 the city was struck again by another important EQ with the same rupture mechanism of the occurred in 1941. The M7.5 EQ was felt this time with lower intensity (VIII) but caused strong damage to the entire building especially at both bell-towers (see Fig. 1b). The restoration and

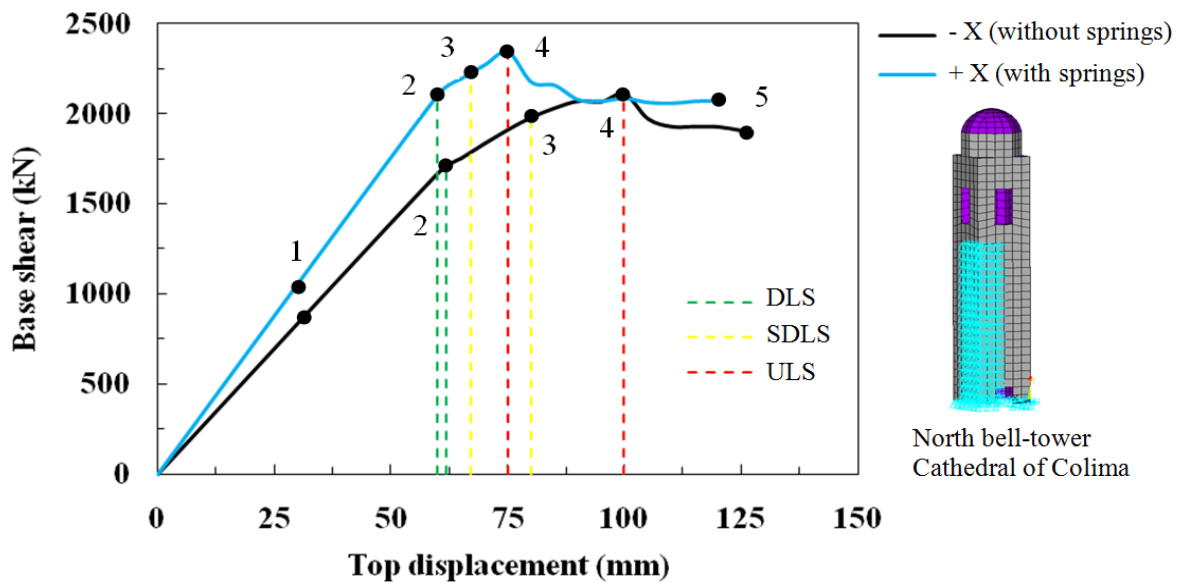
Figure 7: Comparison of capacity curves in original state for a seismic action in  $-X$  and  $+X$  with the damage grades (EMS-98) and limit states (EC-8)

capacity curves illustrated in Figure 7. It is worth noting that the left tower under seismic action in  $-X$  direction presents at ULS a maximum displacement of 100 mm and a lateral force of 2741 kN. Compared to the brittle constrained  $+X$  model, the  $-X$  model presents its characteristic bending behavior due to the disconnection with the façade, represented by 25% of more displacement capability (see Table 5). The  $+X$  model is more resistant to horizontal loading (12%), but less ductile, which is not relevant for seismic energy dissipation purposes, it is more important to reach more ductility with no brittle failure. For this purpose, the technique of prestressing is quite helpful to reach a seismic upgrading of URM structures by increasing strength, ductility and internal confinement.

In order to have comparative indicators of performance it is included at the capacity curves the EQ performance limit states established by the European Code (EC-8) (Eurocode 8, 2004); the damage limit state (DLS) at first yielding; significant damage limit state (SDLS) representing significant damage and the ultimate limit state (ULS) near collapse. Moreover, these limit states

at the capacity curves are correlated to the damage grades (DG) DG2, DG3 and DG4 proposed by the European Macroseismic Scale (EMS-98) reported in Grünthal (1998). For having quantitative indicators of performance at the capacity curves, it is included the seismic coefficient (CS) determined by the ratio between the ultimate lateral force and the vertical loading. The seismic coefficient is typically expressed as a fraction or percentage of the gravity (g). The main drawback of this indicator is that only the lateral strength of the structure is evaluated, disregarding the displacement and ductility which is extremely important in the EQ assessment of structures for energy dissipation capabilities (see Tables 5 and 6).

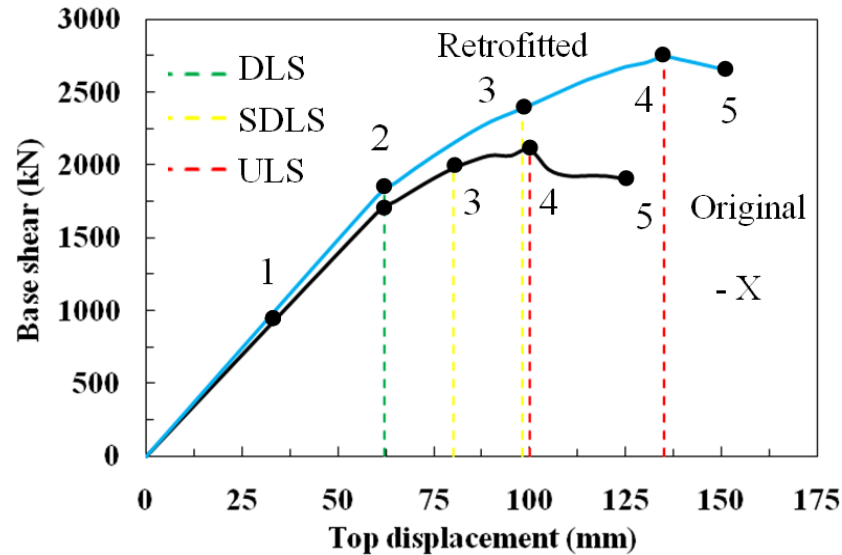
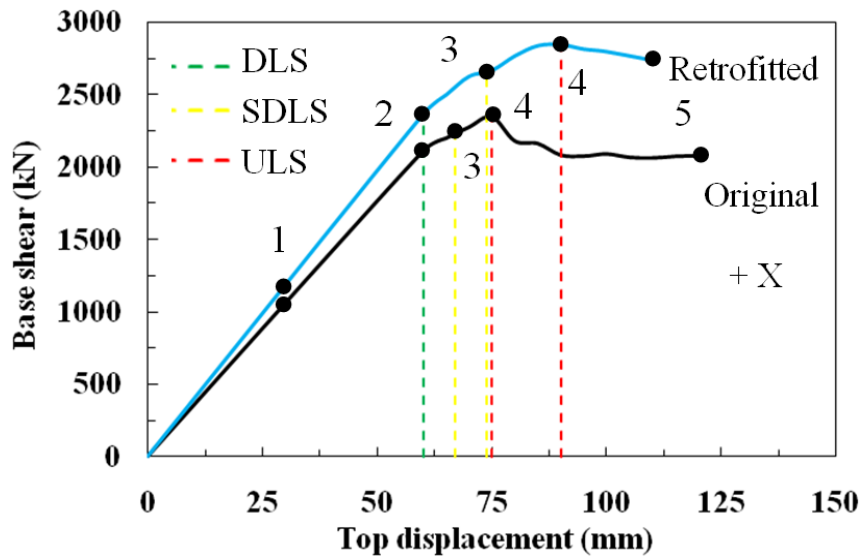
Figure 8: Comparison of capacity curves in original state and retrofitted (0.30Fv) with the damage grades (EMS-98) and limit states (EC-8): (a) -X and (b) +X springs

For similitude of results only the corresponding to the high prestressing level are presented ( $0.30F_v$ ). It is worth noting at the comparative of failure mechanisms of Figures 5, 6 and 8 that prestressing considerably reduces damage at belfry. The seismic performance is enhanced by increasing force, displacement and confinement as shown at the comparative of capacity curves of Figure 8 and Tables 5 and 6. It is observed an upgrading of 35% of displacement (30.2% of force) at the  $-X$  model and 20% of displacement (21.5% of force) at the constrained  $+X$  model. With these results it is corroborated that external vertical prestressing allows a substantial

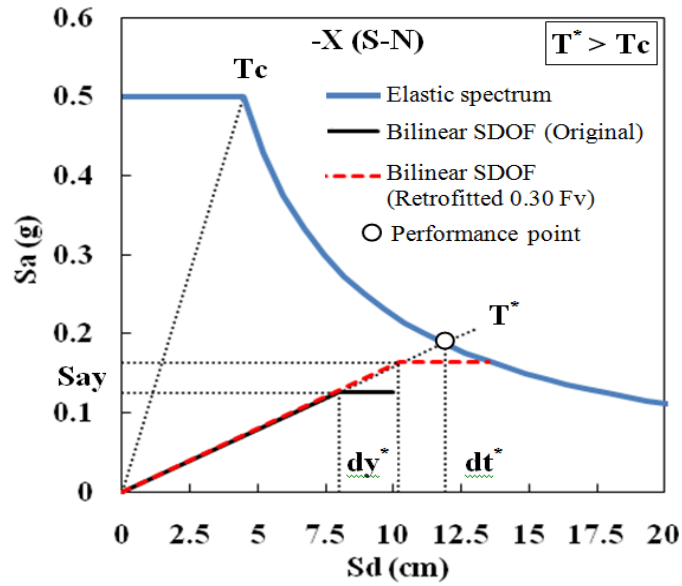
Figure 9: Seismic evaluation of the north bell tower of the Cathedral of Colima by the Capacity Spectrum method: (a)  $-X$  direction and (b)  $+X$  direction (springs)

Figure 9 illustrates the converted capacity curves of the -X (disconnected) and +X (constrained) models, as well as the elastic response spectrum based on the seismic hazard characterization of Section 3. Since  $T^* > T_c$ , the target displacement is directly obtained without reducing the elastic response spectrum. Figure 9 illustrates the transformed capacity curves into bilinear curves of the -X and +X model for computing the ductility available against the seismic demand. The maximum reached displacement  $dm^*$  for both models (-X and +X) is not enough to withstand the seismic demand represented by the target displacement  $dt^*$  (performance point). The maximum performance of the -X model is of about 19% less than the required performance and even more drastic the +X model with a poor performance in the order of 40% (Table 7). The -X model fails more ductile than the +X model as depicted on Figures 5a and 6a. The +X model presents flexural cracks at the lower part of the body and failure of belfry by a combination of bending and shear stresses that allowed it to perform better than the +X model, which fails by shear stresses at belfry.
