OKLAHOMA AGRICULTURAL AND MECHANICAL COLLEGE
AGRICULTURAL EXPERIMENT STATION

in cooperation with
SOIL CONSERVATION SERVICE
U. S. DEPARTMENT OF AGRICULTURE

TESTS ON VEGETATED WATERWAYS

MAURICE B. COX

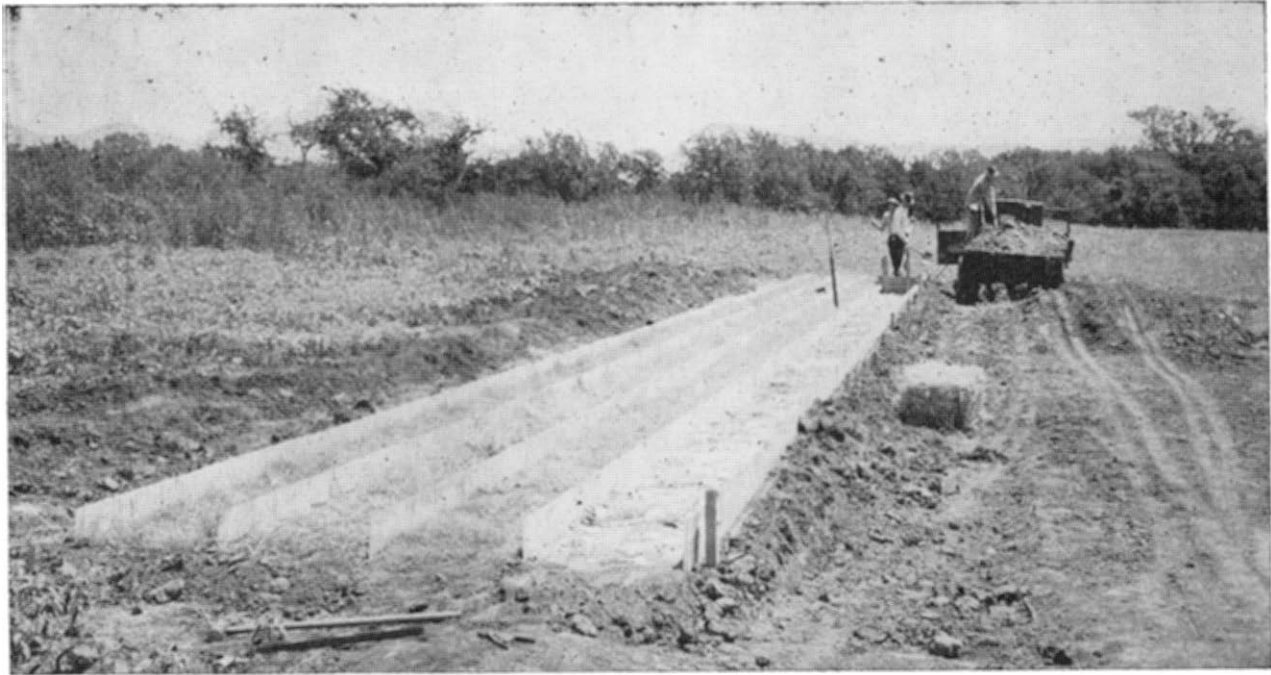
Figure 2.—Installing a channel on one percent slope, using 2" x 12" boards to hold the sheet iron separators to true alignment.

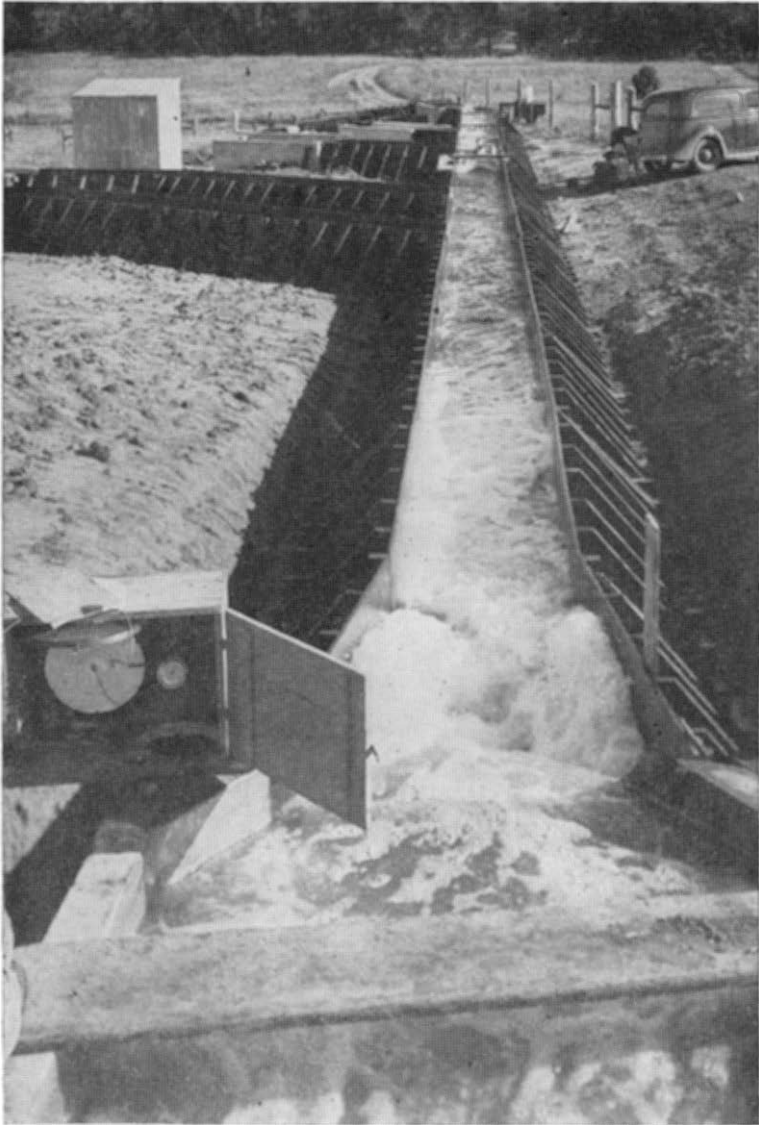
Figure 4.—A flow of 22 cubic feet per second through the type "H" rate-measuring flume and the wood flume used to convey the water to the test channels.

The method employed to measure the flow (Q) through the 3-foot type H rate measuring flume and the wood flume used to convey the water to the test channels is shown in Figure 4. The wood flume was constructed of flooring and made water tight by the use of a thick coat of asphalt.

The tests were conducted by flows of given quantities of water down each of the channels for 30-minute periods, during which time measurements were made of the rate and the cross-sectional area of the flow along the channel. Each flow was established through the measuring flume and conducted through the wood flume to a concrete forebay; from there it was directed to the test channel by a movable duct (Fig. 5). The use of movable gates along the conveying flume made it possible to establish flows through an idle forebay before it was released into the test channel, and also made it possible to shut off the flow at the termination of a test.

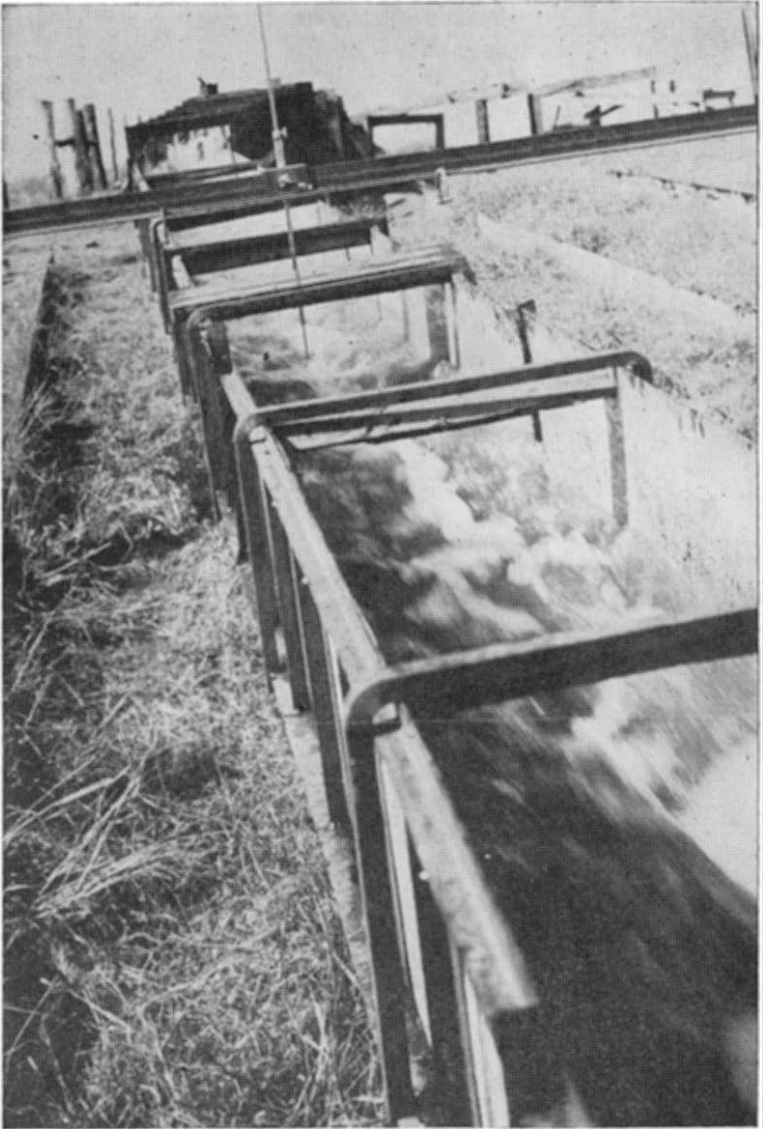
Figure 5.—A very turbulent flow at about 11 feet per second down a 10 percent slope. Note point gage mount and movable duct used to connect upper end of the channel to the concrete forebay.

The cross-sectional area of the flow was measured by the use of point gages mounted on angle iron supports as shown in Figures 5, 6, and 7. Point gage measurements were taken at 0.2-foot intervals across the bottom of the channel before and after each run (Fig. 7), and two sets of readings were taken at the same intervals across the surface of the water during the run. The first set was taken immediately after the flow was established and the second set was taken just before the flow was shut off (Fig. 6). The width of the channel was carefully measured at the bottom and at the surface of each flow at each point gage location.
