Selected Muslim Historic Monuments and Sites in Bulgaria

Samuel D. Gruber

United States Commission for the Preservation of America's Heritage Abroad

SELECTED MUSLIM HISTORIC MONUMENTS AND SITES IN BULGARIA

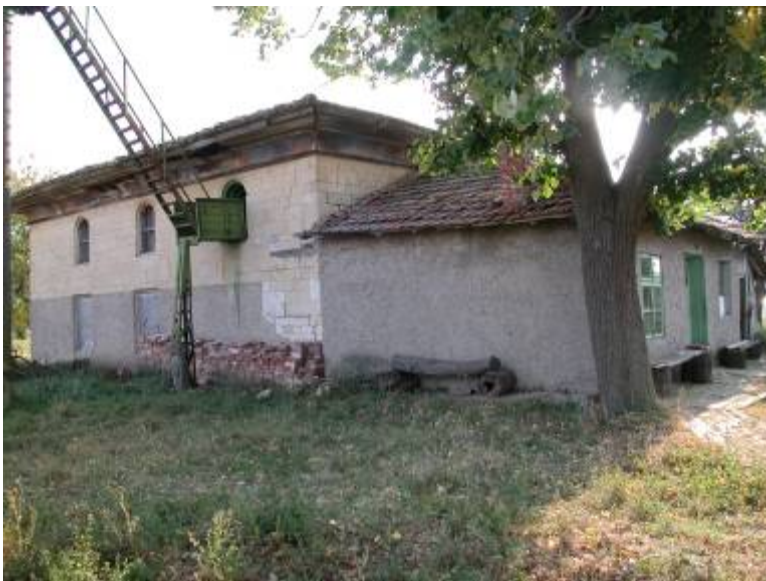
Examination of the exterior shows severe buckling of the walls, possibly due to a poor foundation and shifting soil, a common problem in northeast Bulgaria. Walls need to be reinforced, the gutters should be replaced, the roofing redone, and the foundation may need stabilization.

Oblique view from left. Note bricked-in portico, improvised access to minaret, cracks and buckling at left front corner, and laying of brick in an attempt to shore up wall.
