EARTHQUAKE ENGINEERING RESEARCH LABORATORY

VIBRATION TEST OF A MULTISTORY BUILDING

June 1967

VIBRATION TESTS OF A MULTISTORY BUILDING

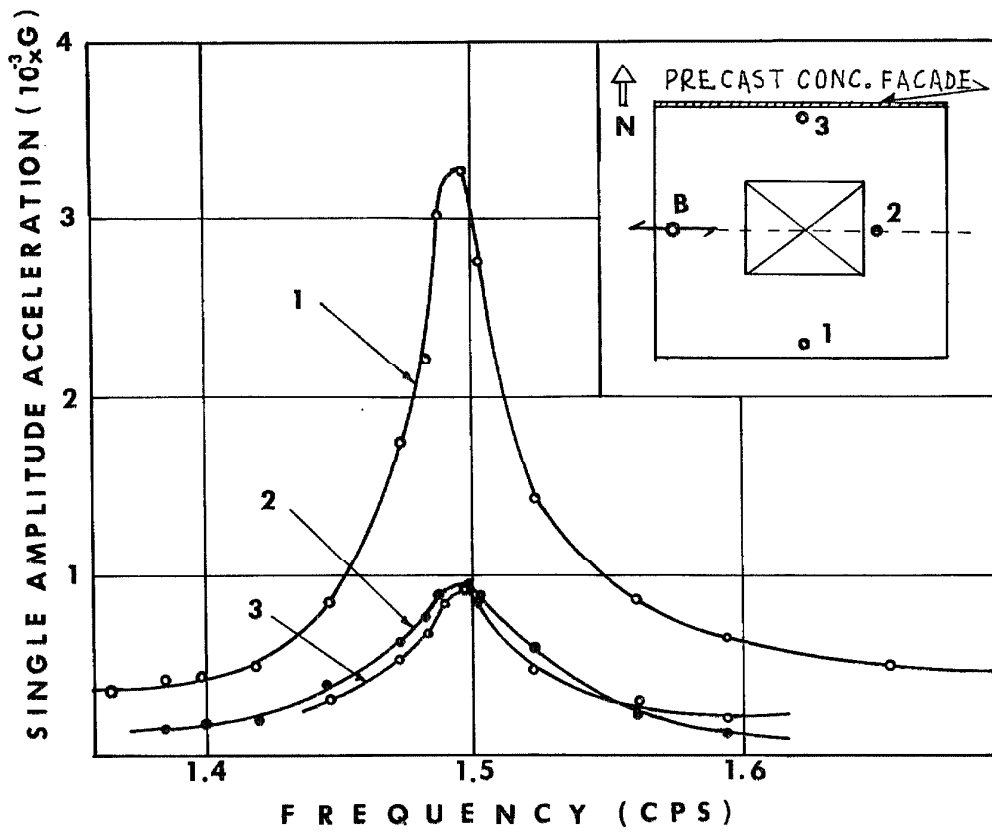
Fig. 7a-1. INFLUENCE OF THE NORTH SIDE WINDOW PANELS ON THE RESPONSE OF THE 9th FLOOR IN THE LOWEST TRANSLATIONAL MODE, E-W DIRECTION

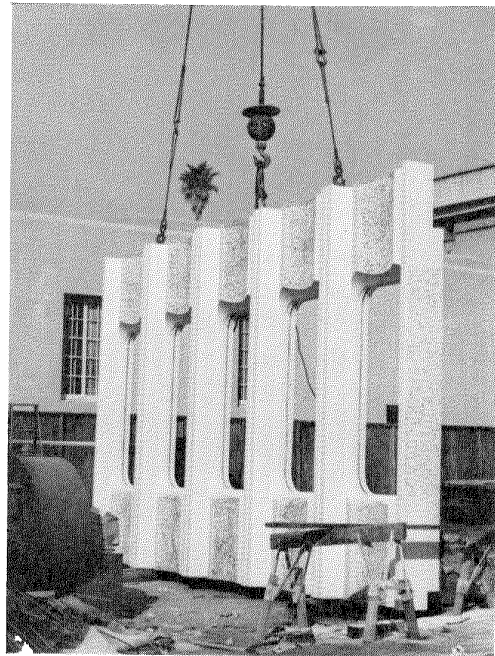
Fig. AV-7. ONE OF THE PRECAST CONCRETE WINDOW WALL PANELS.

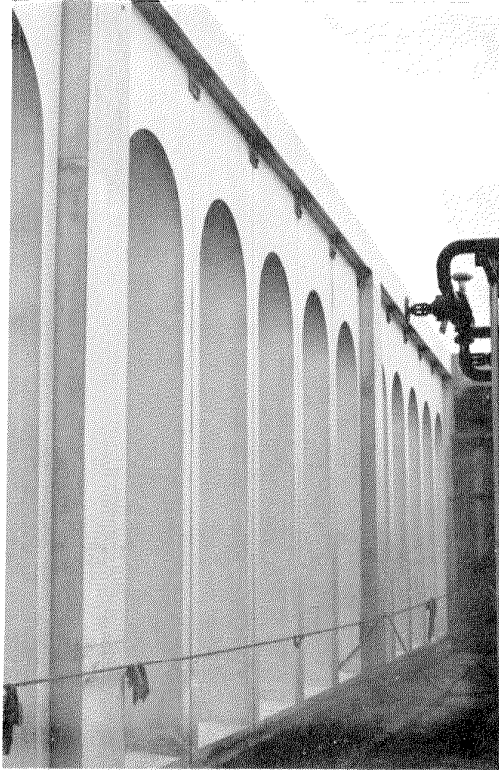
Fig. AV-10. NORTH SIDE ROOF PANEL, LOOKING FROM THE INSIDE OF THE BUILDING. NOTE THE STEEL CONNECTION BETWEEN THE TOP BEAM AND THE PRECAST WINDOW WALL PANELS.
