# The Costs of Facility Development: A Comparative Analysis of Public and Private Sector Facility Development Processes and Costs

Jeffrey A. Lackney

**April 1994**

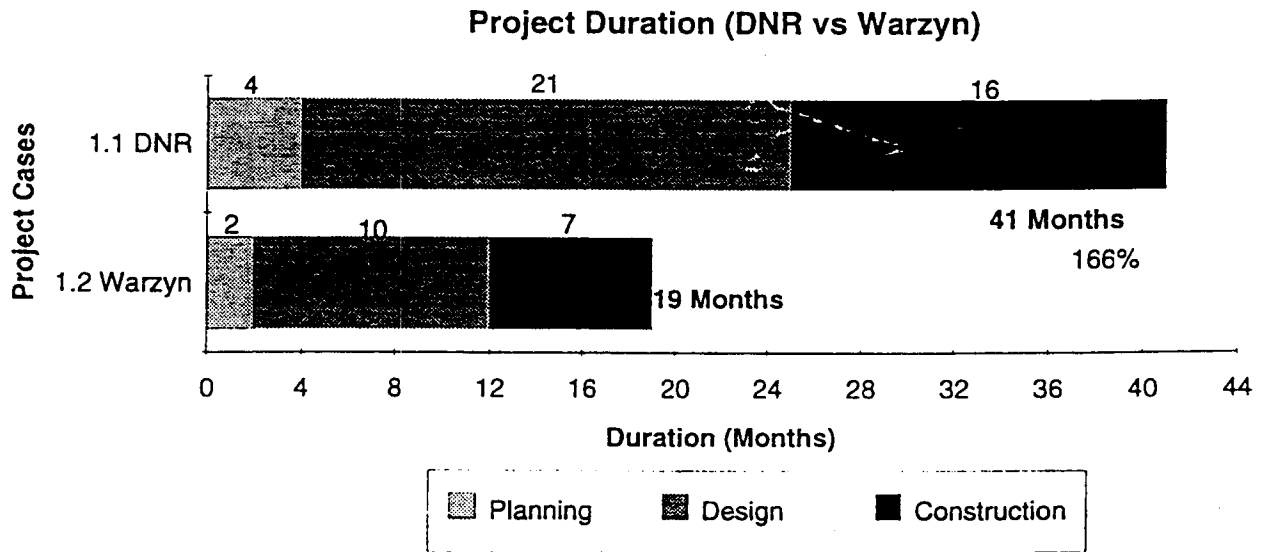
The following is a comparison of the duration of planning, design and construction activities that took place during the Facility Development Process.

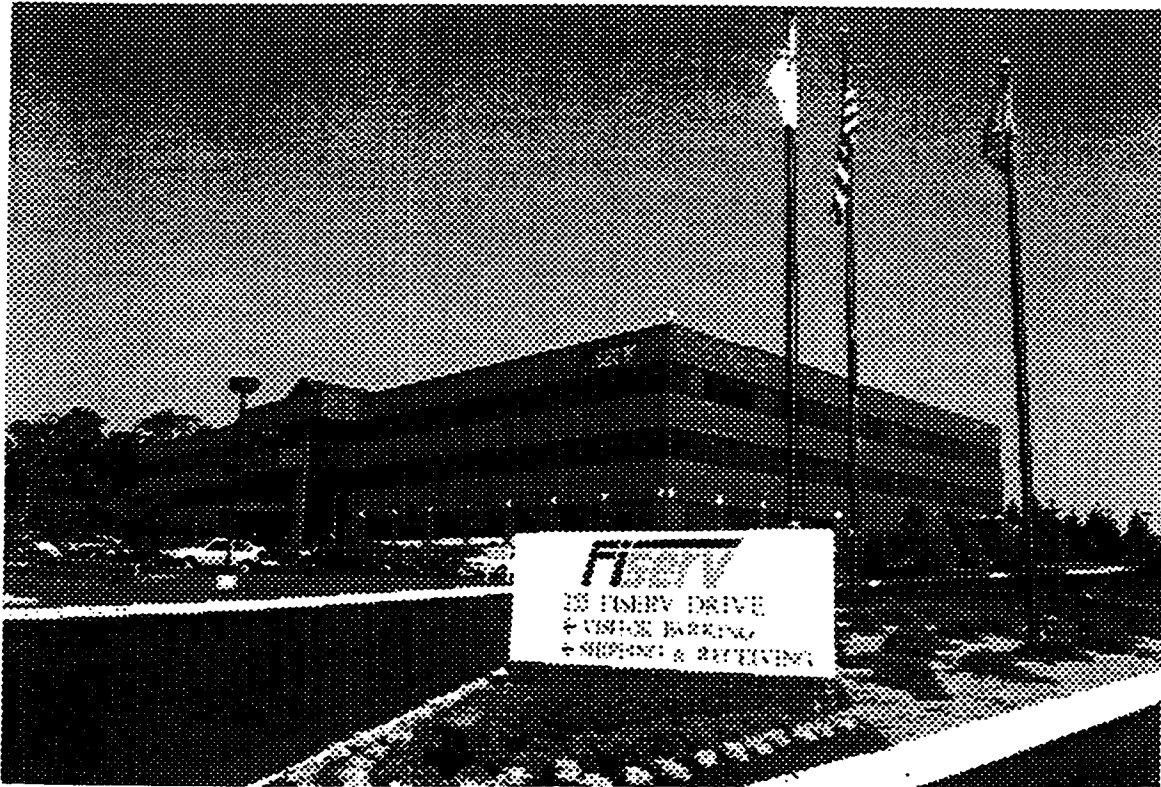
Private Sector Case Study #2-2  
**FISERVE CORPORATE HEADQUARTERS BUILDING**

<b>Client</b>	Fiserv, Inc., Brookfield, Wisconsin
<b>Architect</b>	Kahler Slater, Milwaukee, Wisconsin
<b>General Contractor</b>	Jansen Construction, Brookfield
<b>Project Description</b>	
Program	The program called for a three-story building containing executive offices, conference rooms, various storage rooms and support space, a cafeteria (no kitchen), and a large computer room with special air conditioning requirements. The project also called for extensive landscaping and a 300 stall surface parking lot on the chosen 20 acre site.
Year Constructed	1992
Gross Square Footage	112,786 GSF
<b>Project Costs</b>	
Building Cost	\$6,768,105
Construction Cost	\$7,615,201
Total Project Cost	\$8,197,062

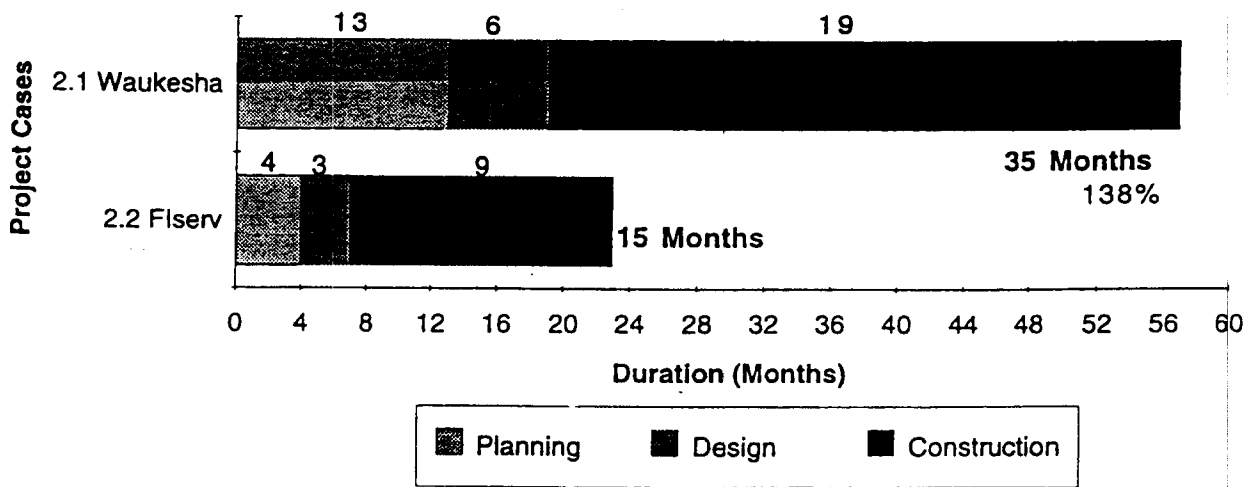
The following is a comparison of the duration of planning, design and construction activities that took place during the Facility Development Process:

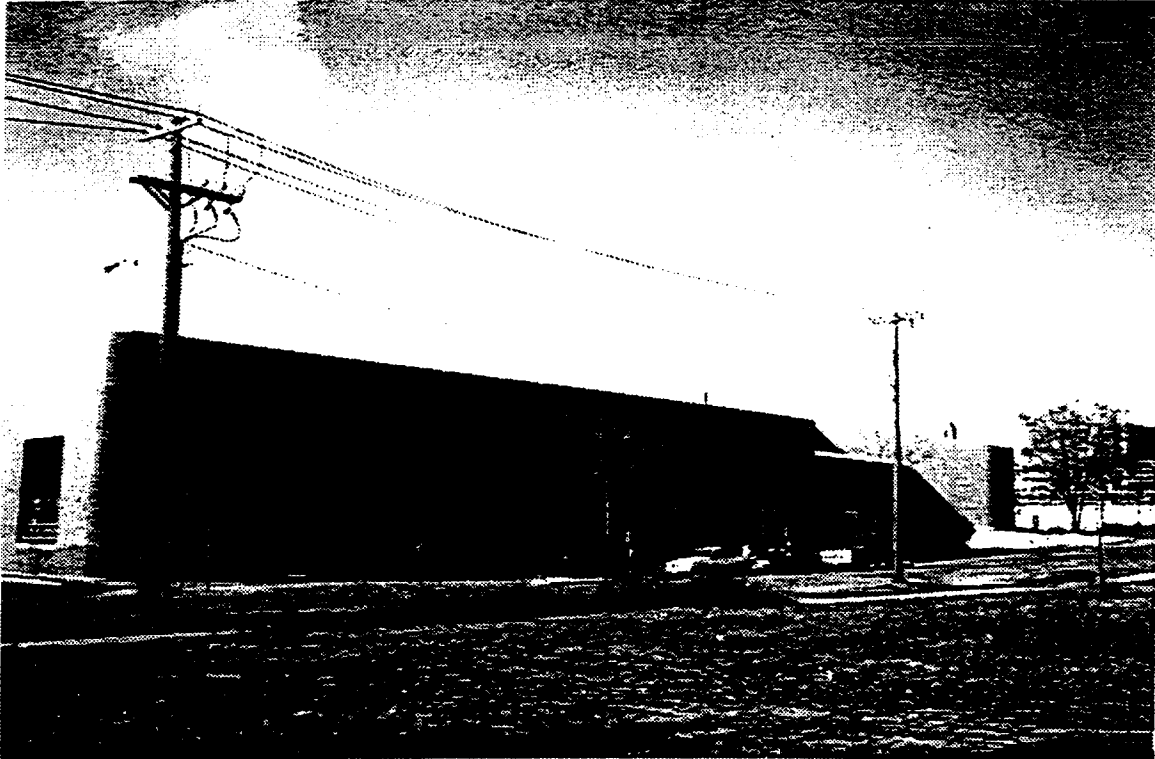
Public Sector Case Study #3-1  
STORES/EXTENSION SERVICES FACILITY

<b>Client</b>	University of Wisconsin System Administration and the State of Wisconsin, Department of Administration and the Division of Facilities Development
<b>Architect</b>	Krueger Shutter & Associates, Inc., Madison, WI
<b>General Contractor</b>	Corporate Construction Ltd.
<b>Project Description</b>	The stated purpose of the project was to combine the existing Stores merchandising operation with University Extension Services (presently housed at five locations) into a new, safe, and efficient facility. The program called for space to house unheated warehouse space, heated warehouse space, offices, and printing, mailing and labeling workareas to be shared by both operations in a single facility.
<b>Program</b>	
<b>Year Constructed</b>	1985
<b>Gross Square Footage</b>	59,632 GSF
<b>Project Costs*</b>	
Building Cost	\$2,628,042
Construction Cost	\$2,887,047
Total Project Cost	\$3,132,883

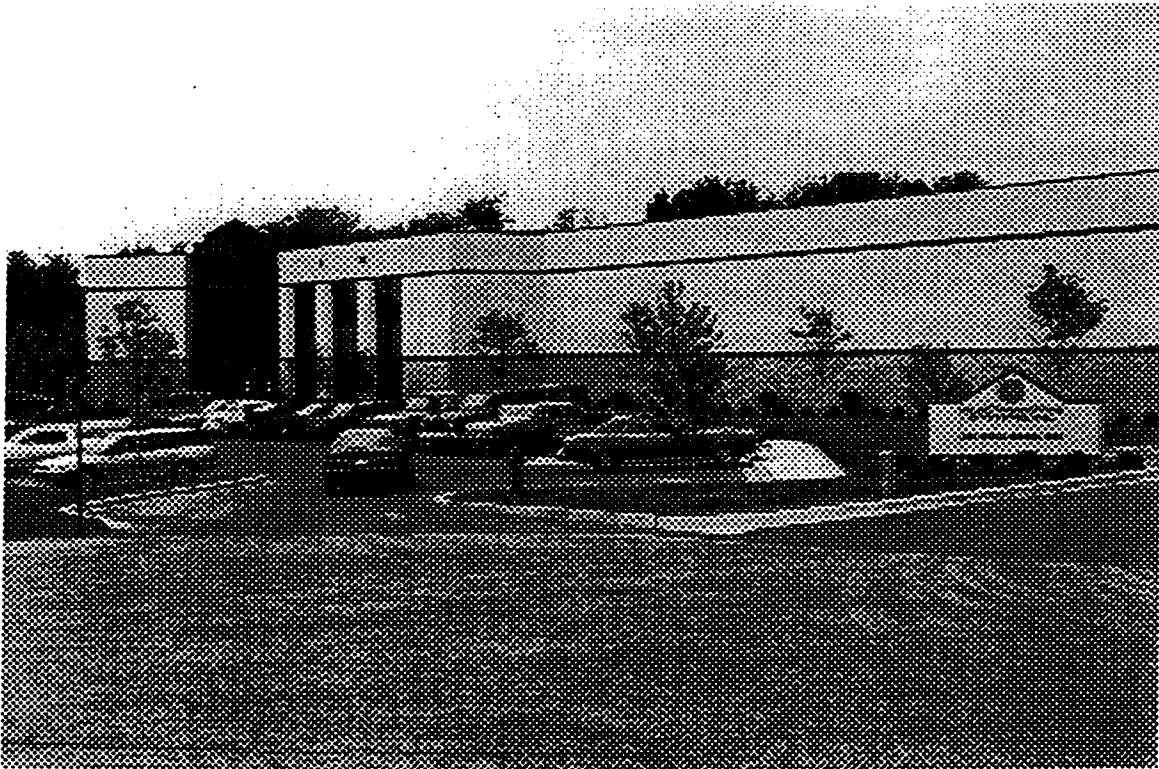
**Private Sector Case Study #3-2  
ELECTROMOTIVE SYSTEMS FACILITY**

<b>Client</b>	Electromotive Systems, Inc., Menomonee Falls, Wisconsin
<b>Architect</b>	Eppstein, Keller, Uhen Architects, Milwaukee, Wisconsin
<b>General Contractor</b>	Berghammer, Milwaukee, Wisconsin
<b>Project Description Program</b>	The program called for a new central facility that would combine service, manufacturing, and office administration functions. In addition, the facility would need to allow for the option of expanding the warehouse facility area within three to five years.
<b>Year Constructed</b>	1993
<b>Gross Square Footage</b>	47,545 GSF
<b>Project Costs</b>	
Building Cost	\$1,605,413
Construction Cost	\$1,739,023
Project Cost	\$1,889,023

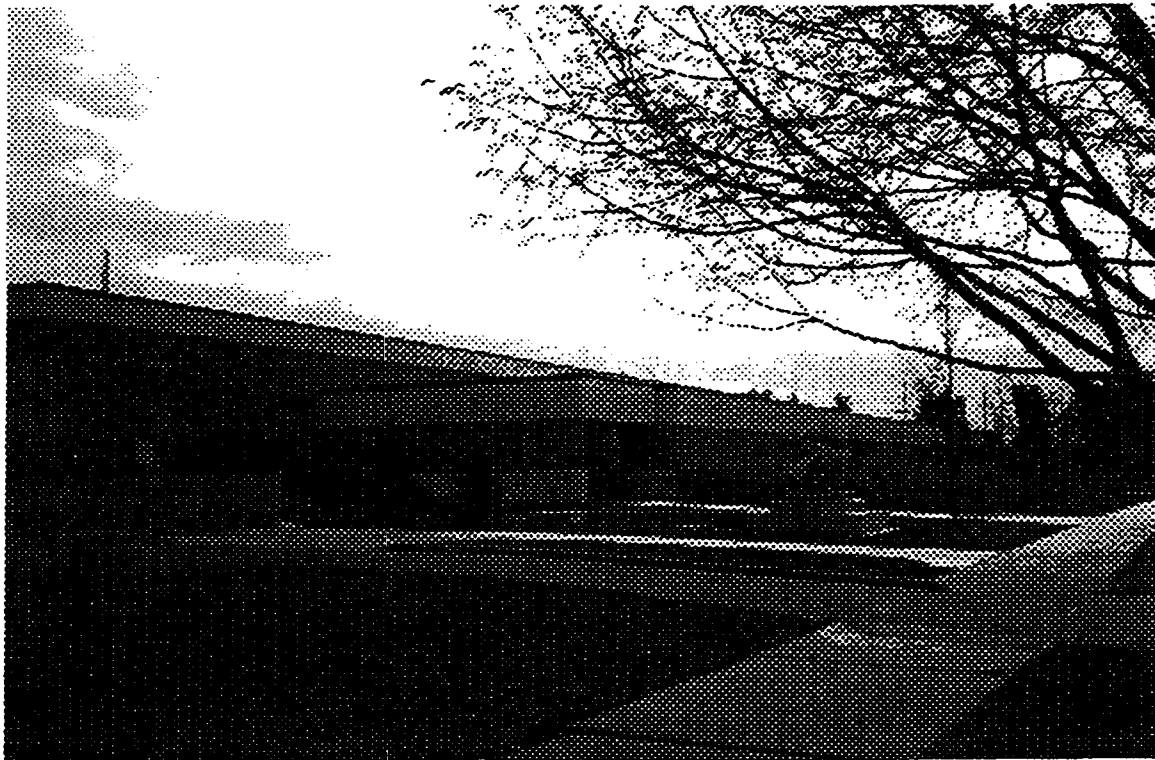
Public Sector Case Study #5-1  
**McPHEE PHYSICAL EDUCATION CENTER ADDITION**

<b>Client</b>	Agency Client: University of Wisconsin-Eau Claire The University of Wisconsin-System Administration and the State of Wisconsin, Department of Administration, Division of Facility Development, Madison, Wisconsin
<b>Architect</b>	Seymour Davis Seymour, A.E., Inc. Eau Claire, WI
<b>General Contractor</b>	Boldt Construction
<b>Project Description</b>	
Program	The program called additional space for: a gymnasium, one classroom, eight handball courts, diving well, weight room, training room, locker rooms and dressing areas, storage room, a mezzanine track, and eight faculty offices. A two-story facility would be constructed on the site adjacent to the existing McPhee physical education building and connected minimally with a glass corridor link at the gymnasium ground floor level.
Year Constructed	1987
Gross Square Footage	79,500 GSF
<b>Project Costs*</b>	
Building Cost	\$4,070,371
Construction Cost	\$4,329,383

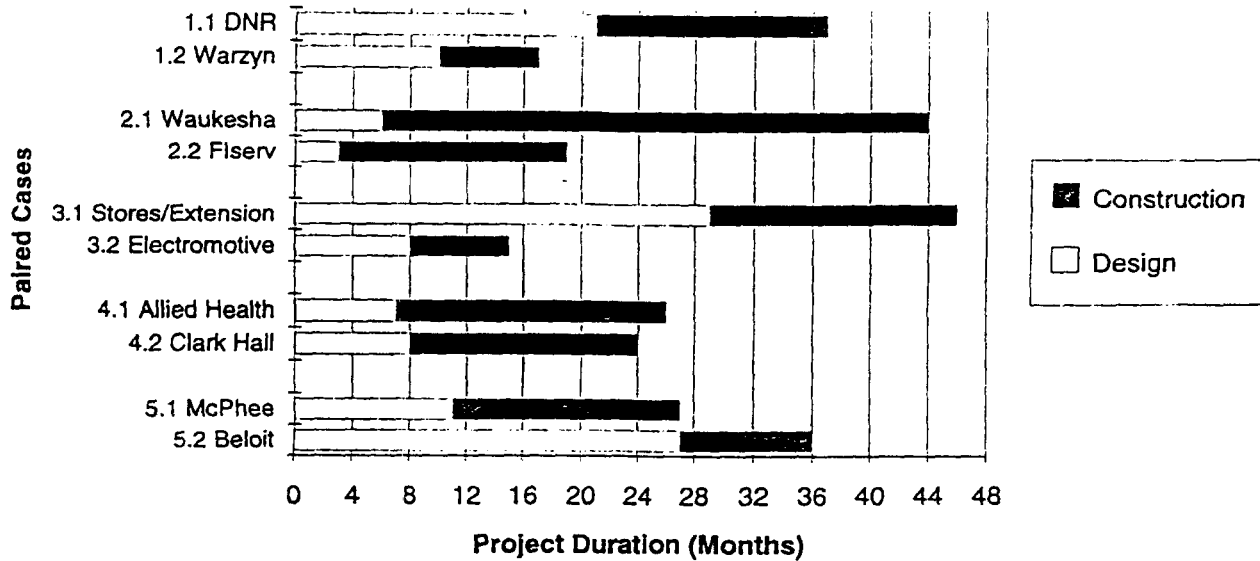
In summary, the public sector development process took LONGER than private sector due to the greater complexity of Structure & Procedures (Cases #1,2,3), Methods of Contracting (Cases #1,2,3), Incidents (Cases #1,3), and Building Configuration (Cases #2,3). In the single case where the public sector process took less time (Case #5), the construction process still took longer.

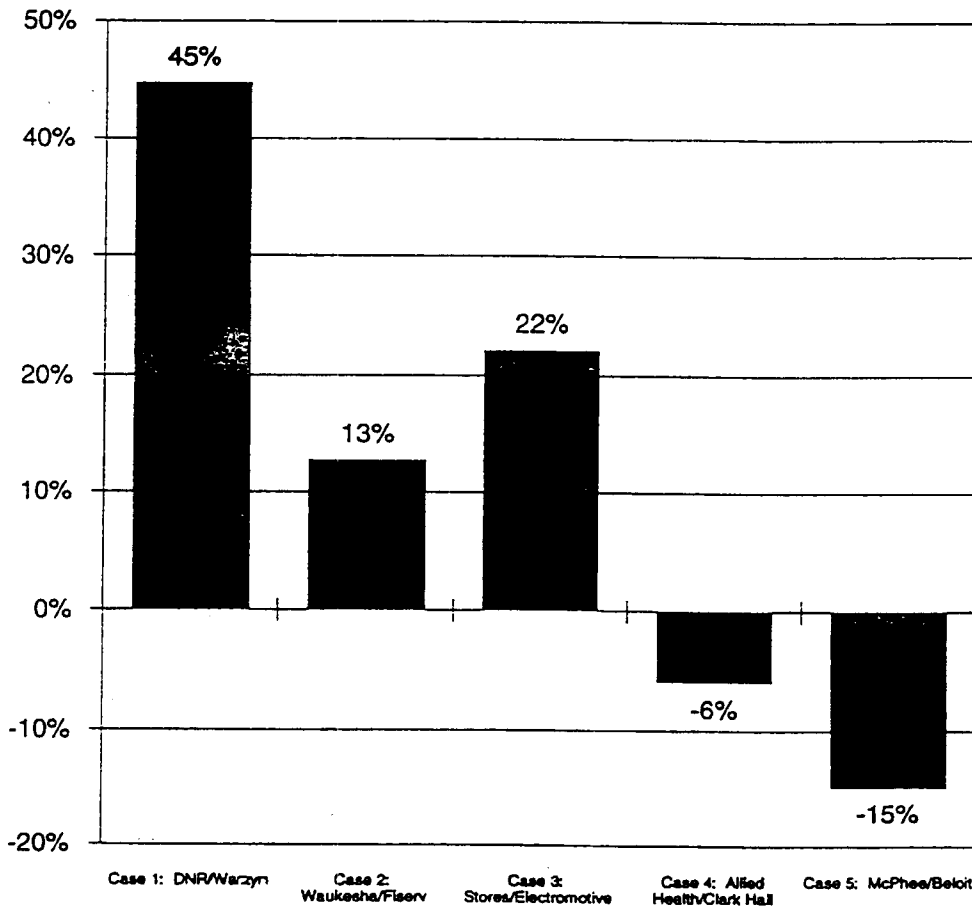
In summary, general construction cost MORE in three public sector building cases due to the increased complexity of Structure and Procedures (Cases #1,2,3), Methods of Contracting (Cases #1,2,3), Incidents (Cases #1,3), Location and Site Factors (Cases #1,3), and Building Configuration (Cases #2,3). General construction cost LESS in two public sector building cases due to less complex Location Factors & Site Conditions (Cases #4,5) and Building Configuration (Cases #4,5).

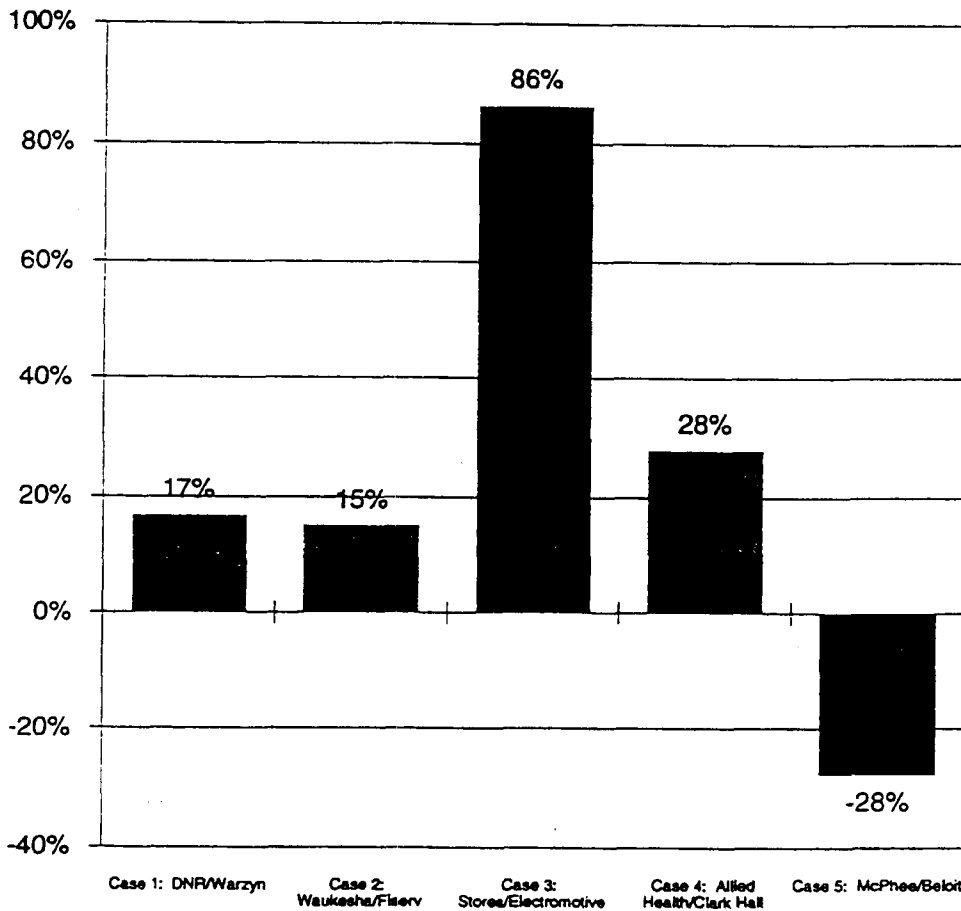
In summary, mechanical/plumbing construction cost MORE in four public sector building cases due to increased complexity of Structure and Procedures (Cases#1,2,3), Methods of Contracting (Cases#1,2), and Building Configuration (Cases#2,4). Mechanical/plumbing costs were LESS in only one public sector building (Case #5) due to a less complex Building Configuration.

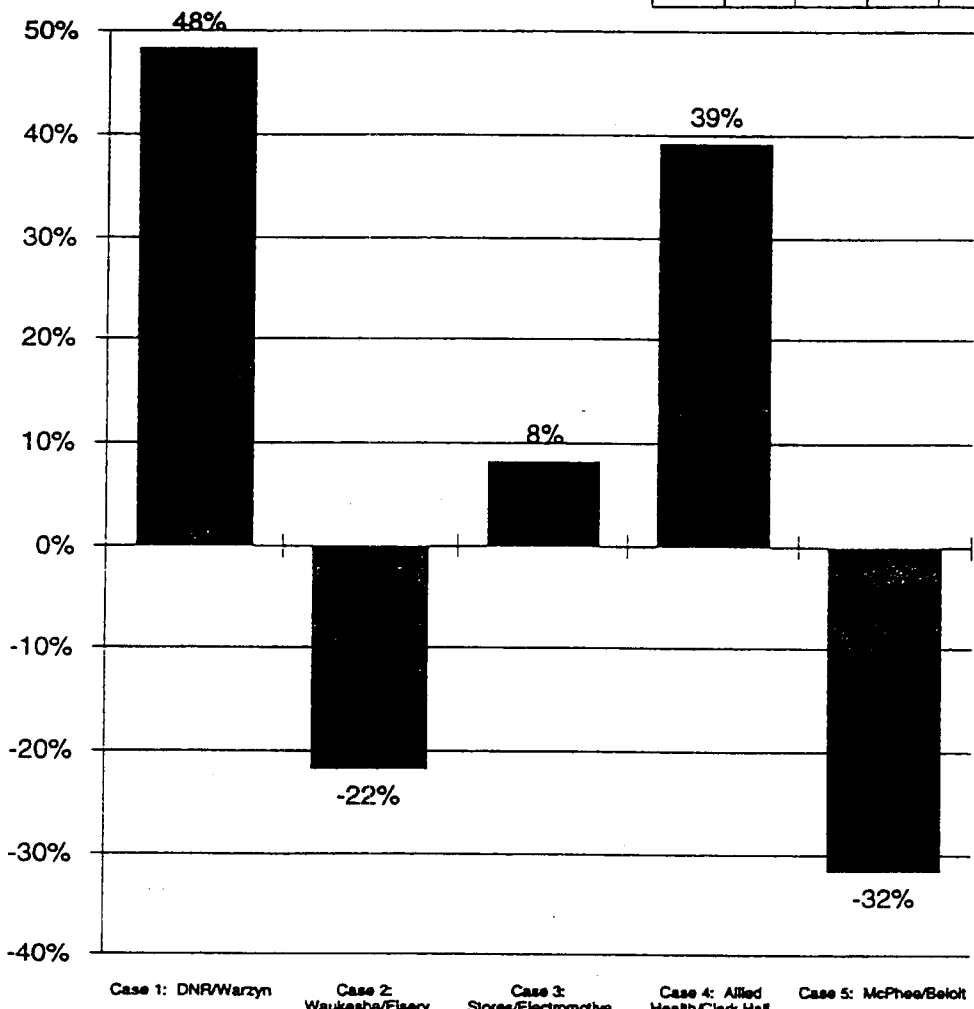
In summary, electrical construction cost MORE in three public sector building cases due to more complex Structure and Procedures (Cases#1,4), and Methods of Contracting (Case#1). Electrical construction cost LESS in two public sector building cases due to less complex Location and Site Factors (Case#2), and Building Configuration (Case#5).

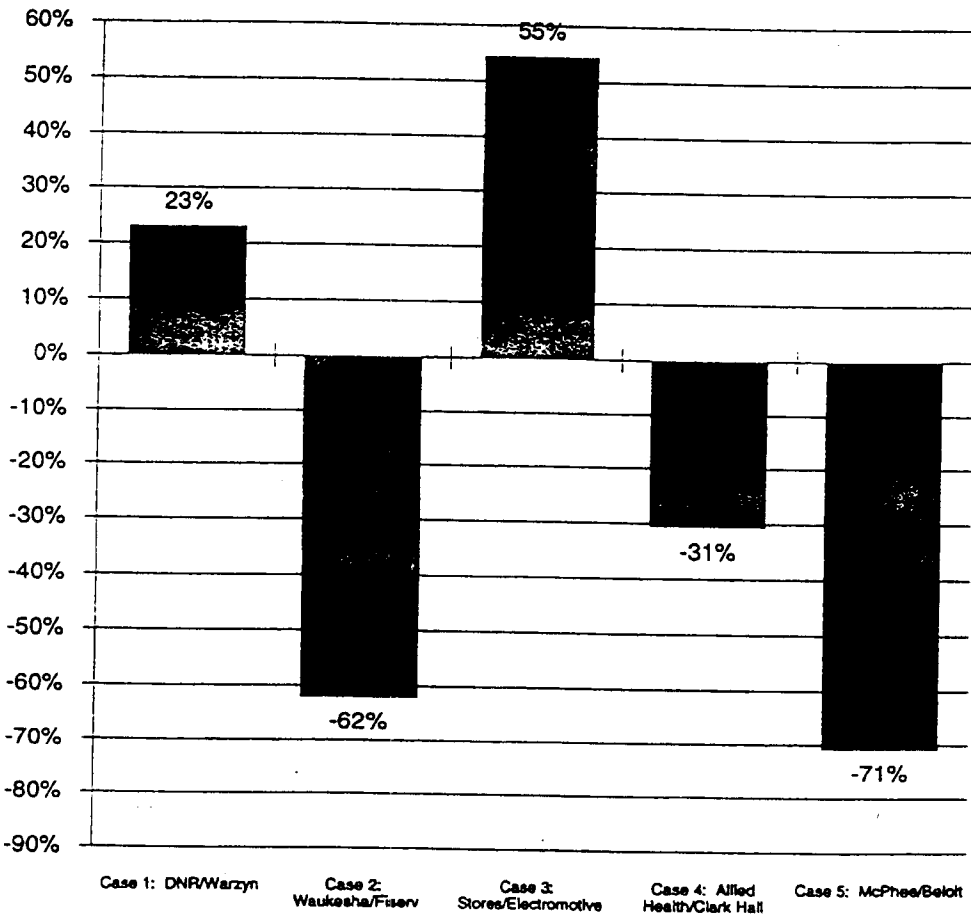
In summary, site development cost MORE in two public sector building cases due to more complex Location and Site Factors (Cases #1,3). Site development cost LESS in three public sector building cases due to less complex Location and Site Factors (Cases#2,4,5).

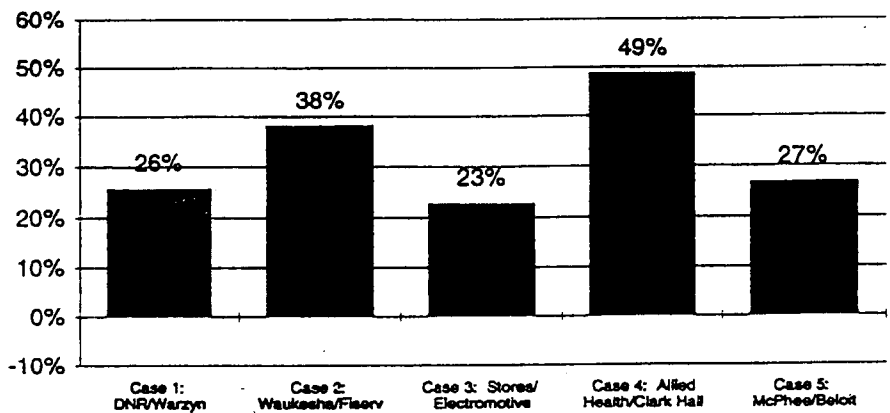
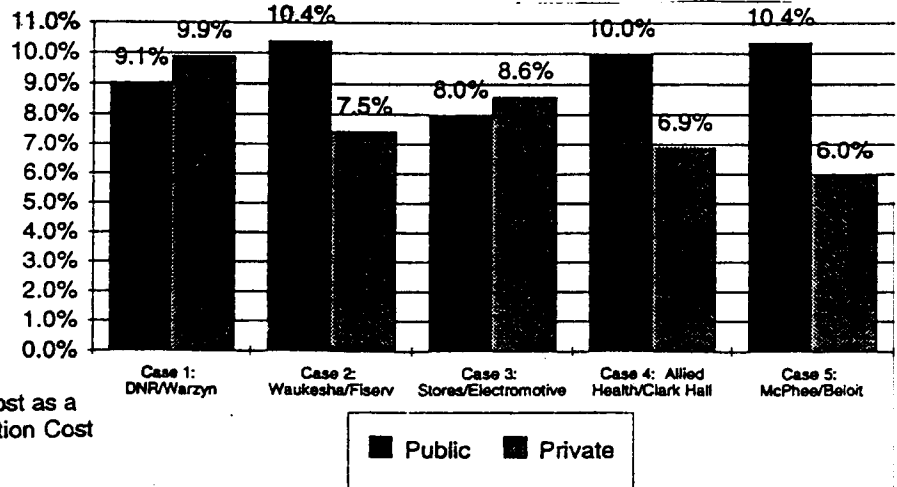
In summary, design and supervision cost MORE in all five public sector building cases due to more complex Structure and Procedures (Cases #1,2,3,4,5), and Methods of Contracting (Cases #1,2,3,4,5).

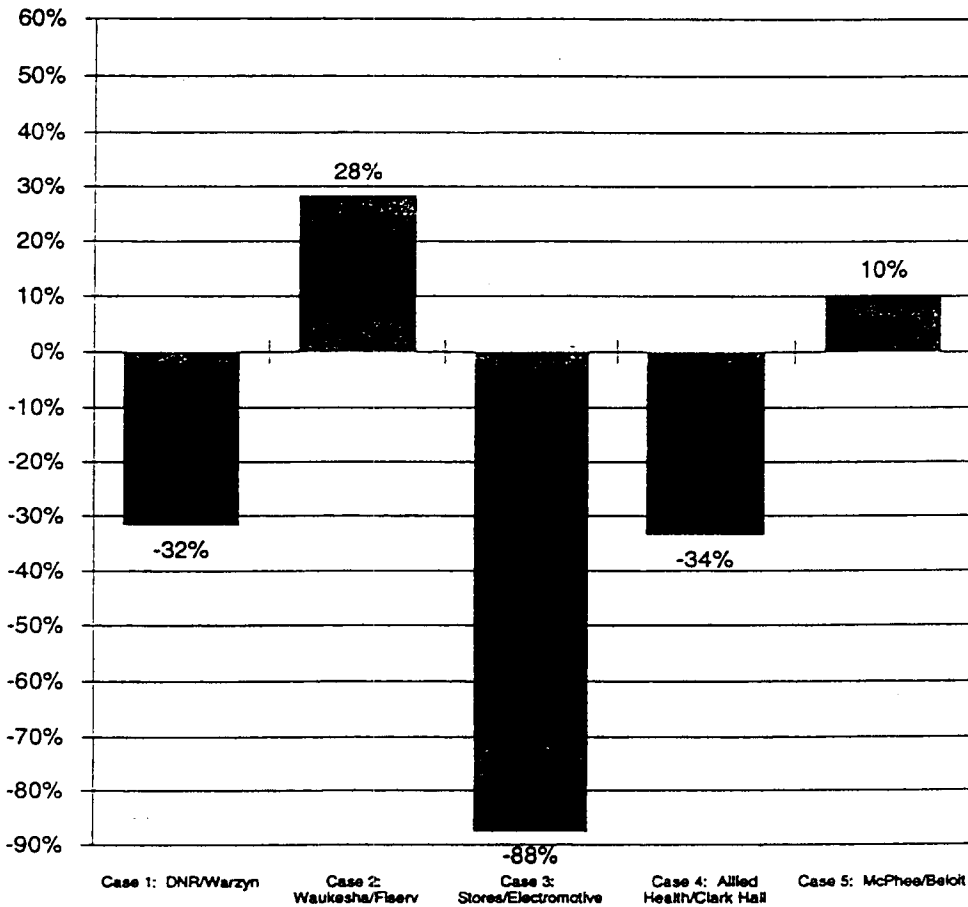
In summary, change orders cost MORE in two public sector building cases due to more complex Structure and Procedures (Case #5), and Incidents (Case #2). Change orders cost LESS in three public sector building cases due to less complex Incidents (Cases #1,3), Location and Site Factors (Case #4), Number of Stories (Case #4), and Building Configuration (Case #4).

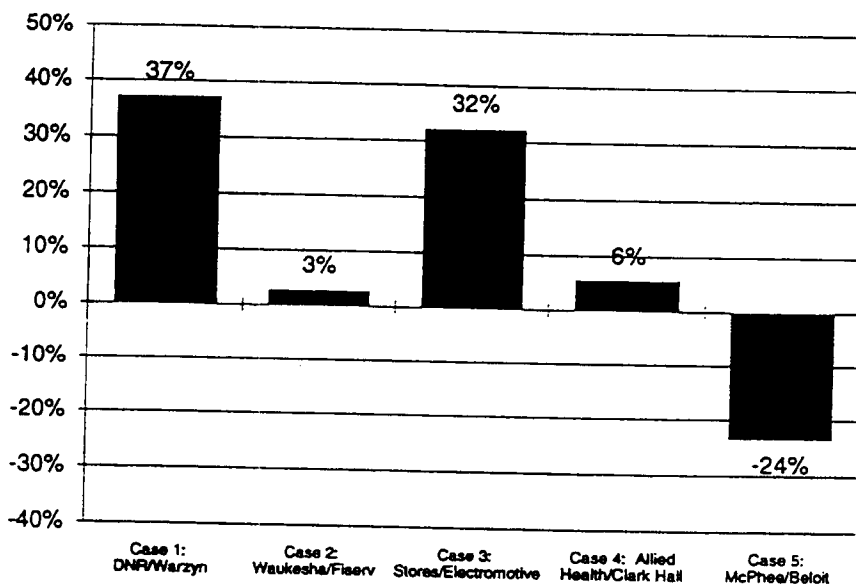
PERCENTAGE BY WHICH TOTAL PROJECT COST FOR PUBLIC FACILITY COST MORE (+) OR LESS (-) THAN PRIVATE FACILITY BY CASE

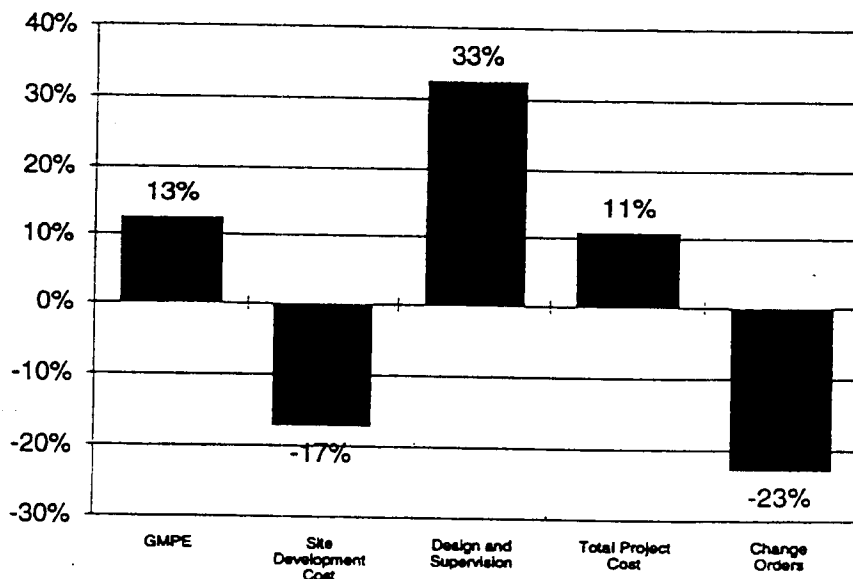
AVG. PERCENTAGE BY WHICH THE PUBLIC FACILITY COST MORE (+) OR LESS (-) THAN THE PRIVATE FACILITY BY COST CATEGORY
