# Surface Treatment and Adhesion Study

Report	Document No:
		Revision: D
	Surface Treatment and Adhesion Study	Author: Maegan DeLessio, Pat Watson

To determine the effect of various wafer-surface treatments on the adhesion of the resist film on the substrate after exposure and development.

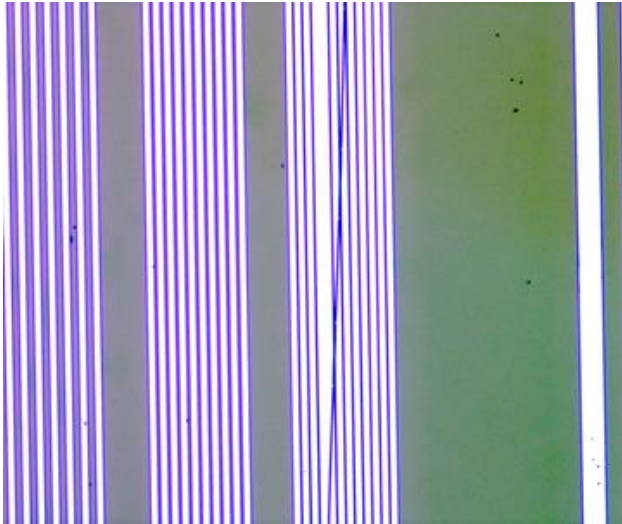
Figure 1: Poor adhesion of 02/10-micron lines

Wafer treatment	Result	Comments	Image
No bake before resist coating	Poor adhesion: micron line and pillar array	Poor adhesion of 02/10-micron lines <sup>2</sup> and 2 μm pillar array; 2 μm pillar dots observed deposited across surface; no adhesion of 1 μm pillar array	Fig: 1, 2, 3, 4
Bake at 115°C before priming	Poor adhesion: micron line and pillar array	Poor adhesion of 02/10-micron, 02/02-micron lines, and 2 μm pillar array; 2 μm pillar dots observed deposited across surface; no adhesion of 1 μm pillar array	Fig: 5, 6, 7, 8
SURPASS coating	Poor adhesion: pillar array	Poor adhesion of 2 μm pillar array; disappearance of pillar dots more gradual than previous two treatments; no dots observed deposited across surface; no adhesion of 1 μm pillar array	Fig: 9, 10, 11, 12
HDMS priming	Good adhesion	No adhesion of 1 μm pillar array; all other features in tact	Fig: 13, 14, 15, 16

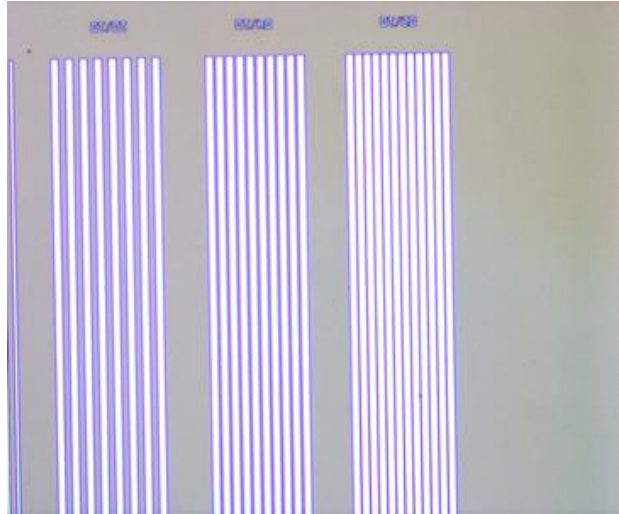
Figure 2: Same 02/10-micron lines on different part of the wafer for comparison

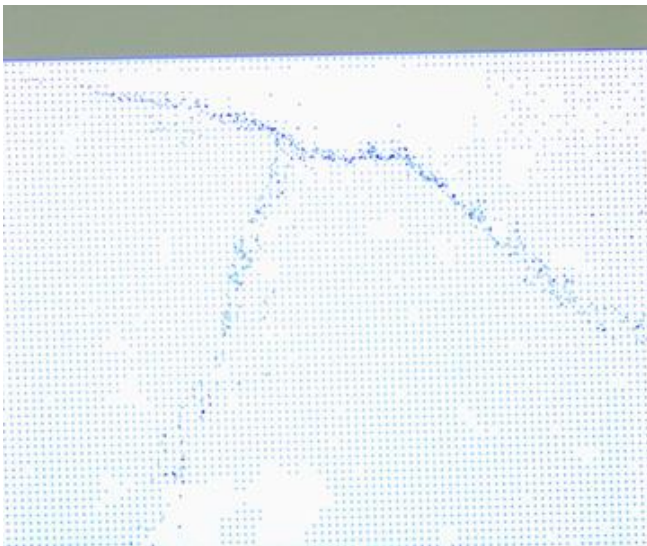
Figure 3: Poor adhesion of 2 μm pillar array

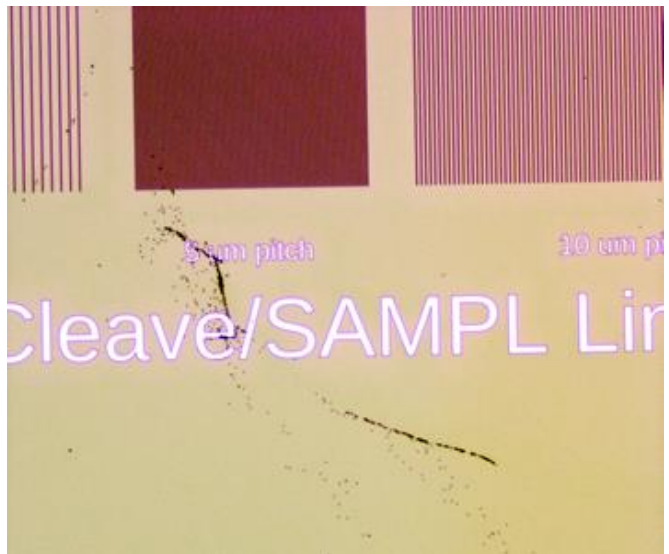
Figure 4: 2 μm pillar array deposited along the surface of the wafer

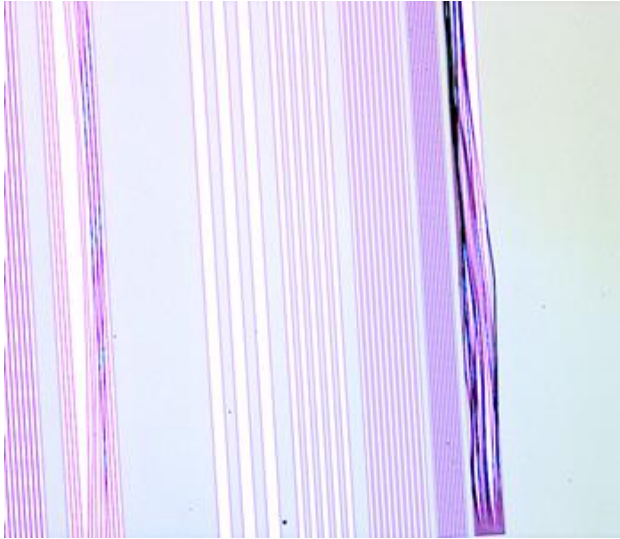
Figure 5: Poor adhesion of 02/10-micron lines (left) and 02/02-micron line array (right)

The results detailed above indicate that the surface treatments of “no bake before priming” and “bake at 115°C before coating” are the least effective adhesion-promoting; both treatments produced wafers with poor adhesion of 2 μm pillar arrays and 02/10 or 02/02-micron lines. SURPASS priming was the next best effective surface treatment; while the developed features showed poor adhesion of some 2 μm pillar arrays, there was good adhesion of all micron lines. HDMS vapor priming was observed to be the most effective wafer-surface treatment; no lack of adhesion was observed across any micron lines or 2 μm pillar arrays.

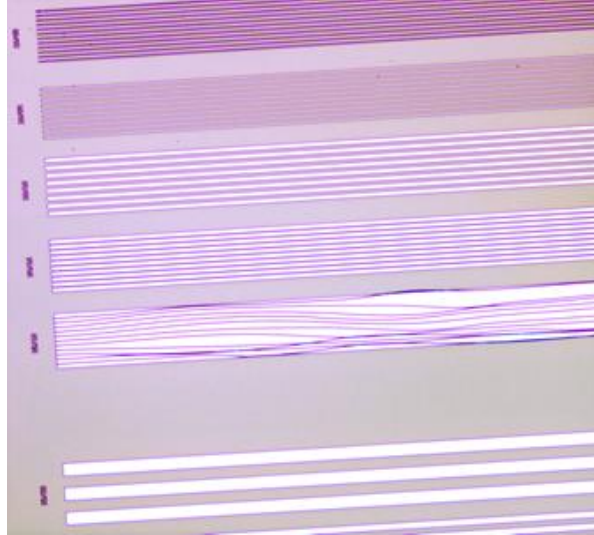
Figure 6: Poor adhesion of 02/10-micron lines on different area of the wafer

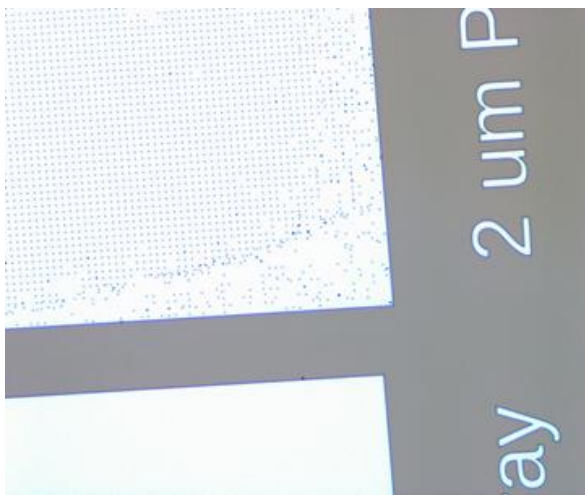
Figure 7: Poor adhesion of 2 μm pillar array

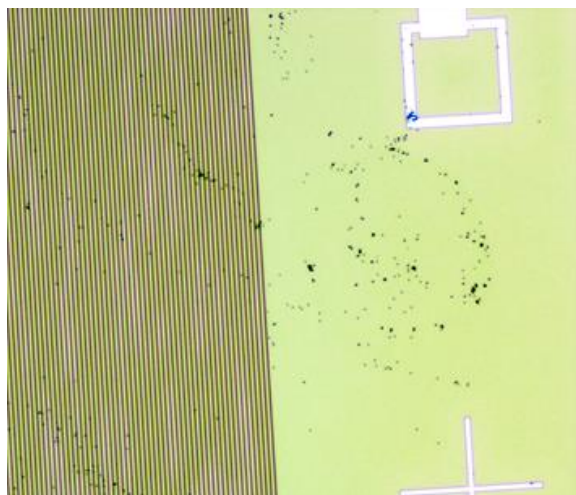
Figure 8: 2 μm pillar array deposited along the surface of the wafer

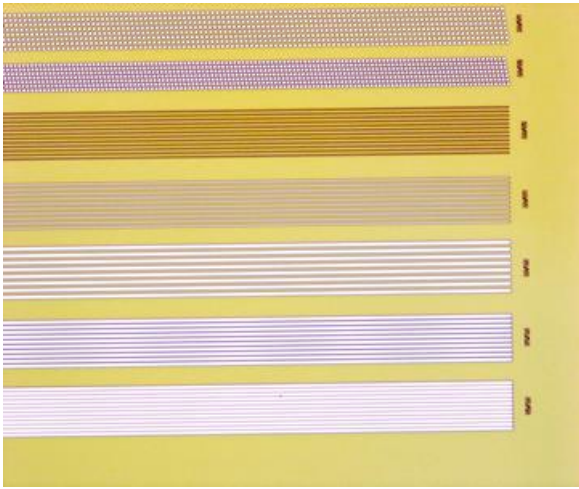
Figure 9: Good adhesion of all line/space arrays, including 02/10 lines (bottom)

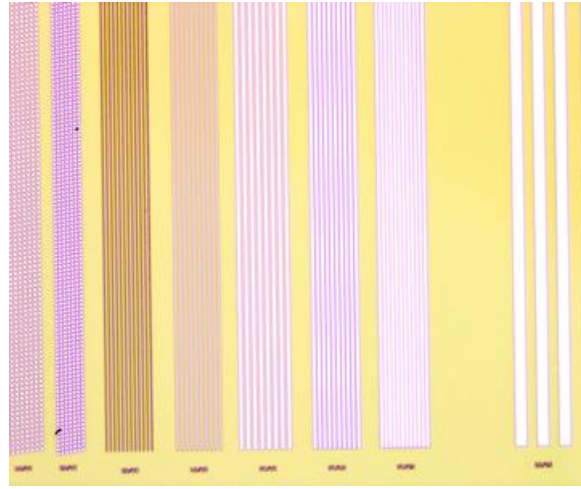
Figure 10: Good adhesion of line arrays on different portion of the wafer

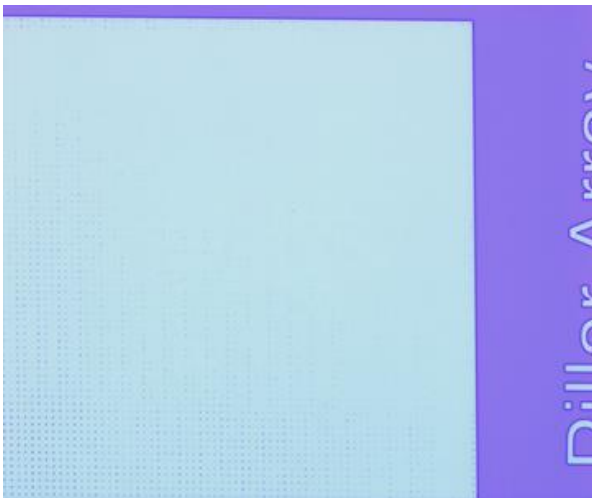
Figure 11: Poor adhesion of 2 μm pillar array, dots gradually decrease in upper right corner

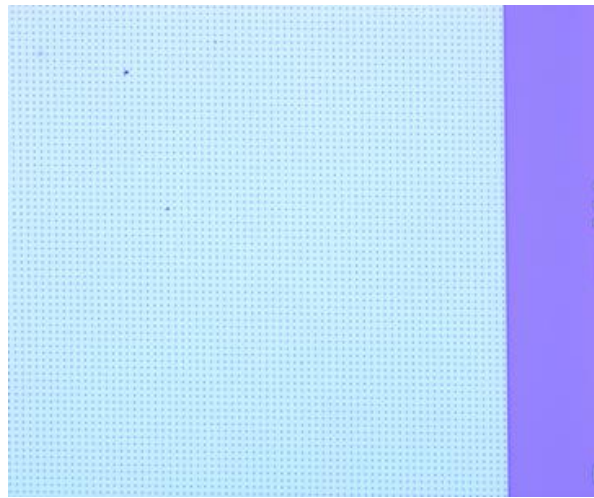
Figure 12: Good adhesion of 2 μm pillar array on different portion of the wafer

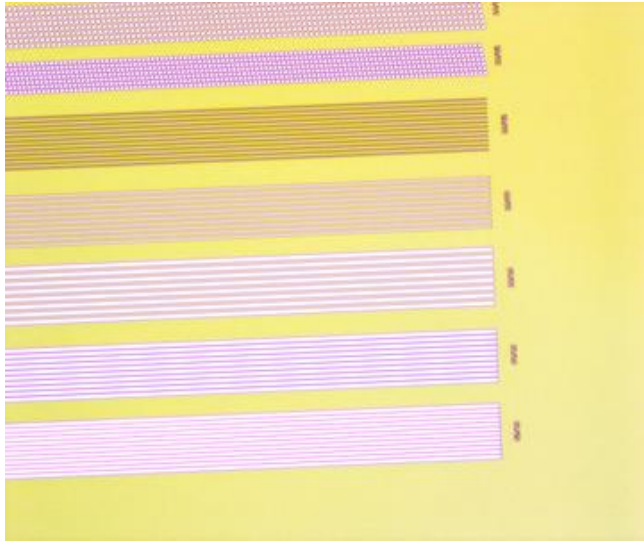
Figure 13: Good adhesion of all micron line arrays

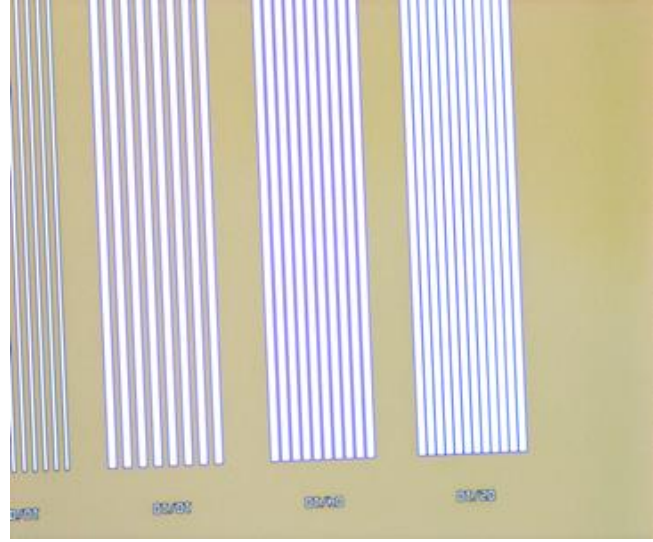
Figure 14: Good adhesion of line arrays on different portion of the wafer

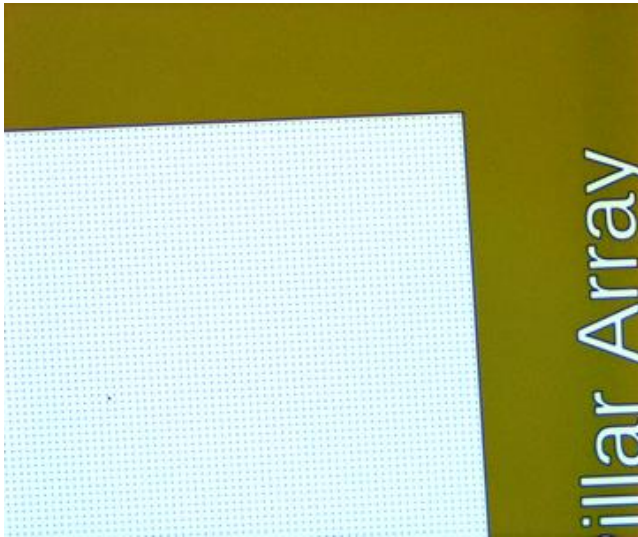
Figure 15: Good adhesion of 2 μm pillar array

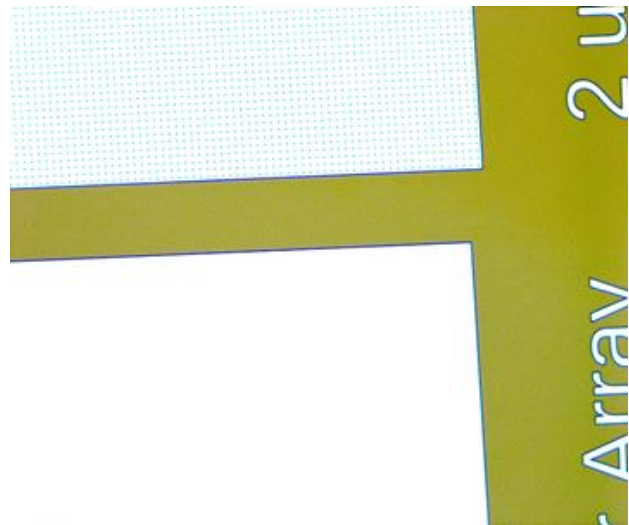
Figure 16: Absence of 1 μm pillar array, with 2 μm array for comparison (consistent feature across all wafers)

First, this study showed that developed features are often subject to adhesion problems. 2 to 10 μm width lines as well as 2 μm diameter pillar arrays were observed to have variable degrees of adhesion depending on the wafer-surface treatment; in wafers produced through less effective surface treatments, the developed features adhered poorly. 1 μm diameter pillar arrays were missing on all wafers, regardless of surface treatment, suggesting that the process conditions and/or photomask properties were inappropriate for features of this size.
