# Lower Hobble Creek Ecosystem Flow Recommendations

Melissa Stamp BIO-WEST, Inc.

Stamp, Melissa; Eddie, Thomas; Olsen, Darren; Allred, Tyler. Lower Hobble Creek Ecosystem Flow Recommendations. BIO-WEST, Inc. April 2009.

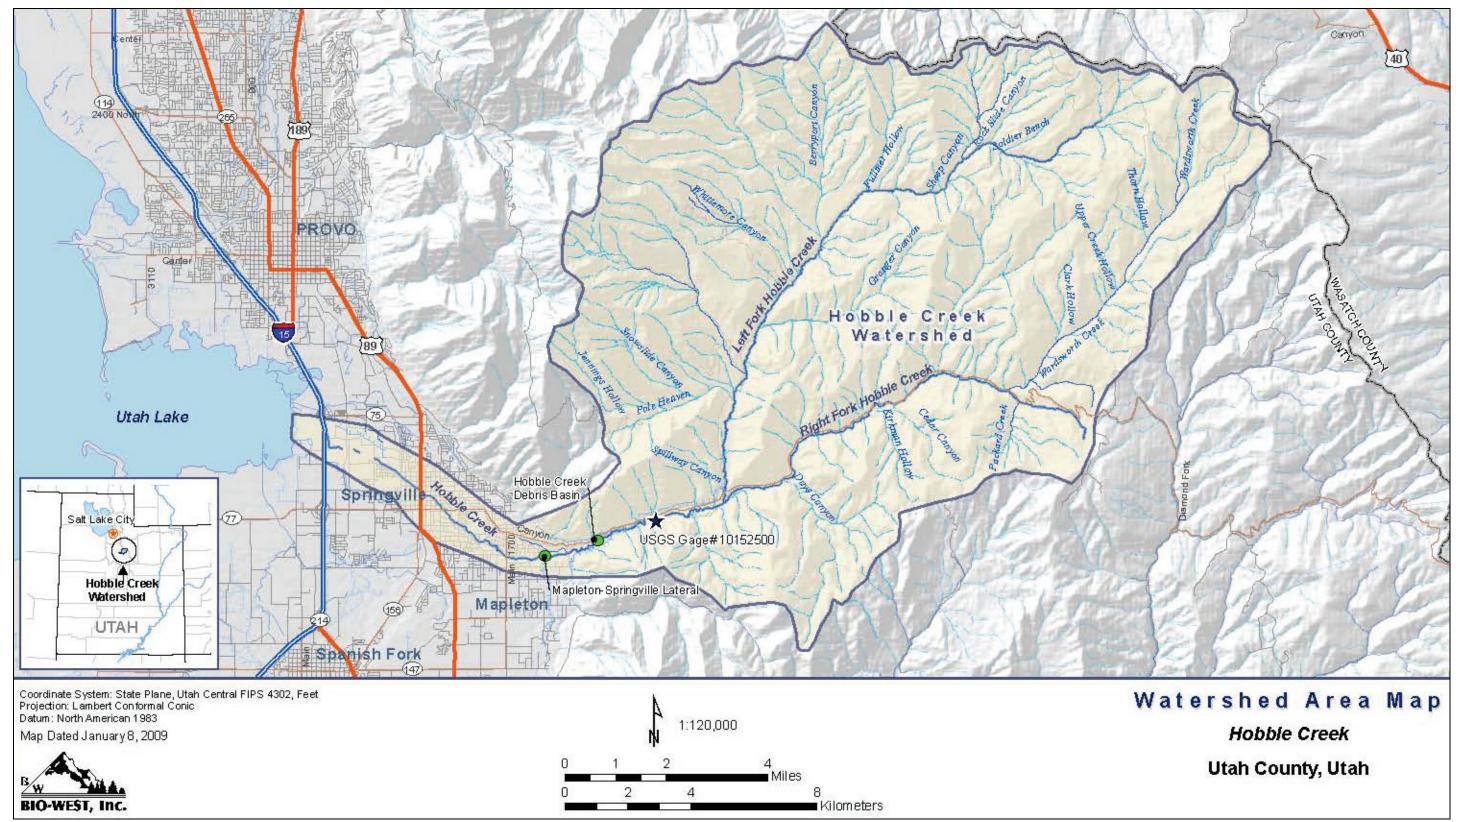
Figure 1.1. Location and watershed area map.

The headwaters of Hobble Creek originate in the Wasatch Mountains of Utah at an elevation of approximately 9,000 ft. The creek begins as two separate forks, Right Fork Hobble Creek and Left Fork Hobble Creek, that merge to form Hobble Creek proper about 3 miles east of Springville City (Figure 1.1). The total drainage area of Hobble Creek at its outlet to Utah Lake is approximately 114 square miles. The majority of the watershed area (approximately 108 square miles) is located in the mountains upstream of the canyon mouth. Lower Hobble Creek, defined as the portion of the creek between the Mapleton-Springville Lateral and Utah Lake, flows west to northwest for approximately 7 miles through Springville City (Figure 1.1).

When operational and under full water delivery conditions, the ULS will deliver water to Hobble Creek at the Mapleton-Springville Lateral Pipeline on the east side of Springville City (Figure 1.1) and will supplement flows within lower Hobble Creek. Of the 12,000 acre-feet, approximately 4,000 acre-feet will be generated by water returned to the U.S. Department of the Interior (DOI) from water conservation projects completed under Section 207 of CUPCA. This 4,000 acre-feet will be available for release to Hobble Creek every year (CUWCD 2004a). The additional 8,000 acre-feet will be available when transbasin CUP water is being delivered to Utah Lake for exchange to Jordanelle Reservoir. During naturally high runoff years when Utah Lake is above compromise level, this portion of Hobble Creek supplemental water would typically not be available for delivery to the creek (CUWCD 2004a). The 8,000 acre-feet of CUP water will build up over time and may not be fully available until up to 10 years after all ULS distribution facilities are constructed and operational. The facility that will deliver supplemental flows to Hobble Creek is being designed to have a 125 cubic feet per second (cfs) maximum release rate (CUWCD 2003). The ULS is currently in the design and initial construction phases, and it is anticipated that the infrastructure will be in place to begin supplemental flow deliveries to Hobble Creek no sooner than 2011.

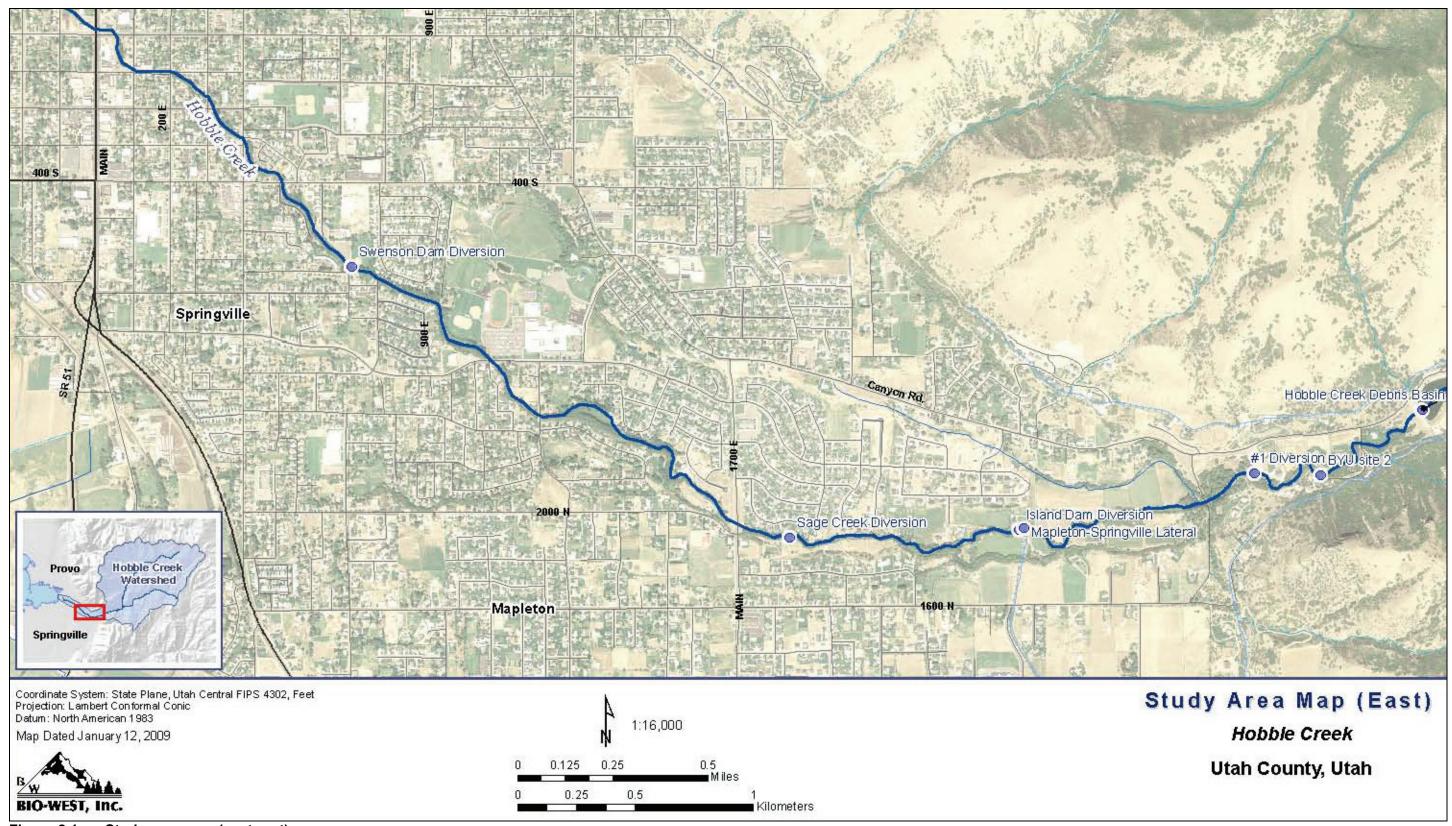
Figure 2.1. Study area map (east part).

A new U.S. Geological Survey (USGS) streamflow gage (#10153100) was installed on lower Hobble Creek near 1500 West in November 2008 (Figure 2.1). Data collected at this gage will be highly valuable in the future; however, at this time the stage-discharge rating relation is still being developed for the gage and data are too limited to describe the hydrology of lower Hobble Creek. Therefore, hydrologic information must be inferred from flow data collected at a discontinued USGS gage (#10152500) that operated in Hobble Creek Canyon approximately 8.9 miles above Utah Lake from 1908–1916 and 1945–1974 (Figure 1.1). Data from this gage were analyzed to provide an indication of the natural hydrologic conditions of lower Hobble Creek. Springville City diverts water for municipal uses from underground springs in a tributary canyon to Left Fork Hobble Creek (FERC 2002); therefore, the hydrology of Hobble Creek at the gage is not entirely natural. Upstream from the gage, flows in Hobble Creek and its tributaries are affected by flow withdrawals for hydroelectric and irrigation purposes. However, the gage is located downstream from the return points for most of the upper watershed irrigation uses, and is below the Hobble Creek Hydroelectric Plant where water diverted for power generation returns to the creek. Therefore, these upstream power and irrigation uses do not substantially alter the hydrology at the gage, and the gage data provide a reasonable estimate of natural conditions.

The majority of irrigation diversions on Hobble Creek occur downstream from the discontinued USGS gage (Figure 2.1). Streamflow and sediment transport are also affected by the Hobble Creek debris basin, located near the canyon mouth about 1.5 miles downstream from the gage location. The debris basin has a 120 acre-foot storage capacity and traps some of the sediment entering from upstream. Accurate, continuous records of flow withdrawals from the Springville City area diversions are not available. As part of analysis work related to the ULS, the Central Utah Water Conservancy District (CUWCD) developed estimates of diversion amounts and average monthly streamflow within Springville City (CUWCD 2004a). These estimates account for diversions by the Springville and Mapleton Irrigation companies between the USGS gage and 400 West Street in Springville City; however, they do not account for the diversions or return flows that occur between 400 West Street and Utah Lake. The total diversion capacity of the agricultural diversions upstream of 400 West is 60 cfs (CUWCD 2003). To generate the data plotted in Figure 2.3, the CUWCD used a "worst case" scenario that assumed 36 cfs would be diverted in April and the full 60 cfs would be diverted from May through October (CUWCD 2003). As evident in Figure 2.3, the diversions above 400 West Street are estimated to substantially reduce average flows in Hobble Creek during the April through October irrigation season.

Bedload transport was field-measured at several locations on Hobble Creek during spring 2006 by Brown (2008). Although data are somewhat limited for the lower reaches of Hobble Creek, multiple samples were taken at a sampling site located near 900 East in Springville (Figure 2.1). Based on these samples, it appears that during the 2006 springtime runoff, significant sediment transport was initiated at about 100 cfs, and that transport rates increased rapidly at flows above about 240 cfs (Brown 2008). In 2006, bedload particle sizes of up to about 25 mm were captured at Site 3, and the maximum streamflow measured during bedload sampling at the site was 304.5 cfs (Brown 2008). However, spring season 2008 bedload sampling by Brigham Young University (BYU) at 950 West and 1600 West did not collect any measurable amount of

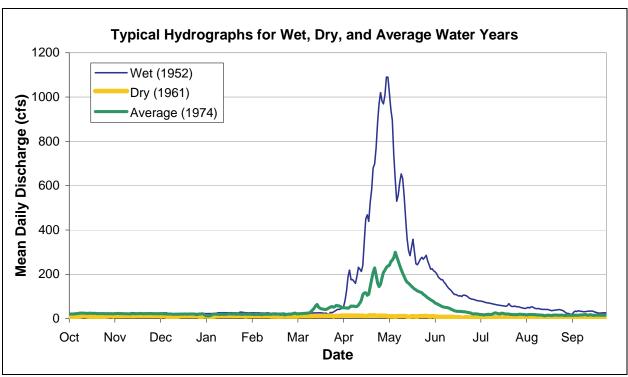
Figure 2.2. Typical Hobble Creek hydrographs (data from USGS gage located 8.9 miles above Utah Lake).

Data from the discontinued gage indicate that, as with most streams that drain Utah's Wasatch Mountains, Hobble Creek's hydrology is characterized by a distinct springtime peak typical of snowmelt-driven systems (Figure 2.2). Flows on Hobble Creek typically peak at the end of April or in May (Table 2.1), with May having the greatest average monthly flow (Figure 2.3). Flows on Hobble Creek vary greatly depending on yearly climatic conditions. In dry years, springtime peaks are essentially nonexistent (Figure 2.2). In wet years with heavy snowpack, flows typically peak later in the year and have a magnitude that exceeds average conditions.

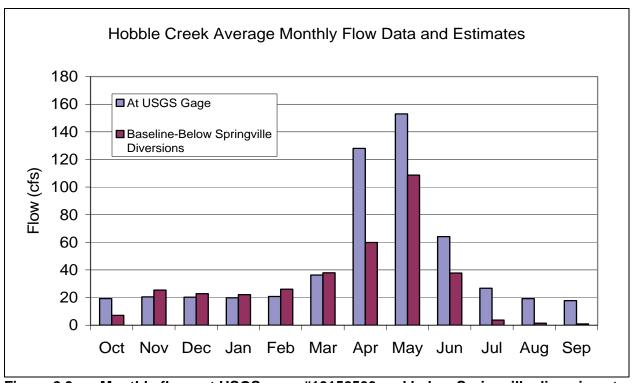
Figure 2.3. Monthly flows at USGS gage #10152500 and below Springville diversions to 400 West. Note: values are averaged over a 40- to 50-year data period, and flow in a given year can vary considerably from this average.

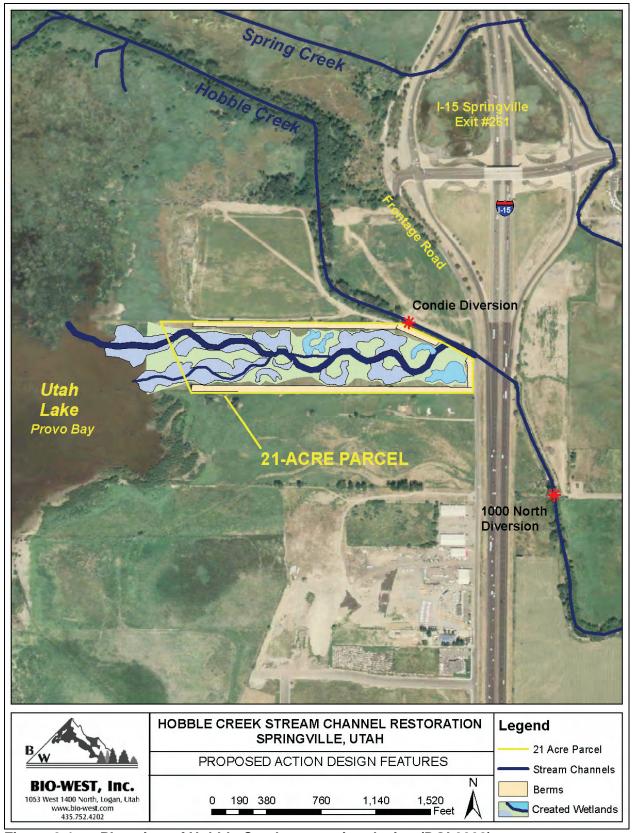
Figure 2.4. Plan view of Hobble Creek restoration design (DOI 2008).

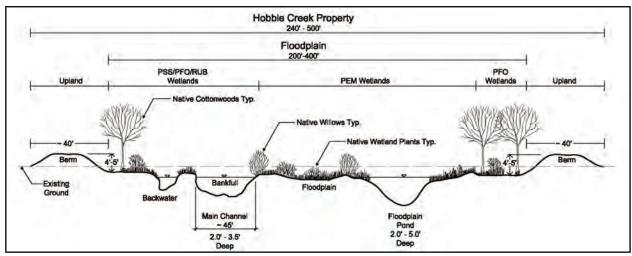
Figure 2.5. Cross section of Hobble Creek restoration design (DOI 2008).

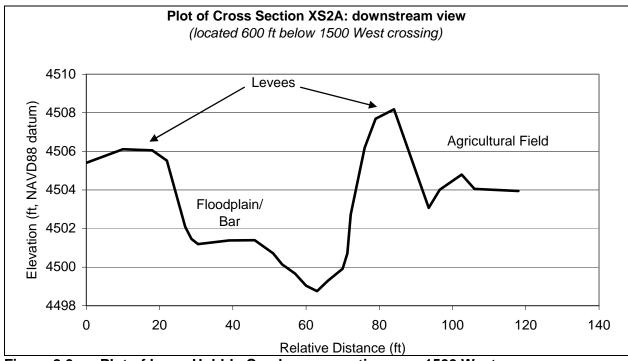
Figure 2.6. Plot of lower Hobble Creek cross section near 1500 West.

The channel in this reach is typically about 30 to 40 feet wide at low flow and about 60 to 75 feet wide between the tops of the levees. The levees are generally about three to five feet higher than the adjacent agricultural fields (Figure 2.6). Average channel slope varies from about 0.2 percent in the downstream portion of the reach to 0.7 percent in the upstream portion of the reach (Stamp et al. 2002). The streambed profile is interrupted by irrigation diversions at 1000 North and at Packard Dam, each of which creates a vertical bed elevation drop of about four feet. These structures flatten the local slope and cause deposition of fine sediment both upstream and downstream. Streambed substrate consists of sand and silt in the vicinity of these diversions and the 1500 West debris basin. In the remaining portions of the reach, bed material typically consists of gravel and cobble particles that are occasionally algae-coated or partially embedded with fines (Stamp et al. 2002).

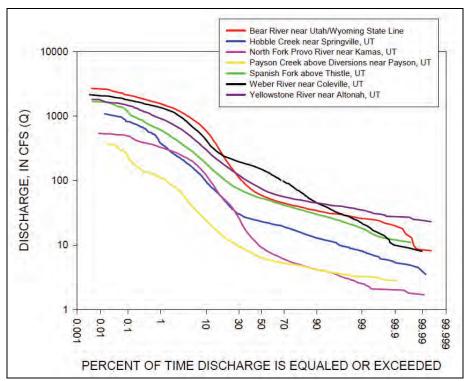
Figure 3.1. Standard flow duration relations for seven Utah reference streams.

Streamflow data from the selected group of reference streams can be plotted to create a standard flow duration relation, as shown in Figure 3.1. Notice that streams of different size are distributed vertically along the y-axis (discharge). Although the curves appear to have similar shapes, the vertical distribution makes it impossible to use the data from one stream to guide flow recommendations on another stream, unless they happen to be of exactly the same discharge volume. In order to use these data to guide flow recommendations, a way must be found to remove the effect of stream size on the data, which would allow basins of different sizes to plot in the same space. This can be accomplished by dividing each of the measured discharges for the period of record by the mean flow for the same period, which produces the plots shown in Figure 3.2. The result is a dimensionless variable that we will call "dimensionless discharge." It is dimensionless because the units of discharge cancel out when dividing by the mean discharge. Notice that the plots that were previously distributed along the y-axis are now grouped much more closely. The new plots are quite useful for determining a natural range of discharge for other streams in the area.

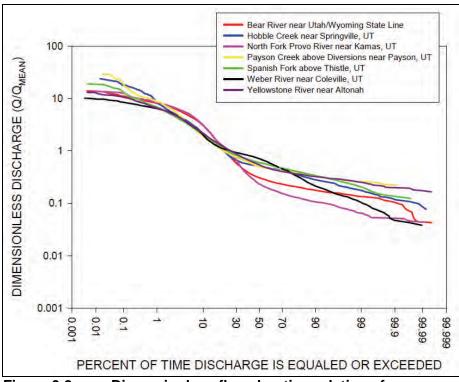
Figure 3.2. Dimensionless flow duration relations for seven Utah streams.

Because this technique is new to most people, a quick example may provide some helpful insight. In a way, the dimensionless discharge units can be thought of in terms of multiples of the mean flow. For example, on Hobble Creek, which has a mean flow of approximately 45.7 cfs, the flow on a given day may be 22.8 cfs, which becomes a dimensionless discharge of 0.50 (22.8 cfs / 45.7 cfs = 0.5), or 0.5 times the mean flow. In the springtime, during the runoff period, the discharge may be 228 cfs, which becomes a dimensionless discharge of 5 (228 cfs / 45.7 cfs = 5), or five times the mean flow. Dimensionless discharges, like those shown in Figure 3.2, can be

scaled for any similar stream by multiplying the values by the mean discharge for the new stream. This simple procedure can be applied to any stream with similar characteristics.

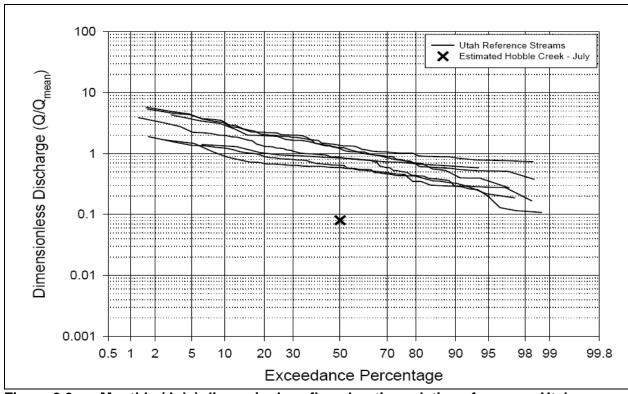
Figure 3.3. Monthly (July) dimensionless flow duration relations for seven Utah reference streams. Estimated average July flow for Hobble Creek below Springville diversions is shown as an X on the plot.

In order to determine a more appropriate range of streamflow during different seasons for Hobble Creek, gage data from the reference streams were analyzed to produce dimensionless flow duration curves for each month. Figure 3.3 provides an example of one of these monthly curves (July) for the Utah reference streams. For comparison purposes, the estimated average July flow on Hobble Creek below the Springville diversions (3.7 cfs) is also plotted as a dimensionless value. This value plots well below the reference streams, indicating that flows are substantially lower in July than would be expected in a less-altered system. These low flows occur during the warmest times of the year, when temperatures in the river are hovering at or above lethal levels for many organisms and oxygen levels are extremely low. The biological implications of these low flows are potentially profound.

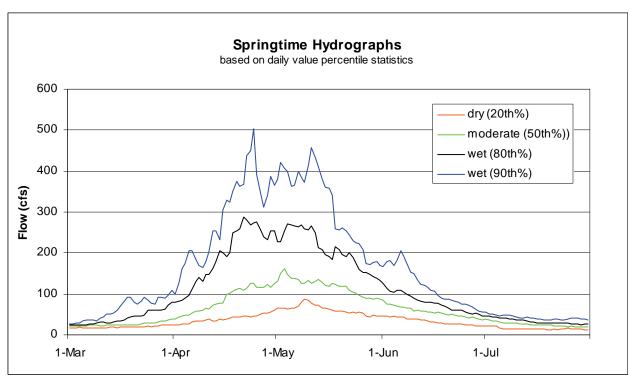
Figure 3.4. Springtime hydrograph plots based on daily percentile statistics at Hobble Creek USGS gage #10152500.

To identify an initial set of hydrographs, percentile statistics (20<sup>th</sup>, 50<sup>th</sup>, 80<sup>th</sup>, and 90<sup>th</sup> percentile water years) were generated for each calendar day using the record of daily flows at the USGS gage. These statistics provide an indication of the types of flow patterns that would occur under dry, moderate, and wet-year conditions. Plots of these hydrographs are shown in Figure 3.4 for the springtime runoff period from March 1 through July 31. Because these plots are based on calculated daily statistics rather than actual flows that occurred on consecutive days in a given year, they may show some unusual day-to-day patterns as a relict of the analysis method. To evaluate this, the percentile plots were compared to various actual gaged hydrographs for dry, moderate, and wet-year conditions. These plots are included as Appendix A. Based on these comparisons, the statistical plots (Figure 3.4) do not generally appear to be unreasonable or unrealistic; however, the actual recorded hydrographs for moderate and wet years tend to have somewhat higher peak magnitudes, slightly shorter overall runoff duration, and somewhat steeper rise and fall rates. Dry-year hydrographs appear to be rather variable, with somewhat lower peaks and shorter runoff duration than the 20<sup>th</sup> percentile plot shown in Figure 3.4.

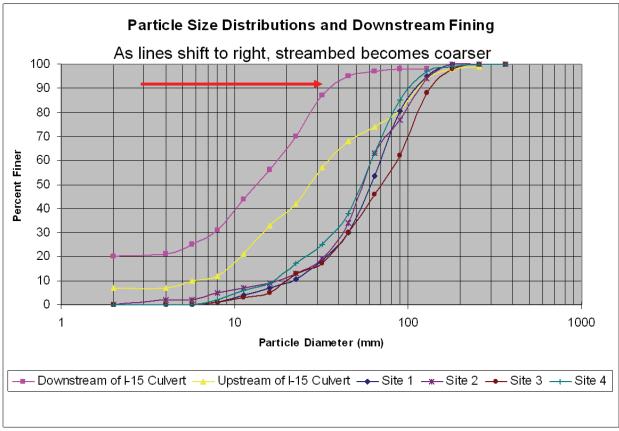
Figure 3.5. Hobble Creek streambed particle size distributions. Figure from Brown (2008). Site 4 is located at 200 West; Site 3 is located at 900 East; Sites 1 and 2 are upstream of the Mapleton-Springville Lateral.

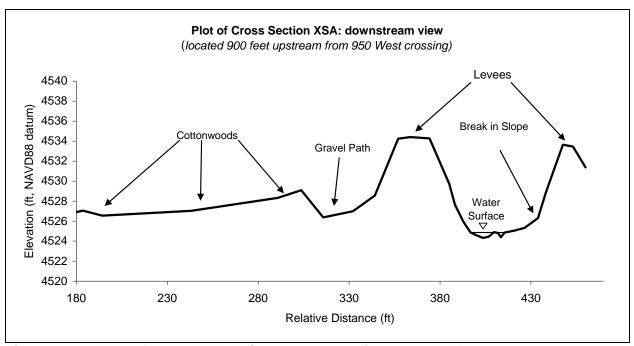
Figure 3.6. Plot of lower Hobble Creek cross section near 950 West.

As part of field surveys and analyses completed for ULS environmental documents, estimates of bankfull discharge were made at several cross sections (CUWCD 2004b). In this report, the term "bankfull discharge" refers to the flow that just begins to overtop alluvial bank features or deposits such as point bars; on lower Hobble Creek, these banks are typically much lower than the artificial levees that line much of the channel. Flows much greater than what we refer to here as bankfull discharge would be needed to overtop the levees on Hobble Creek. Reported bankfull estimates were 140 to 150 cfs for the upstream portion of the Study Area (CUWCD 2004b). Similar values are obtained when the WinXSPRO results at the 950 West and 1500 West cross sections are examined. At 950 West, the wetted width reaches the break in slope at the right bank at a discharge of about 146 cfs (Figure 3.6). At 1500 West, the floodplain/bar surface is fully inundated at flows of about 162 cfs. Within the newly constructed Hobble Creek restoration project, the channel was designed to overtop its banks beginning at flows of about 200 cfs. Although a comprehensive analysis of bankfull discharge or effective discharge has not been completed for Hobble Creek, the available data suggest that flows in the range of 140 to 200 cfs are important for maintenance of the bankfull channel.

Another geomorphic and hydraulic consideration involves base flows to limit vegetation encroachment by grasses, sedges, or woody shrubs. WinXSPRO results at the 950 West and 1500 West cross sections predict that flows of about 18.8 to 23.5 cfs fully inundate the low flow channel and would be adequate to prevent excessive vegetation growth during the summer growing season.

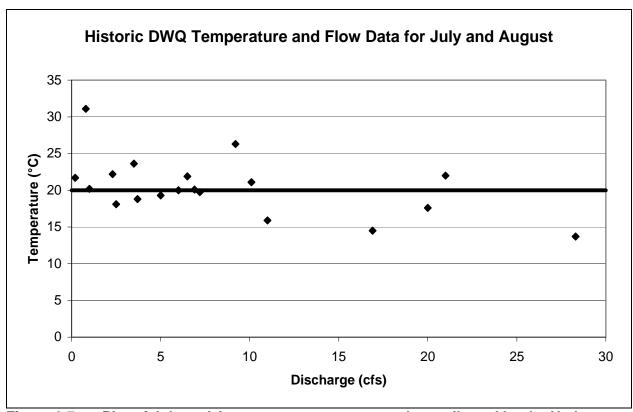
Figure 3.7. Plot of July and August water temperature data collected by the Utah Division of Water Quality (DWQ) on lower Hobble Creek. Thick black line indicates cold water fishery standard of 20 degrees C.

As evident in Figure 3.7, temperatures very rarely approach the 28 degree C chronic lethal level. Therefore, avoidance of temperatures lethal to June sucker will not be a driving factor in recommending minimum base flows.

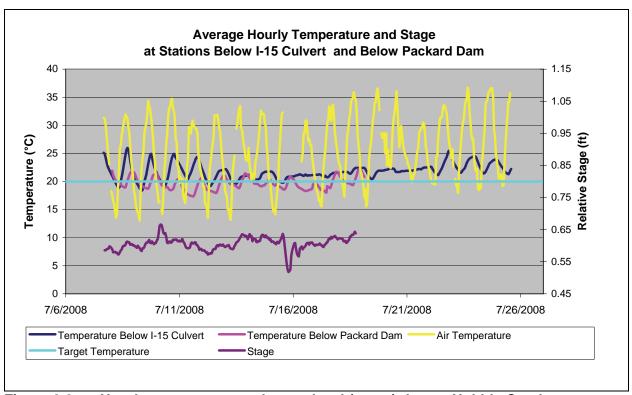
Figure 3.8. Hourly temperature and water level (stage) data at Hobble Creek temperature monitoring sites.

Temperatures above 20 degrees C were observed almost continuously at the station below the I-15 culvert (Figures 3.8 and 3.9). Temperatures were 20 degrees C or greater 91 percent of the time. During lower flow events, average hourly temperatures approached, and in several instances, exceeded 25 degrees C. However, these events would last approximately three to five hours and did not approach the maximum temperature threshold of the June sucker. The maximum temperature recorded below the I-15 Culvert was 26 degrees C (Figures 3.8 and 3.9). Temperatures greater than or equal to 20 degrees C occurred 35% of the time during the sample period at the station below Packard Dam. The maximum temperature recorded below Packard Dam was 22.3 degrees C. Based on recorded water level (stage) data, flow rates during the sample period are estimated to have been between about 0.6 and 2 cfs for the Packard Dam site, and between 0.6 and 7 cfs for the I-15 site. More data over a greater range of flows would be needed to establish a more definitive relationship between discharge and temperature. The available data do suggest however, that flows in this range are not adequate to provide average hourly temperatures below 20 degrees C. When also considering the DWQ data set, the threshold

appears to be approximately 11 cfs. Now that the new USGS gage near Packard Dam is operational, it would be useful to re-deploy the temperature loggers during summer 2009 to obtain a more comprehensive data set and further refine this estimate of the flow needed to maintain water temperature quality. The Packard Dam site has a vegetative canopy that shades the stream which may have influenced the temperature data. Data collected at this site show lower water temperatures and less hourly variability than the downstream I-15 site, which is less shaded (Figure 3.8).

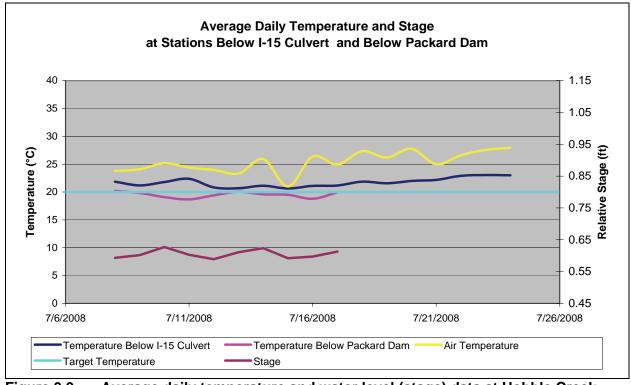
Figure 3.9. Average daily temperature and water level (stage) data at Hobble Creek temperature monitoring sites.

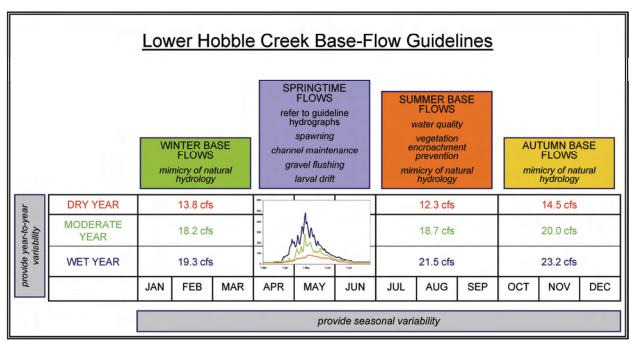
Figure 4.1. Lower Hobble Creek base-flow guidelines.

Base-flow guidelines to protect the lower Hobble Creek riverine ecosystem were developed for dry-, moderate-, and wet-year conditions (Figure 4.1). Guidelines were developed separately for winter, summer, and autumn base-flow seasons. Base-flow guidelines were not developed for the spring season (April–June); instead, the natural springtime runoff hydrograph examples (see below) should be used to guide supplemental flow-release decisions during this time period.

Summer base flows apply from July through September (Figure 4.1). The dry- and moderate-year recommendations of 12.3 and 18.7 cfs, respectively, were calculated by averaging the August and September 20th and 50th percentile values from the analysis of daily flow data recorded at the discontinued Hobble Creek USGS gage (Table 3.4). The Hobble Creek summertime flow values are slightly lower than the values derived from the Utah dimensionless curves (Table 3.4), and therefore were used to guide the recommendations. This approach avoids a recommendation for a flow higher than what would naturally occur on Hobble Creek. The wet-year summer base-flow recommendation of 21.5 cfs matches the September 80th percentile value from the Hobble Creek gage analysis (Table 3.4). The July (dry- and moderate-year) and July-August (wet-year) values were not included in these calculations because they are commonly influenced by the falling limb of the snowmelt runoff period and do not reflect a purely "base-flow" condition.

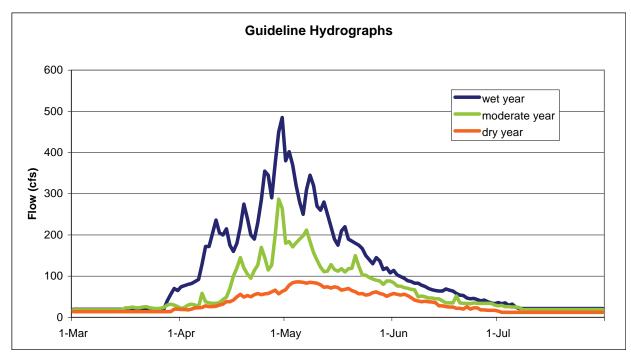
Figure 4.2. Guideline hydrographs for the springtime runoff period.

moderate, and wet years are provided in Figure 4.2. These hydrographs can be used to help guide decisions regarding the timing and magnitude of supplemental deliveries during the spring season. The plots shown in Figure 4.2 were generated by modifying the plots (Figure 3.4) derived from percentile statistics at the discontinued USGS gage.
