# JOINT TRANSPORTATION RESEARCH PROGRAM

## Synthesis Study: Overview of Readily Available Culvert Inspection Technologies

Sheth, A., & Sinfield, J. V. (2018). *Synthesis study: Overview of readily available culvert inspection technologies* (Joint Transportation Research Program Publication No. FHWA/IN/JTRP-2018/17). West Lafayette, IN: Purdue University. <https://doi.org/10.5703/1288284316789>

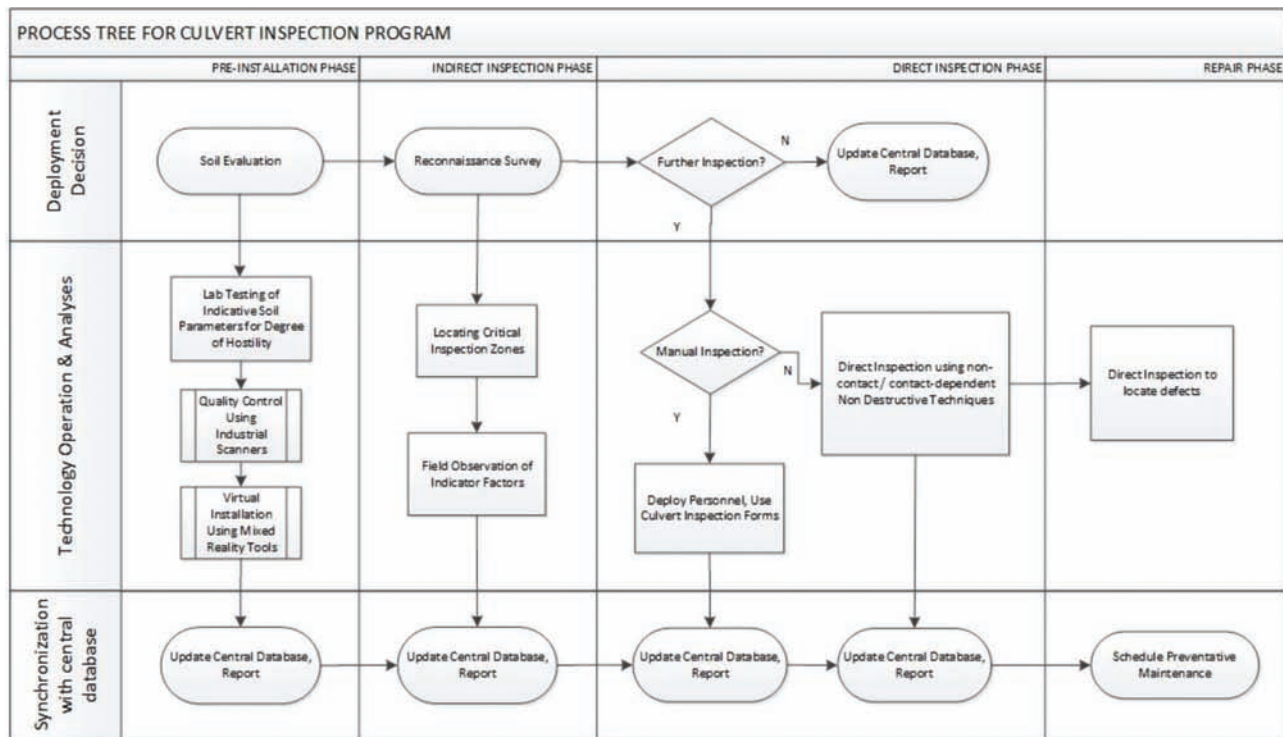
**Figure 4.1** Schematic representation of culvert inspection system process tree.

inspection process tree. The figure shows three processes and cross linkages over four phases of a typical inspection. The process begins with a reconnaissance survey to locate any above threshold deviations in roads or drainage patterns near culverts over a large zone. The reconnaissance survey may be conducted using photogrammetric tools which are either terrestrial or aerial manned/unmanned vehicles fitted with 3D mapping tools passing through the zone under consideration. Reconnaissance can be done specifically for those areas that are already marked critical in the central database. Based on the result, a decision is made on further (direct) inspection. If the culvert is accessible, visual inspection may be carried out. Otherwise, one of the proposed techniques can be employed (as described in section 5). Finally, the diagram highlights a key message that calls for a system solution to tackle the issue of culvert inspection before damage occurs. This is necessary, as although rare, culvert failures lead to high cost delays and significant overall costs.

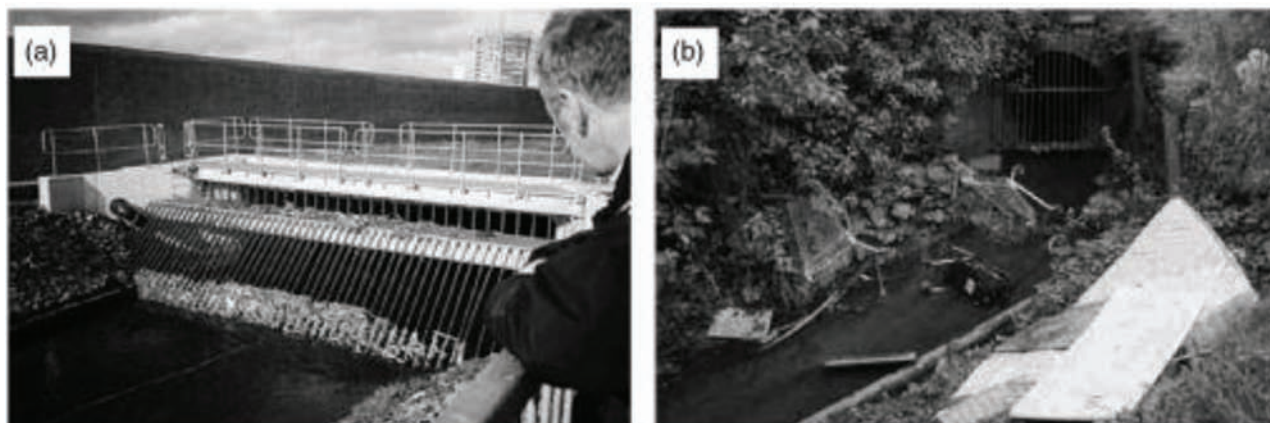
Figure 5.1 (a) Screen protecting inlet to large culvert with leaf-litter accumulation; (b) screen protecting culvert inlet on small channel with fly-tipped waste.

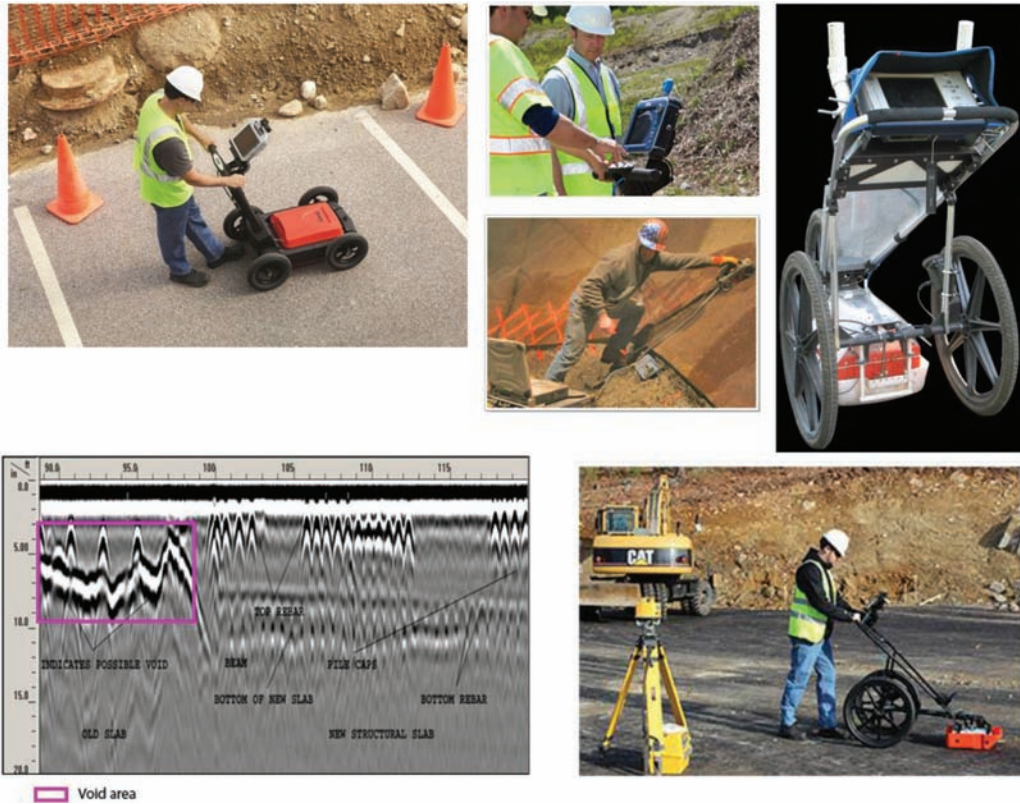
**Figure 5.8** Ground penetrating radar: equipment, in-situ operation, and application output graph showing a detected void. (Images from [envirophysics.com](http://envirophysics.com) & [alphageofisica.com.br](http://alphageofisica.com.br).)

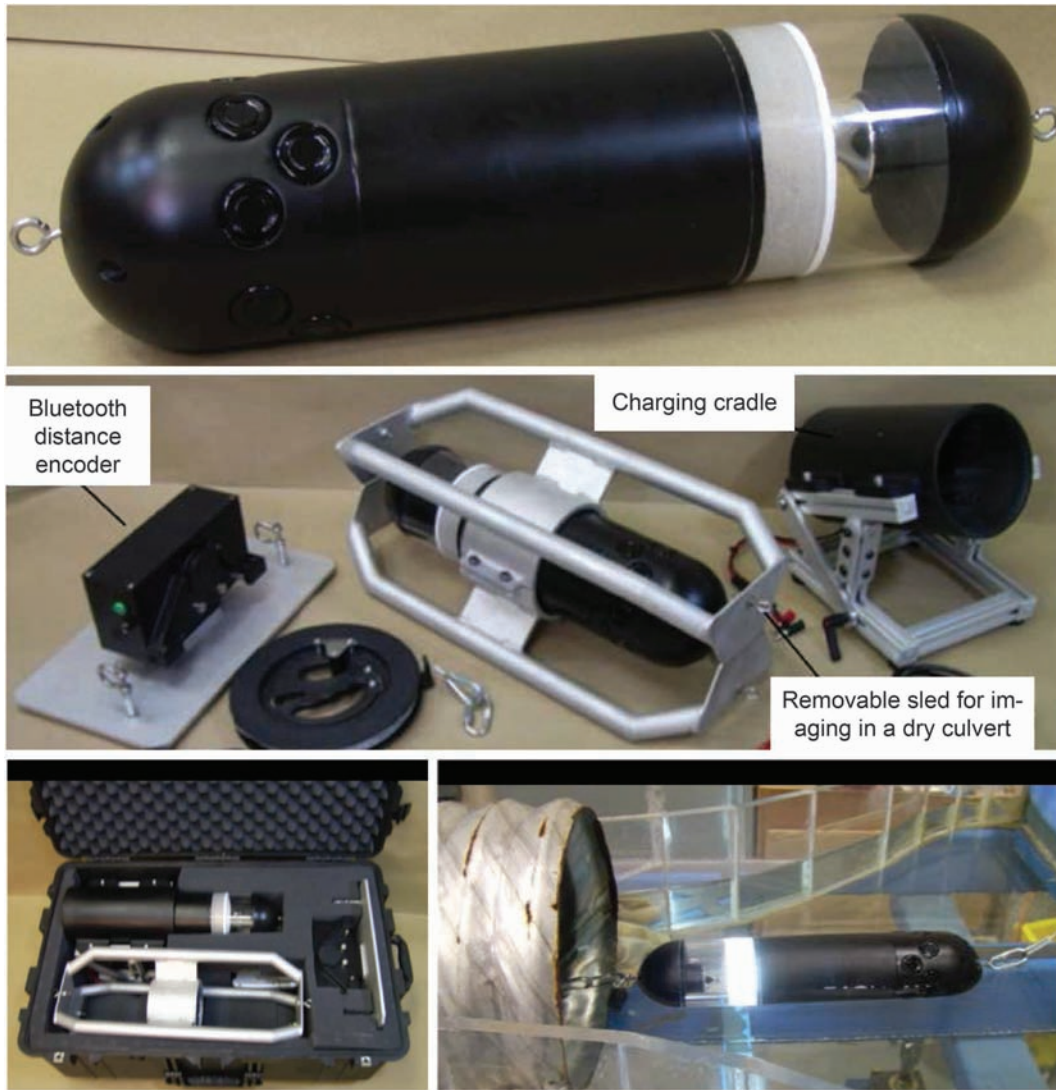
**Figure 5.12** The UCIS device, parts, case in laboratory testing. Jointly developed by SwRI and FHWA.

The UCIS was able to sufficiently locate three test anomalies on a corrugated metal culvert—a dent intruding 3 to 5cm on the top surface, a large plastic piece inserted into the test culvert mimicking debris, and sand-gravel seated in the corrugations of the pipe.

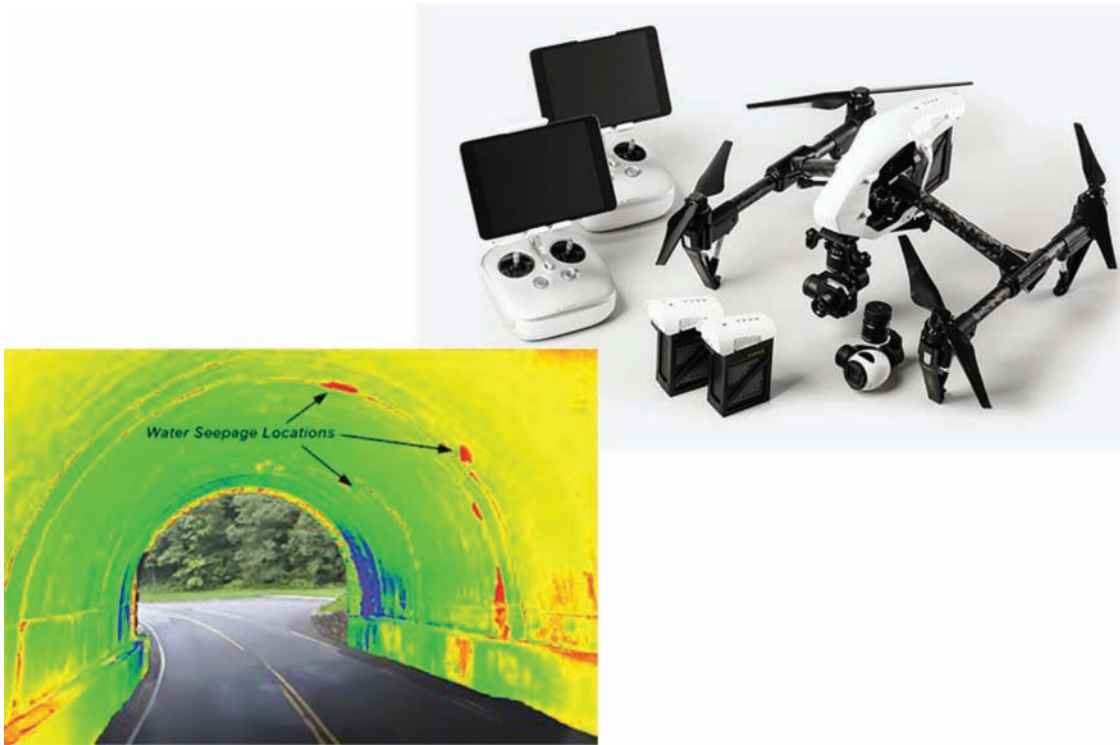
**Figure 5.15** Infrared thermography using drones. (Images from <http://www.flir.com/suas/aerial-thermal-imaging-kits/>.)

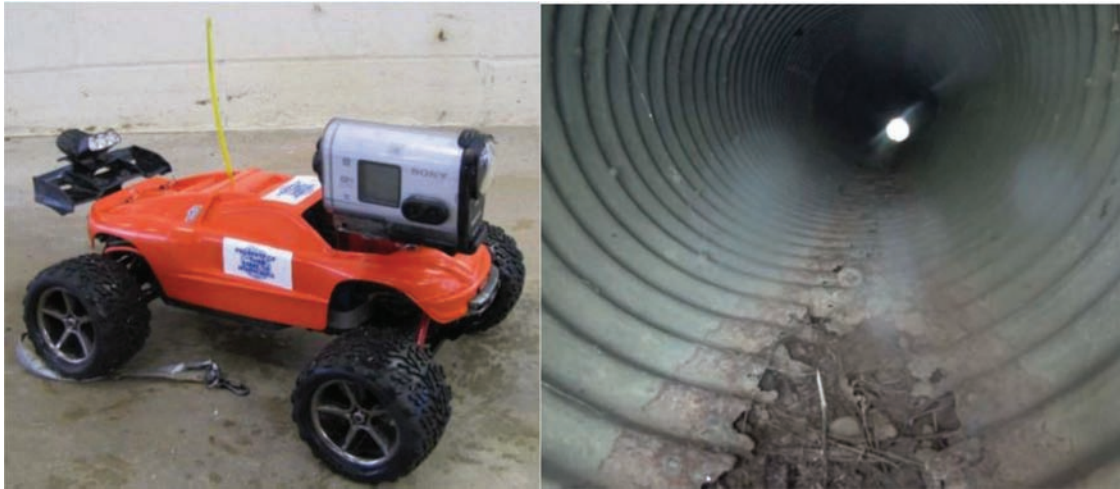
**Figure 6.6** The HIVE camera unit and image taken by it. (Source: <http://dot.state.mn.us/research/reports/2017/201716.pdf>.)

project (Youngblood, 2017) shown in Figure 6.6. In addition, being low weight was given medium to high importance. Deployability from a far distance was
