**Title:** Do deep low carbon domestic retrofits actually work?

**Authors:** Rajat Gupta and Matt Gregg

Low Carbon Building Group, School of Architecture, Oxford Brookes University, Oxford OX3 0BP

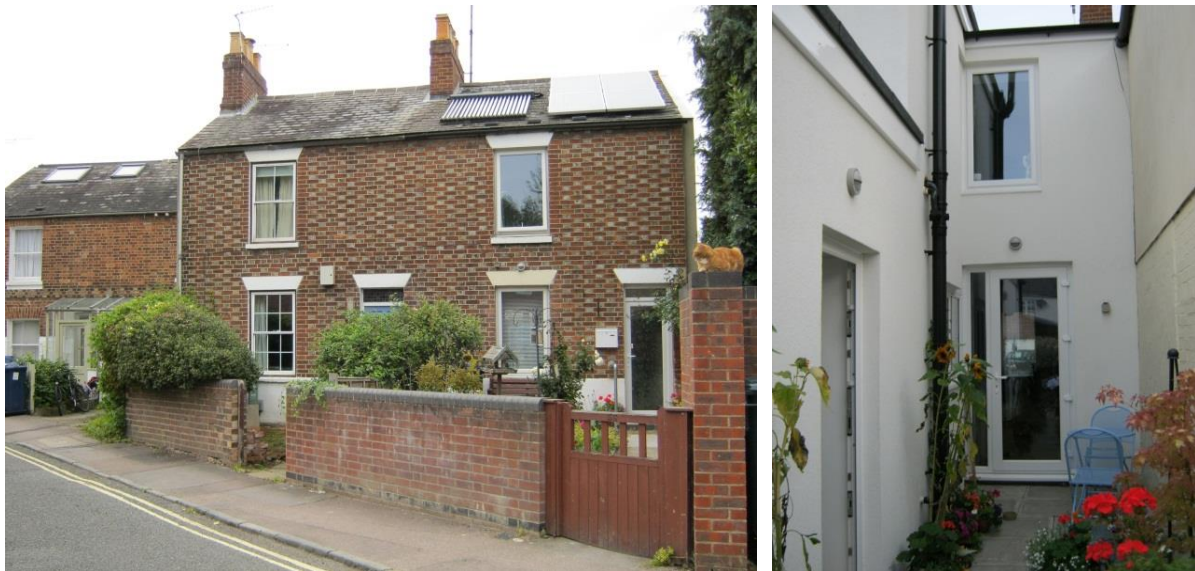
**Figure 1** Victorian dwelling post-retrofit – front (left) and rear (right) facades

The original exterior façade of each dwelling was preserved through the use of internal and cavity wall insulation (figures 1, 2 & 5); external solid wall insulation was installed on the rear. The ventilation strategies were different; a MVHR system was proposed to ensure good levels of IAQ for the elderly occupants in the Victorian terrace. The modern home was retrofitted with built-in, secure, louvered, ventilation panels on the two levels and an automated roof-light (figure 6). This strategy was selected since the occupants in the modern house were smokers and were accustomed to opening windows frequently. With regard to retrofit process, the occupants of the Victorian home were decanted and the modern home occupants stayed in the dwelling through the process. Apart from minor annoyance brought up in occupant interviews for the modern home, no link at this stage can be made between process and overall outcome apart from theorizing that when construction teams are forced to work around occupants, work can be rushed and attention to detail can suffer. In the end, both dwelling's occupants found the retrofit process inconvenient.

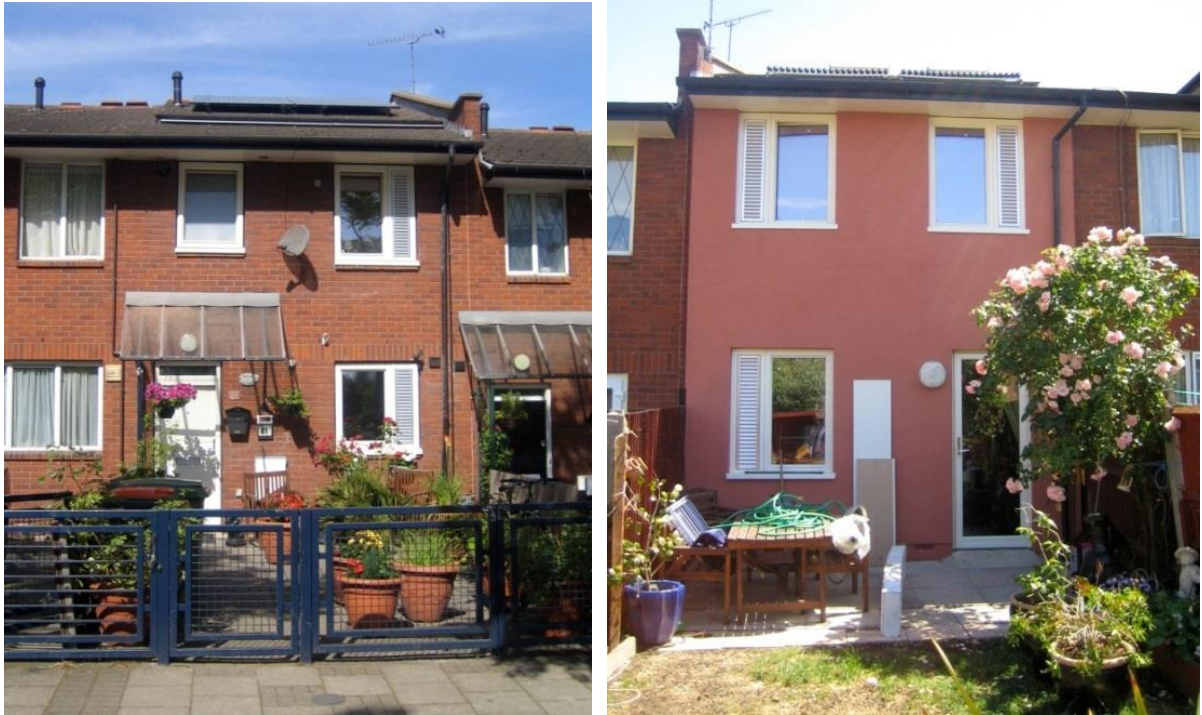
**Figure 2** Modern dwelling post-retrofit – front (left) and rear (right) facades

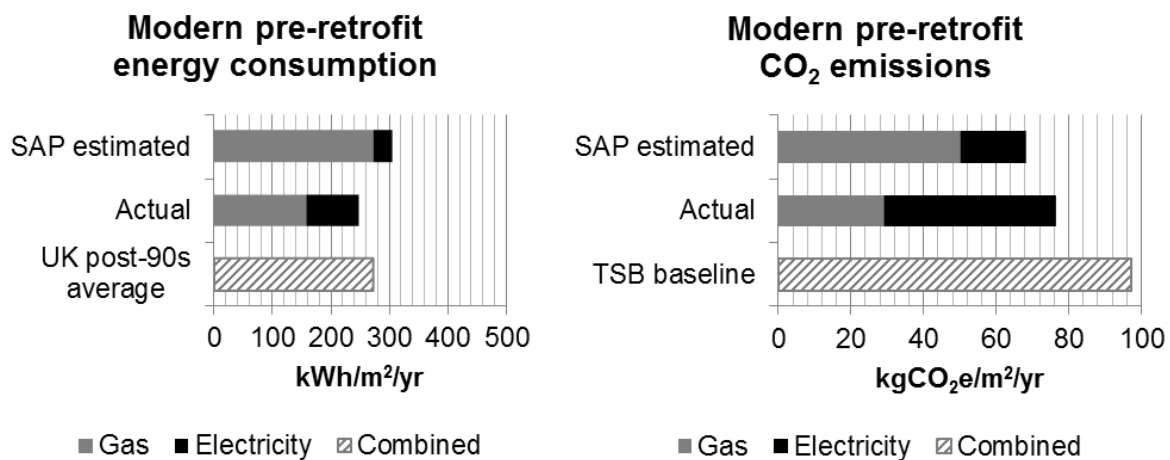
**Figure 4** Pre-retrofit energy consumption (left) and CO<sub>2</sub> emissions (right)

Pre-1919 Victorian homes in the UK have an average mean energy use (heating and lighting) of 480 kWh/m<sup>2</sup>/yr. Post-1990 dwellings' mean energy use is 270 kWh/m<sup>2</sup>/yr. The difference is due to a progression in awareness and concern of fossil fuel consumption and a greater understanding of building physics as time passed [6]. Therefore, it was expected that the Victorian home would consume more energy and be more difficult to retrofit than the modern home. In reality the Victorian home was consuming less pre-retrofit gas and electricity than the modern home (figure 3 & 4). The

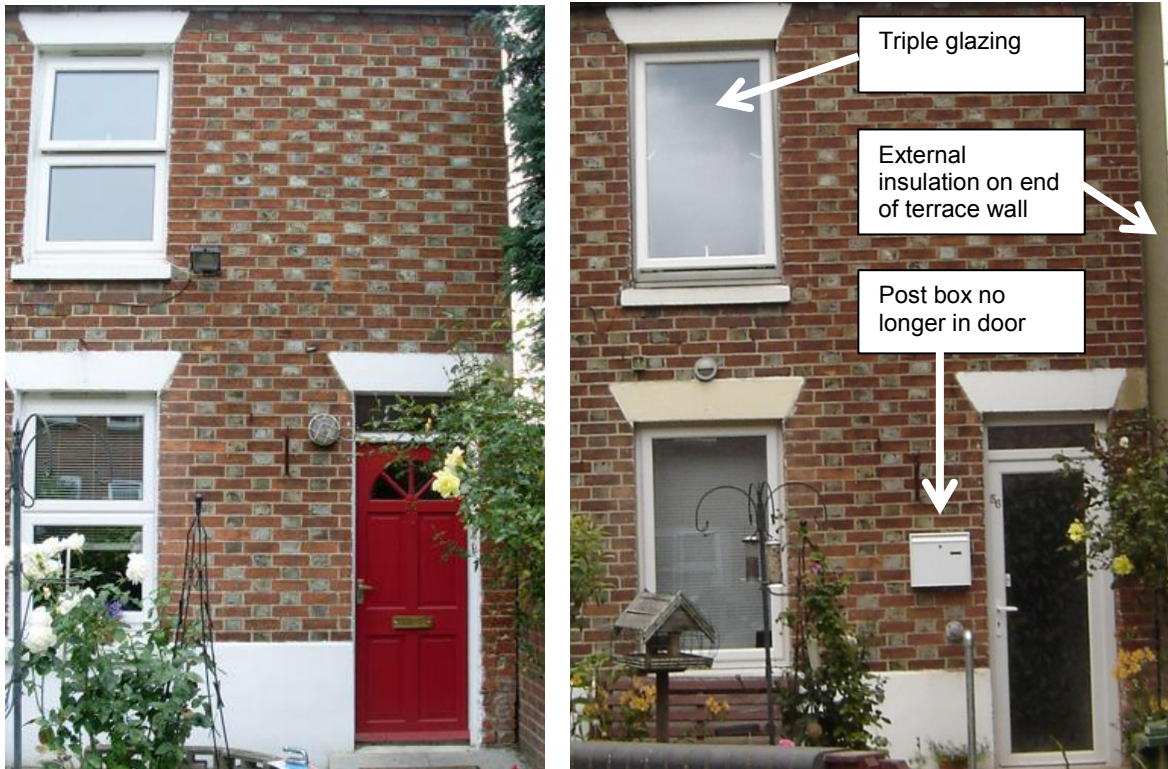
**Figure 5** Front façade of Victorian house before (left) and after retrofit (right)

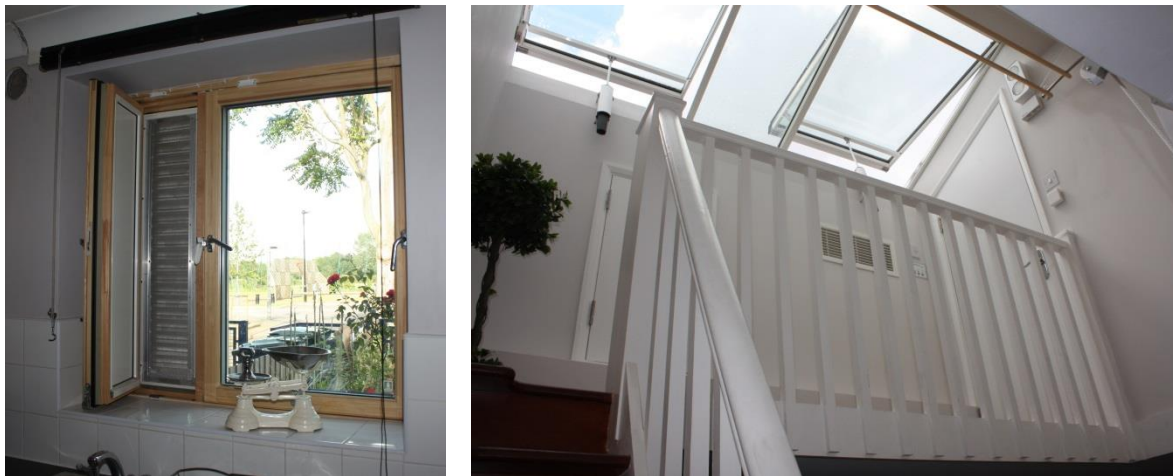
**Figure 6** Modern house triple glazed windows with side ventilation panels (left) and automated roof-lights (right)

In the modern dwelling, temperatures were found to be well regulated and constant but higher than recommended. Primary spaces exhibited overheating; however, occupants found the home thermally comfortable with no mention of discomfort from high temperatures. RH levels are as recommended and IAQ is good; CO<sub>2</sub> levels were predominantly below 700 ppm, while 90% of occupied hours were below 1000 ppm. Good IAQ was also highlighted by the user feedback surveys. The interviews revealed that the occupants leave the ventilation panel slightly open throughout the day and night since they provide adequate safety and privacy in the open position. As the occupants are smokers,

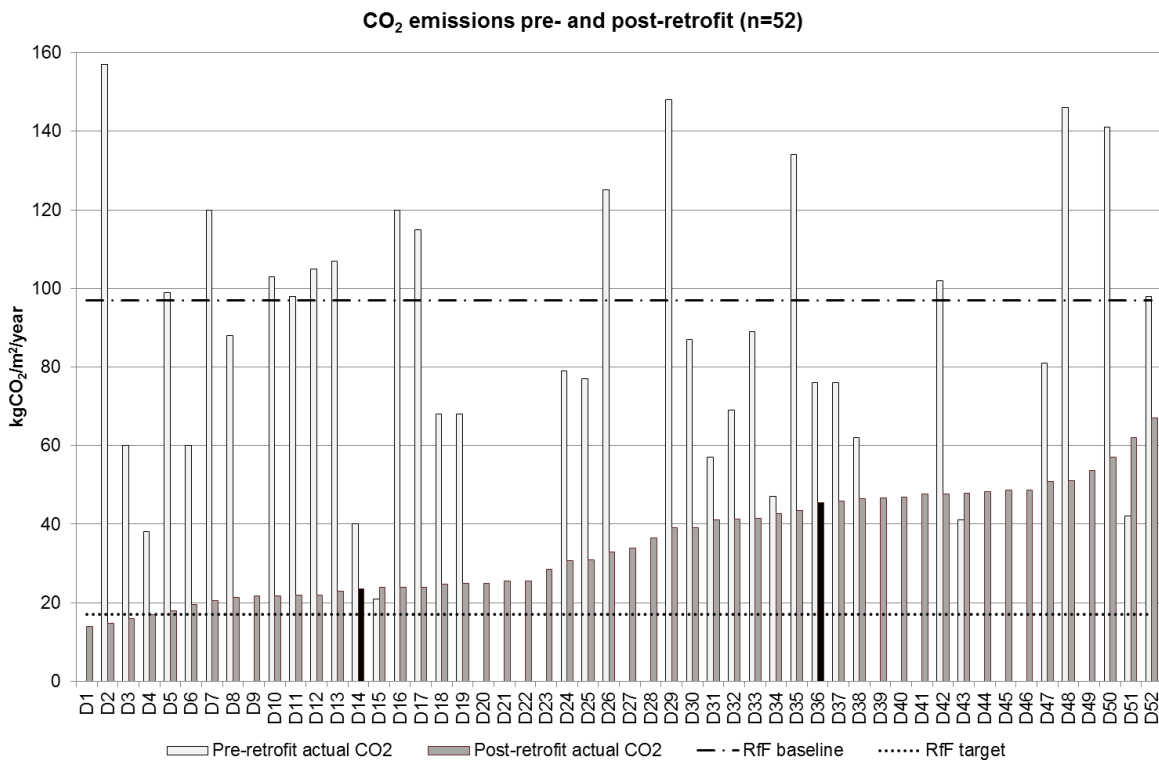
**Figure 9** Pre- and Post-retrofit CO<sub>2</sub> emissions for a select number of RfF projects [6, 34, 35]

Figure 9 shows the two dwellings among a select number of RfF projects for which final CO<sub>2</sub> emissions figures are available. Of 52 projects the Victorian dwelling (D14) ranks 14 and the Modern dwelling (D36) ranks 36. Four dwellings met the target.

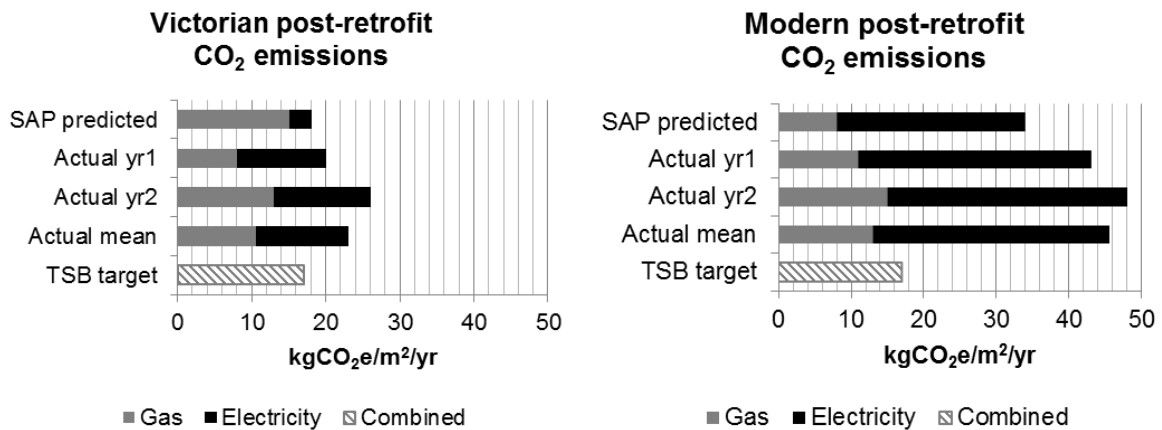
**Figure 10** Post-retrofit CO<sub>2</sub> emissions, Victorian dwelling (left) and Modern dwelling (right)

Both households increased emissions (heating and unregulated; though mostly heating) in the second year of occupancy (figure 10). The presented data is not weather corrected; however, the increase in consumption over the second year is attributed to colder weather experienced in 2012 (26%, Oxford & 27%, London increase in Heating Degree Days in 2012 over 2011). When gas consumption is

normalised for the weather for the two years in both dwellings, both dwellings actually used less energy than expected in the second year, whereas the first year was slightly higher. For the Victorian dwelling mean actual annual energy consumption is below the post-retrofit predicted but because actual electricity consumption is much higher than predicted electricity consumption, the carbon emissions are higher as the emissions from electricity are greater.

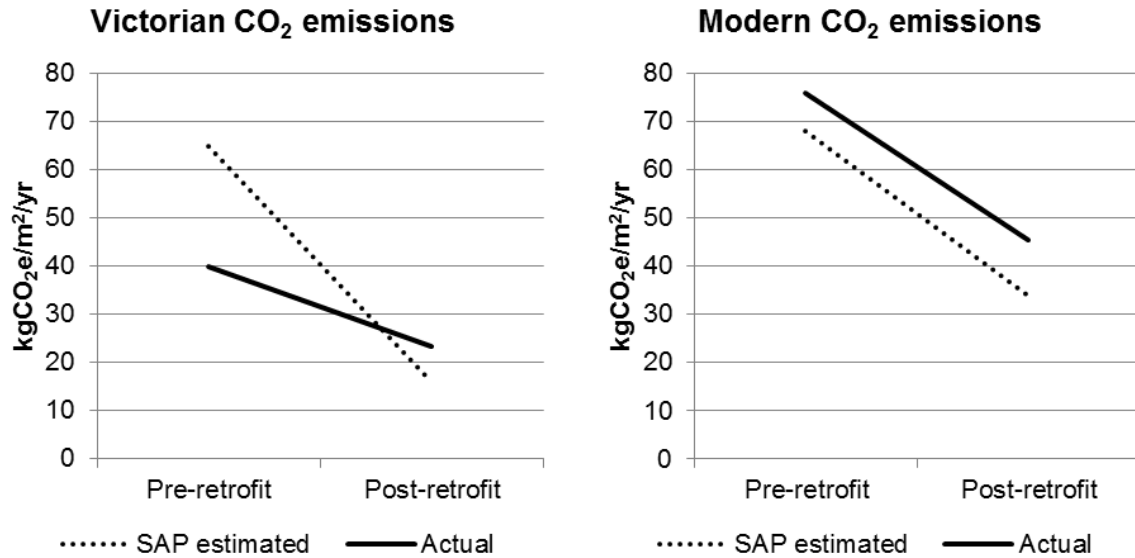
**Figure 11** Pre- and post-retrofit CO<sub>2</sub> emissions, Victorian dwelling (left) and Modern dwelling (right)

Electricity consumption has been the most problematic to predict. Though the Victorian home was successful in consuming less gas than predicted, actual post-retrofit electricity consumption was four times what was predicted. The graphs in figure 11 show the steep slope of the SAP estimated indicating the ambition of the programme. For the Victorian dwelling the slope was not as steep in reality as the pre-retrofit actual emissions were significantly lower than estimated and the post-retrofit emissions were not as low as targeted. For the Modern home, the CO<sub>2</sub> emissions gap in reality was relatively proportionally in line with modelling estimations both pre- and post-retrofit. The figure's pre-retrofit performance gap reflects a common finding across Europe that generally, new dwellings have higher energy consumption than expected and older dwellings have lower consumption [36]. With regard to SAP in particular, the assumed demand temperature for living areas of 21°C may not apply to older dwellings [3]. This was especially true in the Victorian dwelling.

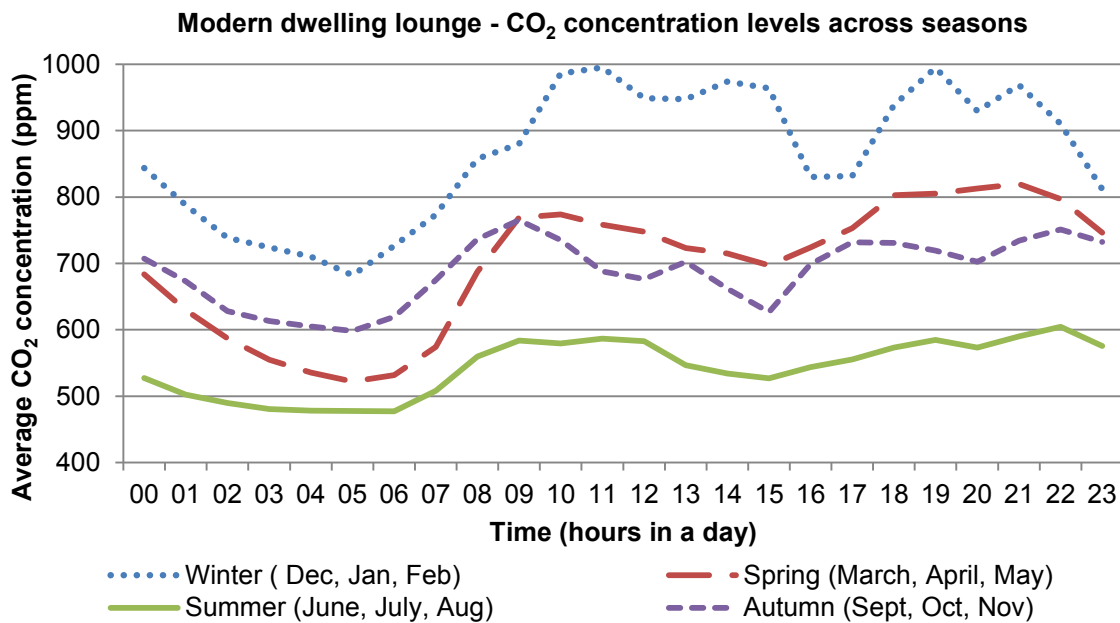
Figure 12 Modern dwelling average hourly CO<sub>2</sub> concentrations in the lounge across seasons

this is a significant improvement in ventilation capability over pre-retrofit conditions. Figure 12 indicates that the ventilation panels are effective, however, obviously as they cannot be used as often in the winter the highest CO<sub>2</sub> concentrations are in winter.
