Energy Conservation Improvement of the Existing Building Park, Constraints and Challenges

Case of granite traditional constructions in the United Kingdom

BENNAJDI, A., SCOTT, J., TAYLOR, B.

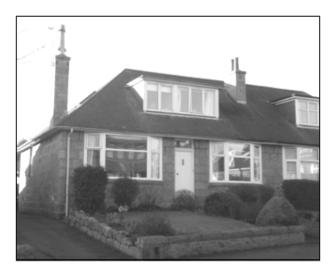
Figure 1: View of the house 1

Case Study One: Semi-detached dwelling house, suburban, 1930'S. Originally four family rooms downstairs, two upstairs home, this has undergone significant adaptation during the intervening period due to changing demographic, technology and fashion. Significant alterations have been conducted to include space additions to the roof and most recently to the rear of the building. Technologically, there has been a change to the heating and an increase in the electrical appliances within the building.
