ECOLOGICAL ENGINEERING
AND
BIOLOGICAL POLISHING
FOR DRAINAGE FROM THE FARO
WASTE ROCK DUMPS (WETLANDS)

prepared by: **Margarete Kalin**
R.O. van Everdingen

August 31, 1990

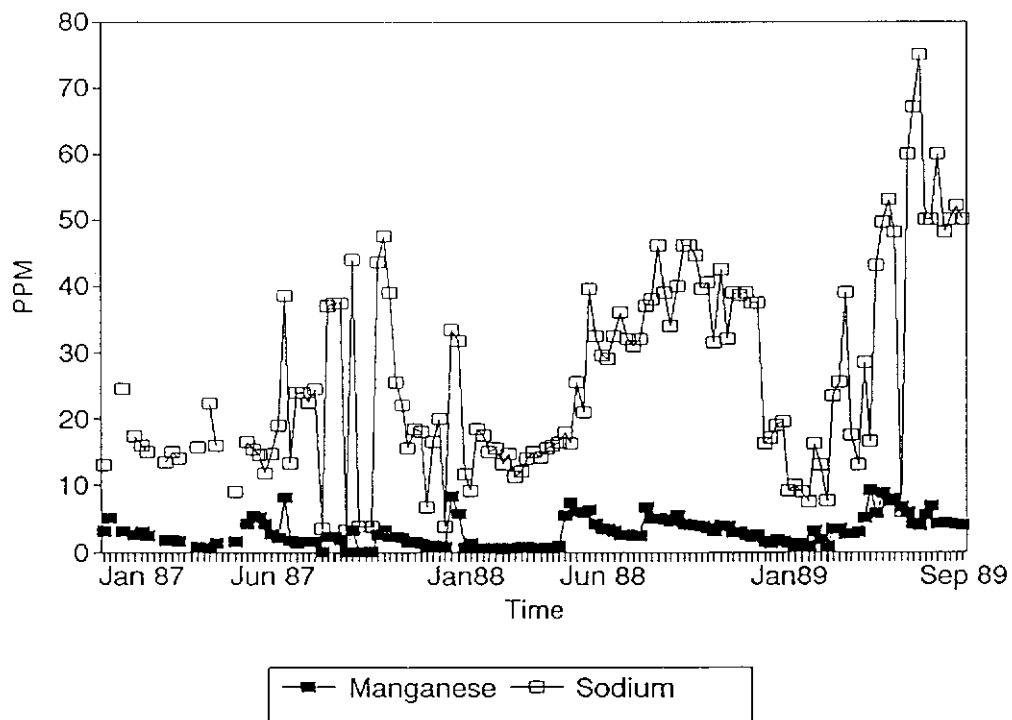
Figure 1: Manganese and Sodium Concentrations in Faro X22

Selective data from stations X22 and X23 (Tables 3a, 3b and 3c) were plotted to highlight seasonal and long-term trends. In Figure 1, the concentrations of Mn and Na are presented

for the period of January 1987 to September 1989. The same data for station X23 are shown in Figure 2. For Na, some seasonal trends appear to be present; concentrations are lower in winter than in summer. For X23, on the other hand, a seasonal trend is less evident. Concentration shifts occur for both Mn and Na in the same fashion.

The water at station X22 is basically that water collecting in the Zone I/III pit, and thus represents a collection of all the wall seeps. These wall seeps are Faro creek water and Faro Valley ground water which has run through different geological formations and waste rock sites upstream from the pit. The water characteristics of X23 reflect the changes in water as X22 water runs through a major portion of the waste rock. Water sampling station X23 is the seepage emerging from waste dumps in the Faro stream valley downstream from the pit. It represents precipitation from the dumps plus seepage losses from the unlined ditch conveying X22 water over the dumps. Therefore, X22 can be considered partly the recharge for X23. Comparison of the two types of water shows that the concentration of Na averages slightly lower, and that of Mn, slightly higher in X23 than in X22. It could be hypothesized that this subtle shift is due to acid generation and subsequent neutralization with disseminated carbonates and silicate minerals (Rhodochrosite - MnCO_3 is probably present). The noted shifts in concentrations of Na and Mg could also be brought about by different interactions of precipitation in the dumps of various ages. Or, alternatively, particularly explaining 1987 trends, the large water volumes which were passing through the system as the pit was dewatered may have caused some of these shifts.

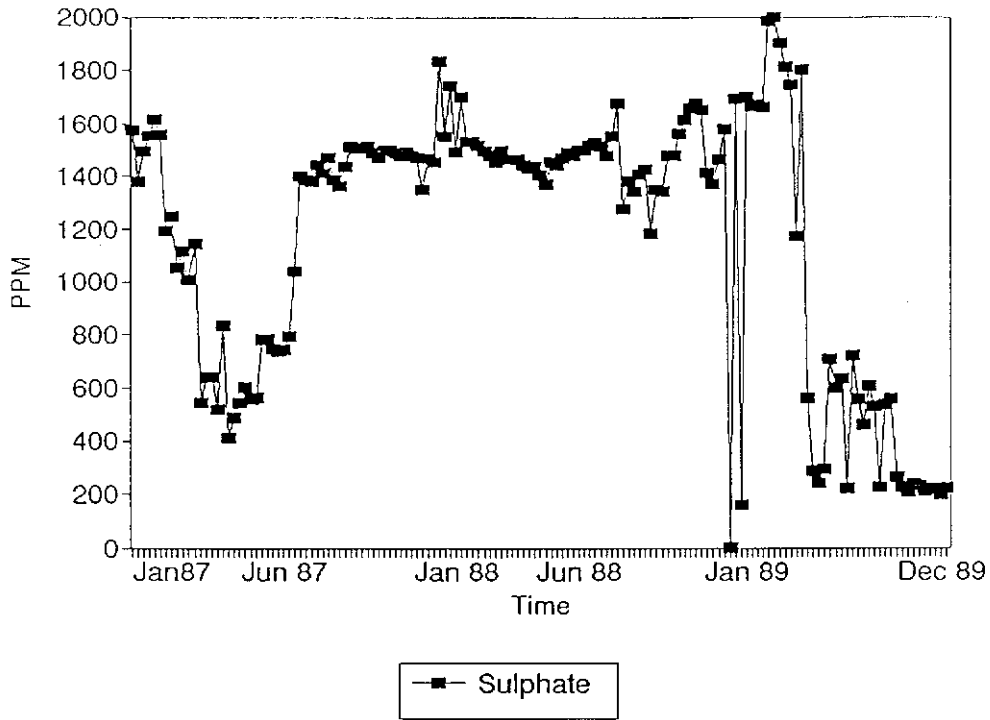
Figure 3: Sulphate Concentrations in Faro X23

Assuming that oxidation of pyritic material is driven mainly by temperature, then a decrease in sulphate would be expected during winter. This phenomenon should be more pronounced in X22 than in X23, given that the X23 water is more insulated inside waste rock pile. Seasonal trends are evident, indicating a drop during the winter and a slight increase in summer. A significant drop in sulphate concentrations in the winter of 1989 from about 1600

mg/l to about 500 mg/l has occurred at X23. It cannot be determined if this is attributable to the temperature regime in the waste rock pile or if it is due to changes in the flow pattern of the X23 seepage. Analyses by Assayers Ontario Ltd. of water collected by Boojum Research Ltd. from station X23 for a) *Chara* toxicity tests and b) for the determination of the distribution of elements in suspended particulate form collected in March and April 1990, are given in Table 4. These results suggest that the sulphate concentrations remained around the higher level and did not drop as indicated by Curragh Resources monitoring data. From these data, it is also evident that some fraction of the Na and Fe in the water is present in the suspended form (compare March 90 filter paper to filtered acidified in Table 4). All other elements occur essentially as dissolved components. The same conclusion has to be reached when the three April 1990 samples are evaluated (Table 4). The Fe concentrations are erratic, as the total acidified water has lower concentrations than the filtered-acidified water to which no acid was added. This essentially indicates that Fe numbers are erratic due to formation of iron-rich flocculants and the variable adherence of iron to storage container walls prior to analysis. Overall, these observations confirm that Fe is precipitated in the waste rock pile as the acid generated is neutralized.

Interpretation of X23 seepage water sulphate is confounded by the fact that ore stockpiles are located above the X23 site. Seepage from the ore stockpiles must contribute to the water quality at X23. It is interesting to note that the ore stockpiles were at an all time low in the winter of 1989 when sulphate concentrations at X23 were low. An 800,000 tonne oxidized ore stockpile was screened and coarse fraction processed between September 1986 and March 1987. The fines remain stockpiled above station X23.

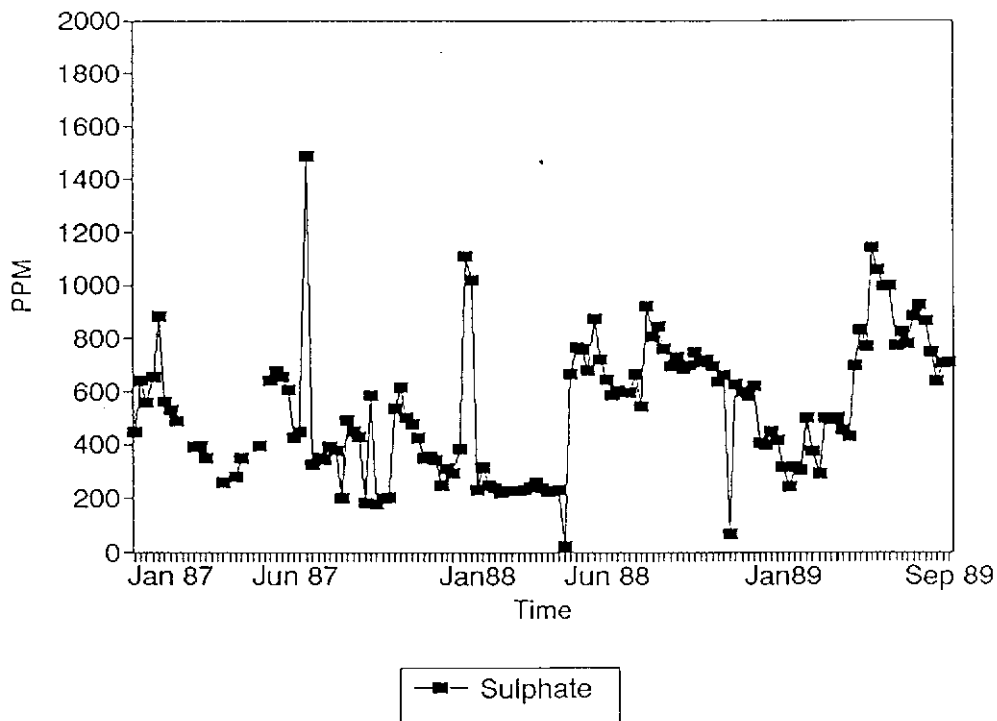
Figure 4: Sulphate Concentrations in Faro X22

Acid-generation in the waste rock dumps followed by neutralization could proceed to different degrees in different sections of the waste rock pile. This should be detectable from the sulphate concentrations in X23 and X22 (Figure 3 and Figure 4). If temperature is a major controlling factor, AMD would be expected to be more extensive in the waste rock pile than in the wall seeps which collect in the pits. The waste rock pile is expected to reach higher temperatures due to the breathing phenomenon of waste rock piles. At X23, sulphate concentrations are in fact higher (around 1400 mg/l) than those of X22, generally ranging between 400 and 800 mg/l.

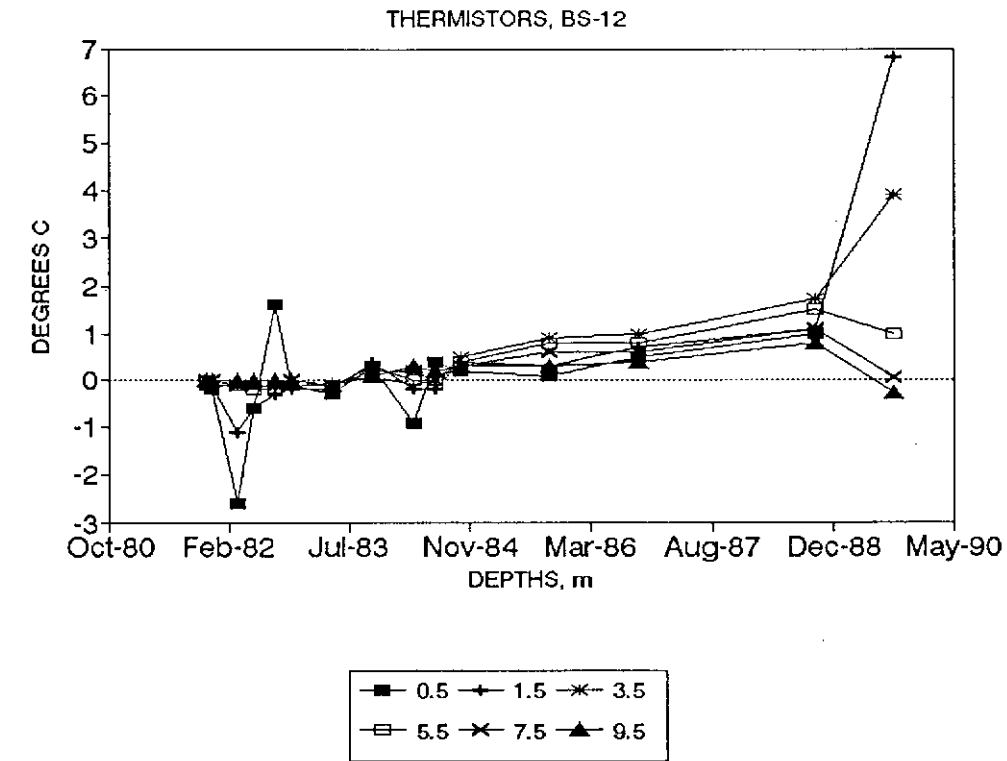
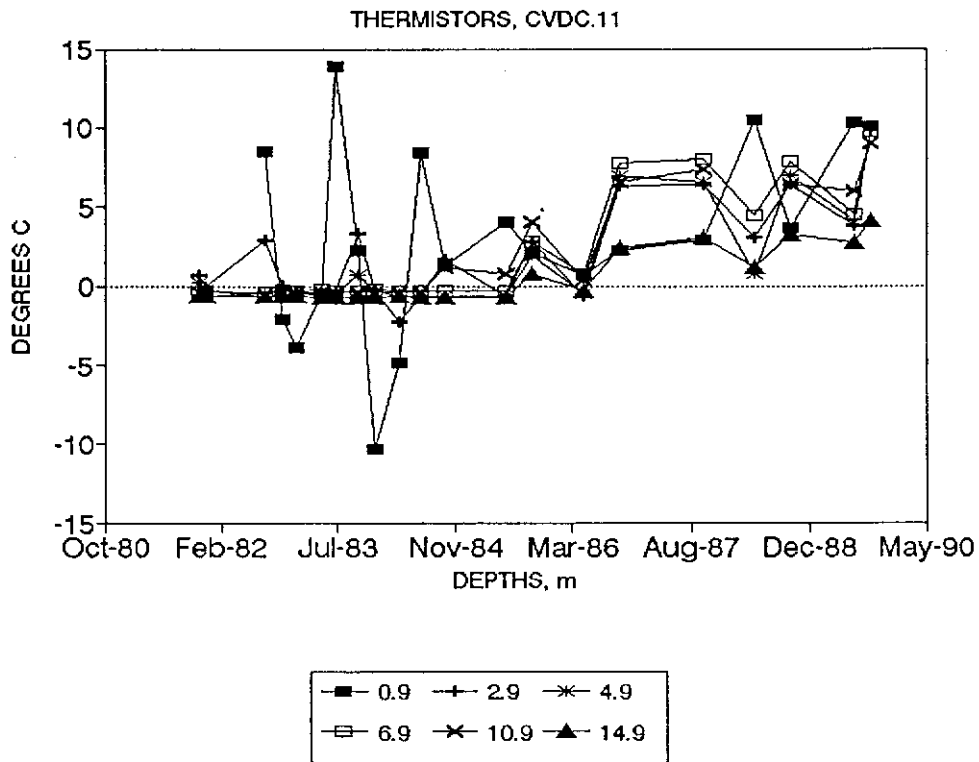
Figure 10: Thermistor Readings from Boreholes in Tailings Area

Thermistor strings have been installed in a number of boreholes in the tailings area in 1981, 1985 and 1988. Permafrost was found to exist in some locations, particularly in north-facing slopes. In at least two locations, the measurements indicate that permafrost is thawing (Figure 10). Unfortunately, the varying frequency of measurements and the often long intervals between successive measurements (up to 2 years; Figure 11) make it difficult to distinguish between natural temperature variations and changes due to deterioration of the thermistors. The latter commonly occurs as a result of the saturation of cable insulation with water. Figure 11 demonstrates the improvement in information quality that resulted from recently increased measurement frequency. The 1989/90 part of Figure 11 provides a much improved representation of the ground thermal regime, allowing at least preliminary estimates of both the phase shift and the attenuation of the temperature cycle with depth. Figure 12 demonstrates that measurement intervals should be no longer than 4 weeks, and preferably no longer than two.

These brief evaluations of the temperature and thermistor string data lead to the following recommendations. Thermistor readings should preferably be taken at regular intervals of two weeks. The resulting temperature data should allow adequate definition of the thermal regime of the ground.
