Anesthesia and Resuscitation

# Migration of a Correctly Positioned Tip of a Central Venous Catheter from the Superior Vena Cava to the Left Subclavian Vein within a Short Time

Shiro FUKUDA<sup>\*1</sup>, Hiroaki MATAYOSHI<sup>\*1</sup> and Nanae MIYAKE<sup>\*1</sup>

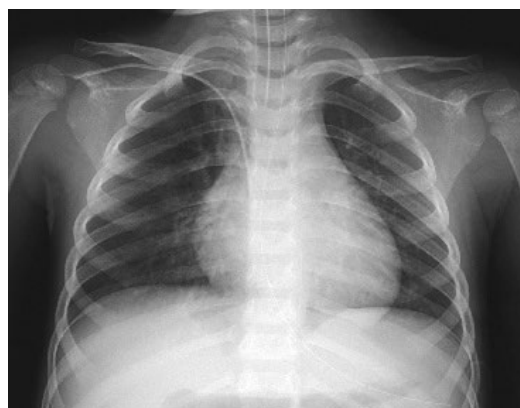
Figure 1: Chest image on day 4 in the intensive care unit. Plain radiography of the chest is used to assess the position of the catheter tip after insertion of the central venous catheter via the right subclavian vein approach. The catheter tip is correctly located slightly caudal from the tracheal bifurcation.

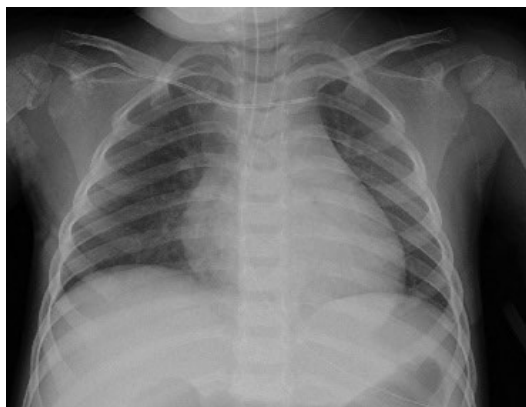
Figure 2: Chest image on day 11 in the intensive care unit. Plain radiography showing that the central venous catheter that was placed via the right subclavian vein approach continued horizontally to the left side of the patient's body trunk, and the tip migrated into the left subclavian vein. There are no significant differences in the length of the catheter inside the patient's body, lung field radiolucency, or heart shadow compared with those in Figure 1.

mandatory ventilation and pressure support of 8 cmH<sub>2</sub>O with positive end-expiratory pressure of 5 cmH<sub>2</sub>O, an inspired oxygen concentration of 0.4, and a respiratory ratio of 24/min. At that time, the central venous catheter was removed from the right internal jugular vein, as its length or placement in the body was insufficient. Instead, central venous catheterization using the same type of catheter was performed with the right subclavian vein approach, inserted for 8.0 cm. The catheter length from the junction between the SVC and innominate vein was approximately 3.5 cm judged by chest radiography. A chest radiograph taken immediately after placement showed that the tip nearly reached the inlet section of the SVC of the right atrium, which was deemed sufficient (Figure 1). On day 5 in the ICU, the patient was started on a continuous infusion of fentanyl. Seizure-type body movements, however, continued. A routine chest radiograph on the morning of day 11 in the ICU showed that there was no abnormality in the catheter tip position. However, the infusion pump obstruction alarm sounded and a second chest radiograph was obtained on the same day, which revealed that the catheter tip had migrated to the left subclavian vein (Figure 2). We believe that the migration of the catheter tip itself had no

The catheter tip migration in the present case could have been caused by the regular thoracic movement from the artificial ventilation.<sup>5)</sup> With the subclavian vein approach, catheter fixation is believed to be superior to that with the internal jugular vein approach. However, considering the mobility of the shoulder joint, it is possible that the catheter could shift position during seizure-like body movements involving involuntary movements and instability of intrathoracic pressure, whether or not the person is receiving artificial ventilation or sedation.

It is also possible that the central venous catheter position may have shifted due to the "jet effect" that occurs

during drug injection.<sup>6)</sup> This is a phenomenon wherein pressure during drug injection via a catheter causes the catheter tip to move. After intubation and exchange of the CVC, the patient in the present case received continuous infusion of fentanyl (5–15  $\mu\text{g/hr}$ ), midazolam (2.4–7.2 mg/hr), and dexmedetomidine (8–12  $\mu\text{g/hr}$ ) intravenously, and 2–6 mg of midazolam was additionally injected for sedation several times daily until the migration of the tip was recognized. However, the "jet effect" may not have played a role in the catheter movement, because the size of the catheter was small, and the frequency of the bolus injection had decreased from seven times to once by the time the CVC tip migration occurred.
