O'Sullivan, J. B. and Hussey, K. M. (1957) "Problems Associated with Soils Stabilization. in the Vicinity of Point Barrow, Alaska," *Proceedings of the Iowa Academy of Science*: Vol. 64: No. 1 , Article 45.
Available at: <https://scholarworks.uni.edu/pias/vol64/iss1/45>

Problems Associated with Soils Stabilization in the Vicinity of Point Barrow, Alaska

By J. B. O'SULLIVAN and K. M. HUSSEY*

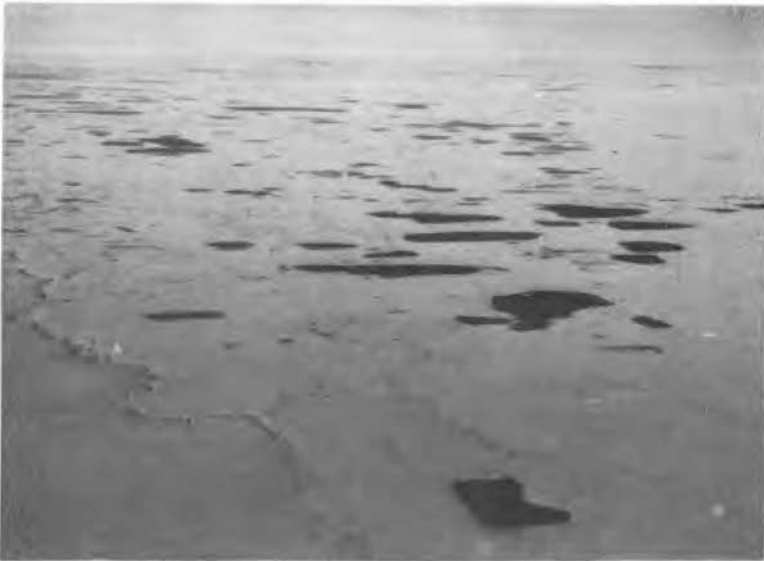
Figure 3. Oriented lakes of the Northern Arctic Coastal Plain though polygonal ground is present, scale too small to be defined.

Many of the elongated lakes (Figure 3) are oriented with their long axis approximately 10° to 15° west of north in the vicinity of Barrow. This orientation is true especially for the more northern of the coastal plain lakes. The exact reason for this orientation is not obvious. Black (1) and Livingstone (2) have both appealed to the

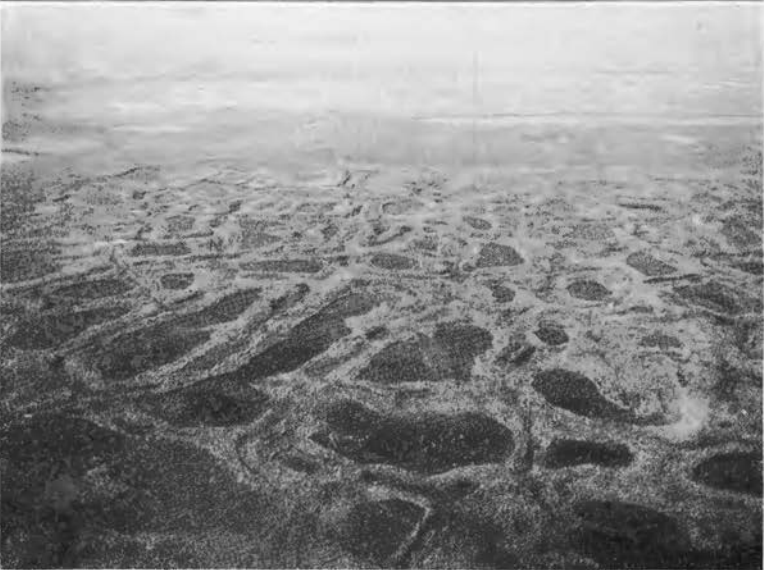
Figure 4. A view of the tundra with the ubiquitous Polygonal ground (Low centered Variety).

In brief, the polygonal ground (Figure 4) found in evidence over practically the whole surface of the tundra is caused by the forming of contraction cracks in the frozen ground during the annual fall freeze-up. Water from the spring thaw fills these cracks and later freezes causing wedge shaped masses of ice to occur in the network of cracks. These wedges grow by annual accretion until, as in some areas, they may make up over 70% of the material immediately underlying the surface. These cracks ideally tend to develop in a hexagonal pattern comparable in expression to the pattern in columnar basalt, mudcracks, and lake icecracks, except on a much larger scale averaging 15 feet with exceptional ones over 50 feet. Since conditions are not ideal, due mainly to slope, heterogeneity of materials, and differential heat transfer, the ice-wedges are seldom arranged in the ideal hexagonal pattern. Such variations as squares, rectangles, and semicircles are common. Permafrost, perennially frozen ground, allows their growth and protects them from ordinary thermal destruction. The initial growth of the wedge displaces material laterally and upward causing the formation of micro relief. Surface drainage, which is largely controlled by the polygonal pattern, adds to the total relief attained.

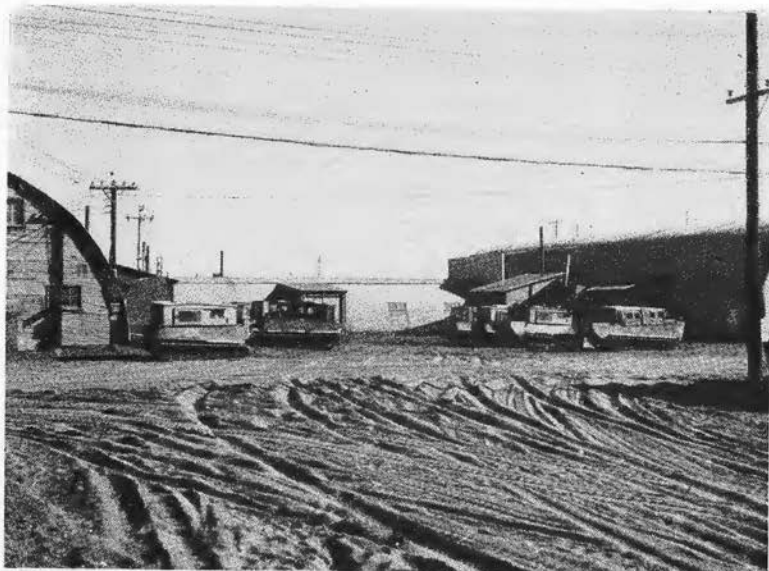
Figure 5. View of beach used as road at Barrow Base. Note "weasels" and deep ruts in low bearing capacity gravels. The deeper ruts are made by jeeps and trucks.

Runways are especially vital in this day of jet aircraft where an extremely long runway and high take off speeds are necessary, this requires a smooth surface hardly attainable by steel matting laid on nonstabilized beach material of inherent low stability (Figure 5). Any use of heavy transports requires that a large strip be available, some of the planes landing on the strip at Barrow would be unable to take off if they were fully loaded; as it is, the strip is just long enough for take-offs when they are empty. Considering the conditions air freight is the only possible method of transportation in the summer since ocean travel is restricted to a few short unpredictable weeks, and the distance of passage and ground conditions over the tundra make surface travel impossible.

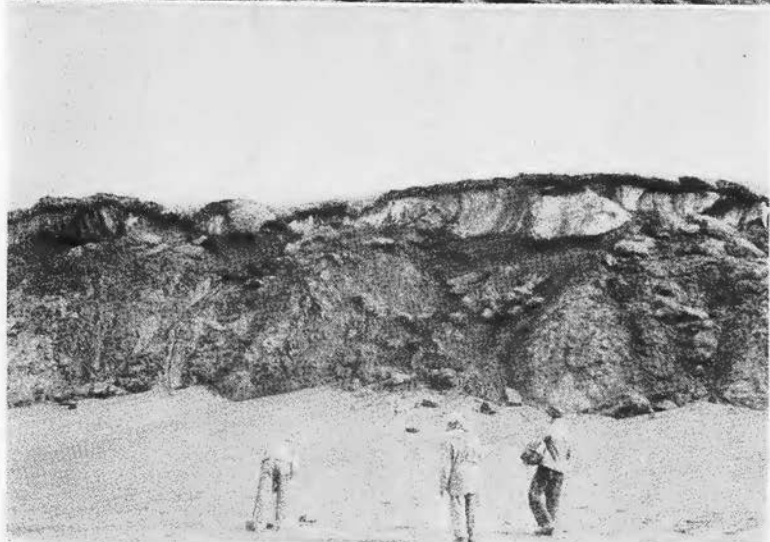
Figure 6. Ice wedges below surface of tundra as exposed in cliffs, about 8 miles below Barrow Base.
