Proceedings of the Iowa Academy of Science

A NOTE ON A SINK HOLE

E. J. CABLE

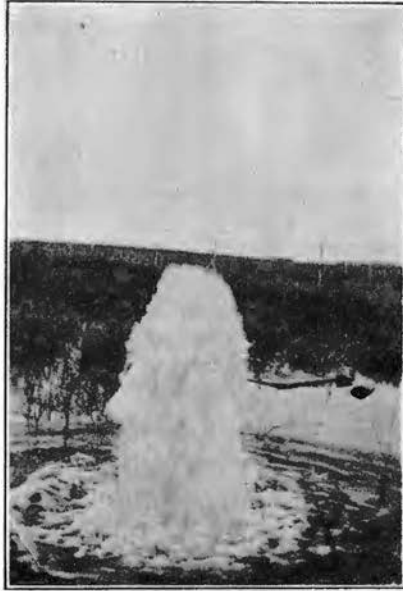
Fig. 32. Sink hole south of Rolfe, Pocahontas county.

hole not only filled up with water, but became a spouting spring. A column of water several feet high and several inches in diameter was continuously forced up. The phenomenon was so unusual that its fame spread and people came from considerable distances to witness the novelty. Although the spouting was continuous for three or four weeks the amount of water forced up varied and it was observed that there was a gradual decrease in the flow, until after the heavy spring rains the flow ceased and finally even the lakelet disappeared. Compare figures 32, 33 and 34.

That the water was not the immediate run-off was shown by the fact that the water forced up through the sink hole was clear and free from sediment. The phenomenon may have been due either to tile ditches connected with this particular sink hole, or a natural drainage to this particular joint or fissure. Sufficient underground drainage was directed to the joint to develop the hydrostatic pressure.

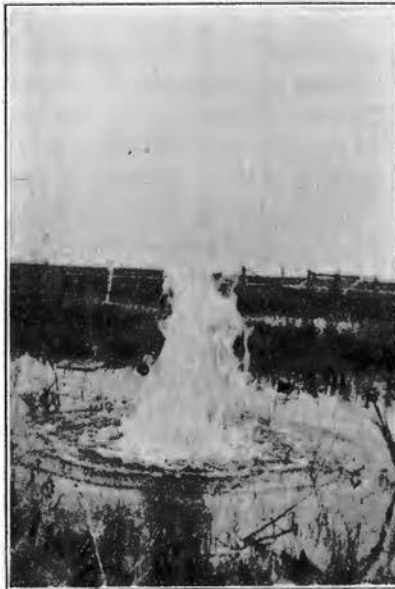
Fig. 33. The same sink in a later stage.

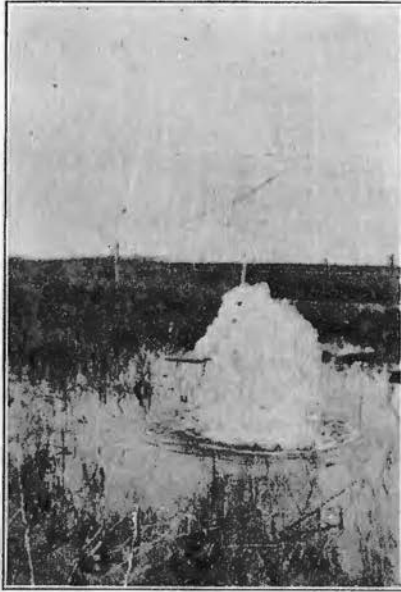
Fig. 34. The same sink in a still later stage.
