EARTHQUAKES IN CENTRAL ITALY IN 2016: COMPARISON BETWEEN NORCIA AND AMATRICE

Keywords: 2016 Central Italy earthquakes; damage prevention; strengthening.

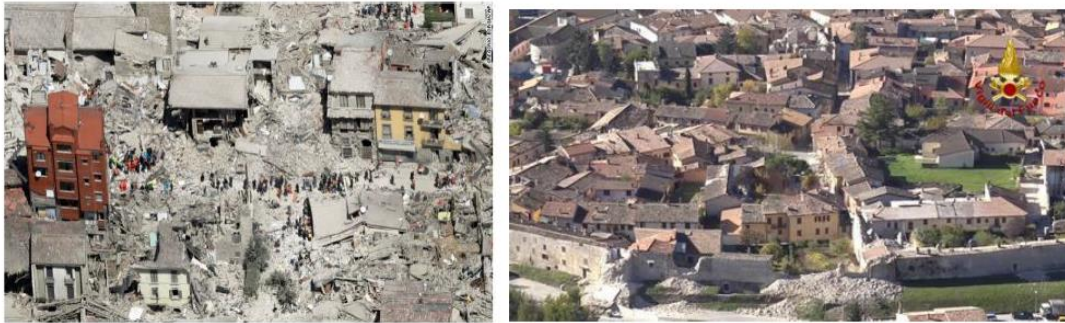
The result of the seismic crisis of August and October 2016 was the destruction of the historical core of Amatrice and a total number of 299 victims out of which 234 in Amatrice. On the contrary, in Norcia, despite damages in many houses and some collapses of historical constructions, as some of their exterior walls and churches, most of the houses were standing and, above all, no one died. Figure 3 provides a good comparison of the state of both villages after the earthquake.

Figure 3. Left) Amatrice after the August 24th earthquake. Right) Norcia after the October 30th 2016 earthquake

Most of Amatrice constructions collapsed or were severely damaged during the August 24th earthquake. Ordinary buildings had complete failures as well as civil protection buildings or buildings belonging to the cultural/educational structure of the town. The town structure was broken. For instance, the masonry wing of the Capranica elementary school collapsed and the RC wing was unusable. The RC new wing of the Grifoni Hospital was unusable. The Police Station as well as the Carabinieri and the Ranger Stations were unusable. The Roma Hotel was unusable and only one out of nine restaurants was usable. The supermarket was inoperative and 50% of agricultural activities were impractical. Due to extended damage, after the August 24th earthquake, the historical core of the town was closed to the general public, and could only be accessed under the supervision of the Italian fire brigades. This included the KnowRISK structural engineers that only got permission to visit the town when the fire brigades could receive them. The survivors of the earthquake had no alternative than to leave town and stay in hotels, in nearby villages or more far away, mainly in the Adriatic coast, while others went to live with relatives or friends.

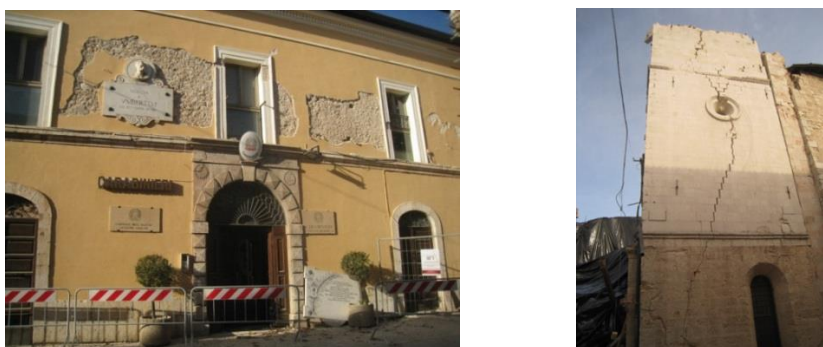
Figure 4 - Damage in Norcia after the October 2016 earthquakes

Norcia was strongly hit by the sequence of October earthquakes, mainly by the one of October 30th. However, damage was much less extensive than in Amatrice. Some monumental constructions suffered partial collapses and several constructions inside town were damaged, a few ones strongly. Figure 4 shows some of those cases. The KnowRISK team was in Norcia three times, on the 26th of October, just four hours before the 5:11 p.m UTC earthquake, on the 28th October between the major earthquakes of that week, and on the 19th December. The photos shown in Figures 4 and 5 were taken

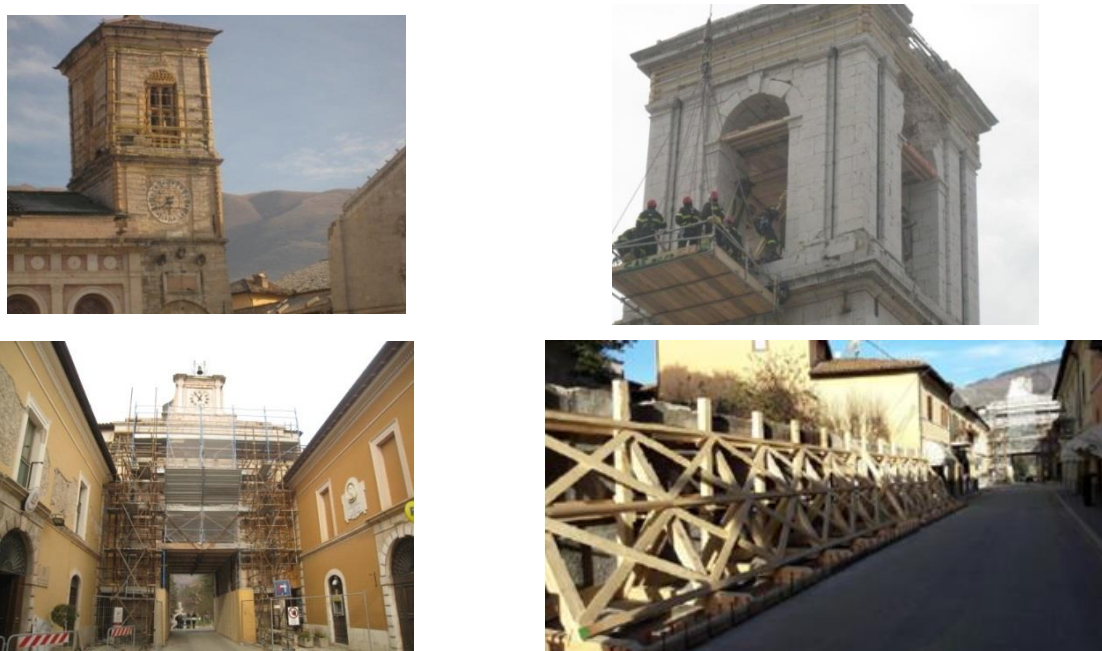
In general, in Norcia, most constructions appeared, from the outside, to have no damage or slight damage, but there were also a few with parts in risk of collapse. In these conditions, any aftershock could lead to more damage, making it unsafe to walk on the streets. Therefore, the centre of Norcia was closed to the public, until conditions to safely use the streets could be re-established. This comprises essentially two conditions: i) all constructions in which there is partial risk of collapse onto the streets must be braced to avoid that risk, and ii) the seismic crisis must be over. Regarding the first condition, when the KnowRISK team visited Norcia in December 2016, together with members of the Italian fire brigades, those works of bracing unstable structures were going on in several parts of the town, which could take a few months to complete. Figure 5 illustrates some of those cases.

Figure 5 - Bracing of unstable constructions in Norcia by the fire brigades

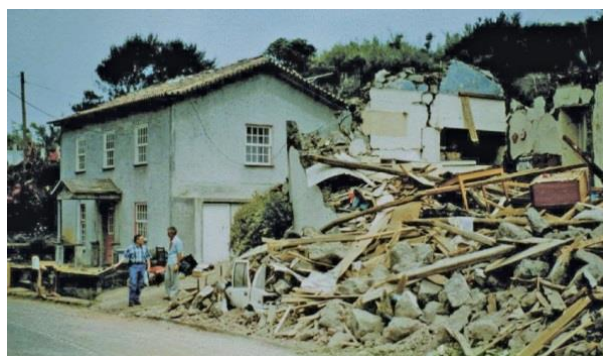
The first major lesson from the comparison of the different performances of Norcia and Amatrice constructions is that, in seismic areas, prevention pays off. The seismic strengthening of constructions is able to avoid major collapses and, most important, to save lives. Other comparisons between the seismic performance of old strengthened and unstrengthened constructions, lead to the same conclusion. This inference was also found in events of other countries. Figure 99 shows one of those examples: two adjacent houses in the island of Faial (Azores, Portugal) stroke by a violent earthquake on the July 9th 1998 (Mw 6.1). Both houses are old, and none of the original constructions had been designed to resist earthquakes. However, the left hand side house had been strengthened against earthquakes and the other had not.

Figure 9. Difference of seismic performance between adjacent constructions

The houses were so close that there were no geotechnical differences between their locations and both were subjected to the same seismic action. The comparison is clear and straightforward: the figure shows that the strengthened house resisted the earthquake with minor damage and the unstrengthened house collapsed. Therefore, it is important to draw attention of decision makers and managers of programs of urban rehabilitation in seismic zones for the importance of seismic strengthening in the rehabilitation of constructions. In seismic zones, improvement of aesthetics and living conditions of old and unsafe houses should in general be accompanied by seismic strengthening.

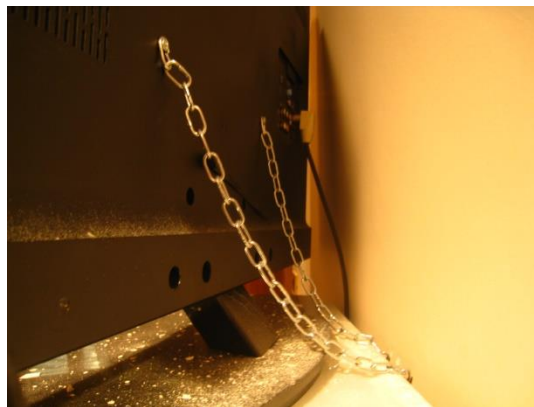
Even though properly strengthened houses survive strong earthquakes, they vibrate and deform during the vibration. These may introduce relevant non-structural damage, part of which can be avoided by appropriate measures taken by common citizens, which is the subject of the KnowRISK project. Moreover, reducing non-structural damage reduces the probability of people getting injured by falling objects and reduces economic damage. Note that the reduction of economic damage is also important for the affected populations to resume their normal life. Figure 10 shows a recent example in Norcia: during the August earthquake the television fell down and broke. After that, a new television was bought to replace the broken one, but was fixed with chains, as shown in Figure 10 (photo shot by the KnowRISK team on October 28th). With the chains, the television suffered no damage during the October 26th October earthquake. The above example has already been used by the Portuguese team in KnowRISK actions in schools, during which young students are taught how to reduce seismic risk from non-structural elements at school and at home.

Figure 10. Televisions connected to walls by chains to avoid toppling
