# 53. IWK

.....  
**PROSPECTS IN MECHANICAL ENGINEERING**

J. Schneider/ H. Tehen/ R. Stengler

## **Determination of the Scratch Resistance of Annealed and Tempered Glasses by Using UST (Universal Surface Tester)**

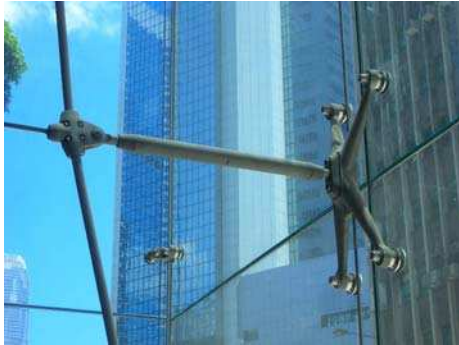
Fig. 1: Structural application of tempered glass (Point fixed glass in-plane loaded, 3 Pacific Place, Hong Kong)

The brittle nature of glass prevented real structural applications of glass in architecture up to the 1990s. Due to improvements in tempering and laminating big sizes of flat glass, today glass is not only used as a cladding material in windows or façades but also as a real structural element. More and more, the glass sustains high and permanent structural loads and even high local stresses are introduced in holes (fig. 1, 2).

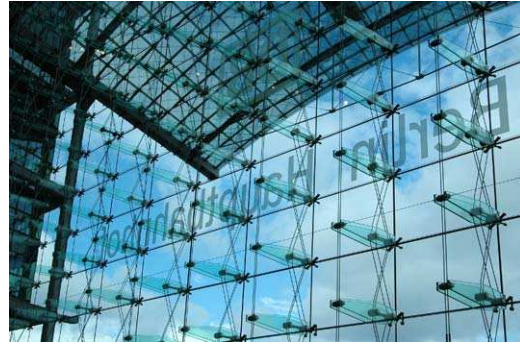
Fig. 2: Structural application of tempered glass (Glass beams, Lehrter Bahnhof, Berlin)

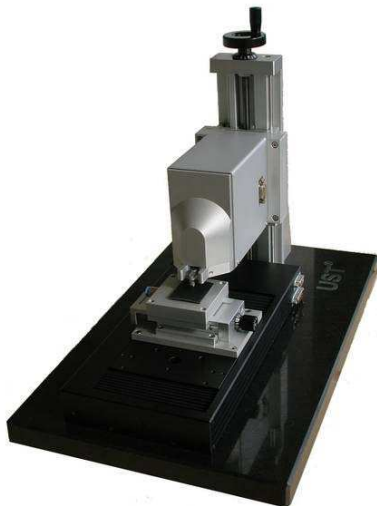
Fig. 5 UST-Universal Surface Tester

The Universal Surface Tester (UST), fig. 5 developed by company *Innowep* in collaboration with *Darmstadt University of Applied Sciences*, determines the micromechanical properties of materials near the surface.

Several standardized testing heads or spikes (e.g. different diamonds, steel needles,... ) can be used to test various types of surfaces. The procedure (fig. 6) is a scanning along a straight line divided in three steps:

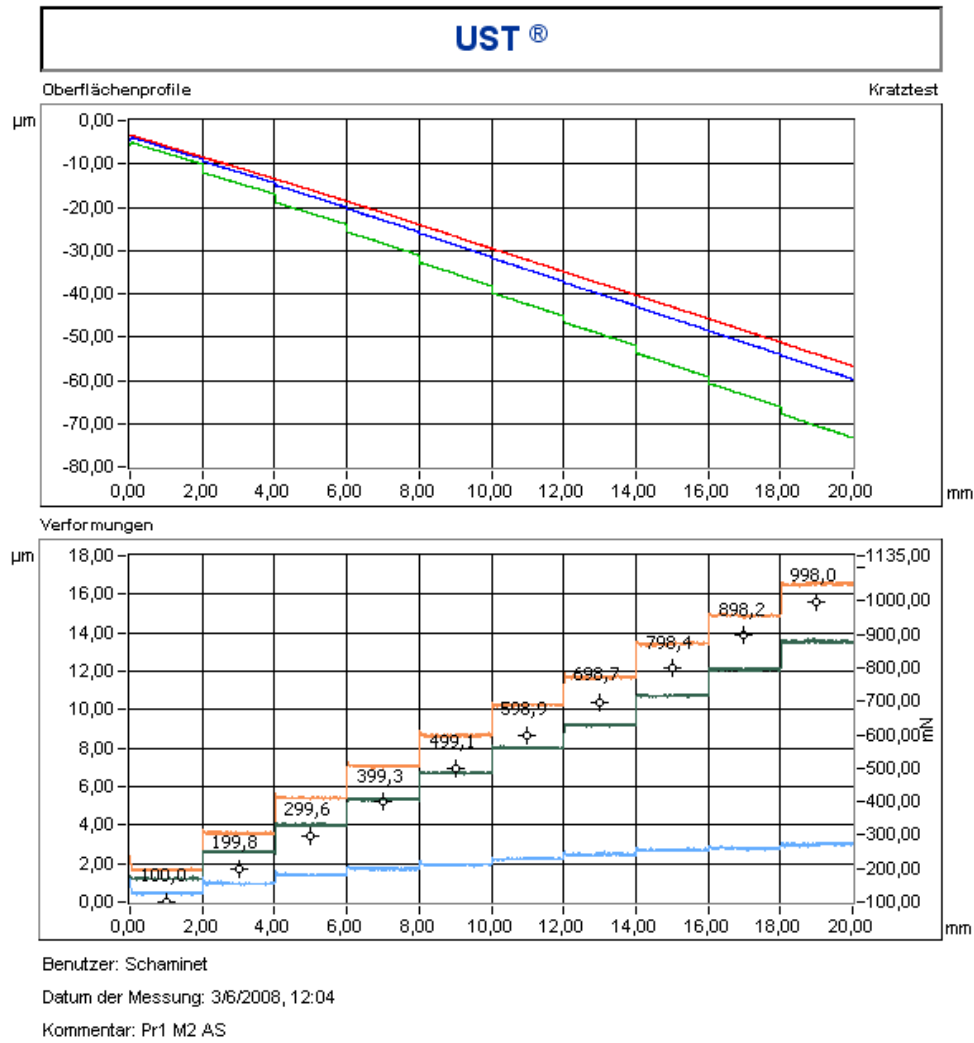
**Upper diagram:**

Red line:  
Initial surface scanning  
(step 1)

Green line:  
Scanning the surface  
while scratching with a  
defined load. Here, the  
load increased stepwise  
by 100mN  
(step 2)

Blue line: scanning the  
surface again without  
force to determine elastic  
and plastic deformation  
(step 3)

**Lower diagram:**

Orange line:  
Total deformation

Dark green line:  
Elastic deformation

Light blue line:  
Plastic deformation.

Left axis:  
Deformation [µm]

Right axis: Force [mN]

Fig. 7: Resulting diagrams for a measured surface profile and the resulting deformations due to an increased load by steps of 100 mN on a distance of 20 mm with a 60° cone diamond, 8 mm tempered glass

Figure 7 shows a typical result of a scanning process in the described three steps in two diagrams. Note that the apparent inclination of surface profile (approx.  $60 \mu\text{m}$  on a measuring length of  $20 \text{ mm} = 0,172^\circ$ ) shown in the upper diagram is only due to a slight inclination of the table below the instrument during measurement. From the diagrams it is possible to identify the load and associated deformation in detail. Moreover, any abraded material in the crack during step 2 is identified by step 2 as the graph (blue line) gets irregular in this case.
