19th World Conference on Non-Destructive Testing 2016

Comparison of NDT Techniques to Evaluate CFRP -Results Obtained in a MAIzfp Round Robin Test

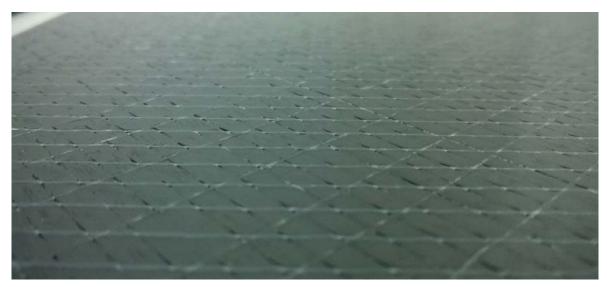
Fig. 3. Example of a CFRP specimen with porosity

The samples with porosity artifacts consisted of two series with six plates. The porosity samples from automotive (Fig. 3) had a dimension of about 420 mm x 200 mm with a thickness of 1.8 mm, 1.9 mm and 2.5 mm and zones with different porosity content. The aeronautic samples had a dimension of 420 mm x 200 mm with a non-uniform thickness and nine different porosity zones.

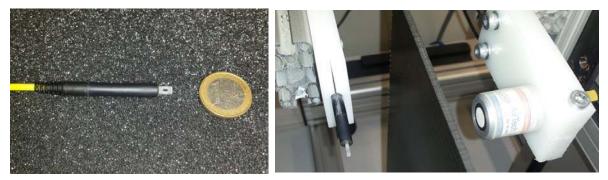
Fig. 6. Optical microphone (left) and novel configuration for ACU measurements (right) [Guruschkin 2015]

The group took the opportunity to test during the project even a new ultrasonic sensing technique, which uses a Fabry-Pérot-Etalon instead of piezoceramic materials or membranes [Guruschkin 2015]. Guruschkin showed in a close collaboration between the *Chair of Non-Destructive Testing (TUM)*, *Siemens, Xarion Laser Acoustics* and *Airbus Group Innovations*, that an optical microphone [Fischer et al. 2015] can successfully replace the receiver probe and its required preamplifier [Hillger et al. 2012] in a commercial ACU system (Fig. 6). This novel acoustic sensor without any moving parts uses the resonance of a compact and rigid Fabry-Pérot-Etalon, which is open to air. The transmitted wavelengths of the laser are altered by the refractive index of air and hence by the sound pressure in the cavity at the tip of the microphone. This optical sensor provides a high dynamic and frequency range and has the major advantage for ACU systems, that one ultrasonic air-solid transition is eliminated.
